<b>Topic</b>	Bentayga - Seven Seat - Third Row Safety Belt (RE20/06)
<b>Market area</b>	Bentley: worldwide (2WBE)
<b>Brand</b>	Bentley
<b>Transaction No.</b>	2058805/2
<b>Campaign number</b>	RB48
<b>Note</b>	
<b>Type</b>	Recall Campaign
<b>US code</b>

### Technical background

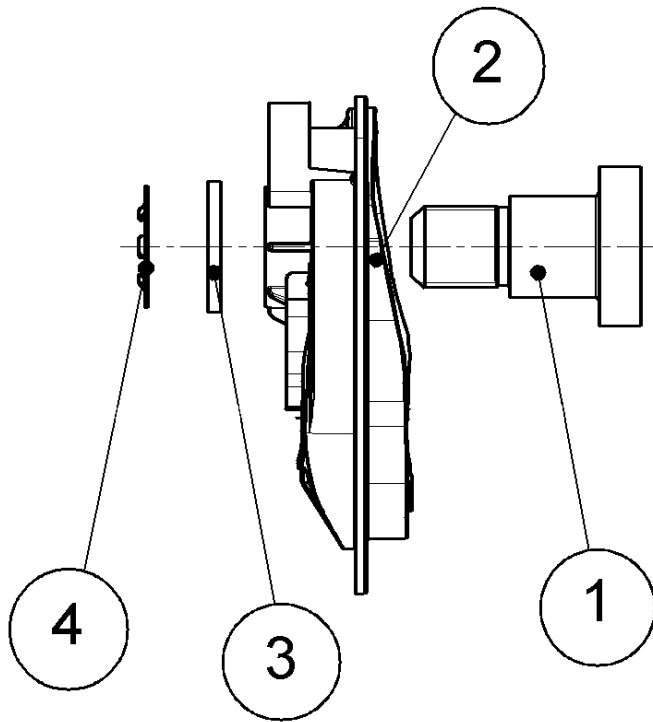
Item	Part Number	Description	Quantity Per Vehicle
1	N.912.382.01	Socket Head Collared Bolt With Inner Multipoint Head	2 off
2	4H0.857.731C / 732C	Pillar Loop	Re-Use original
3	N.909.006.02	Plain Washer	Re-Use original
4	36A.853.390	Retaining Clip	2 off
