Revision 3 May 2020

# Safety Recall W30 / NHTSA 20V-191 VP4 Radio Software

**2019 - 2020 (WD) Dodge Durango**

*NOTE: This recall applies only to the above vehicles equipped with an 8.4" radio display (Sales Code RFL).*

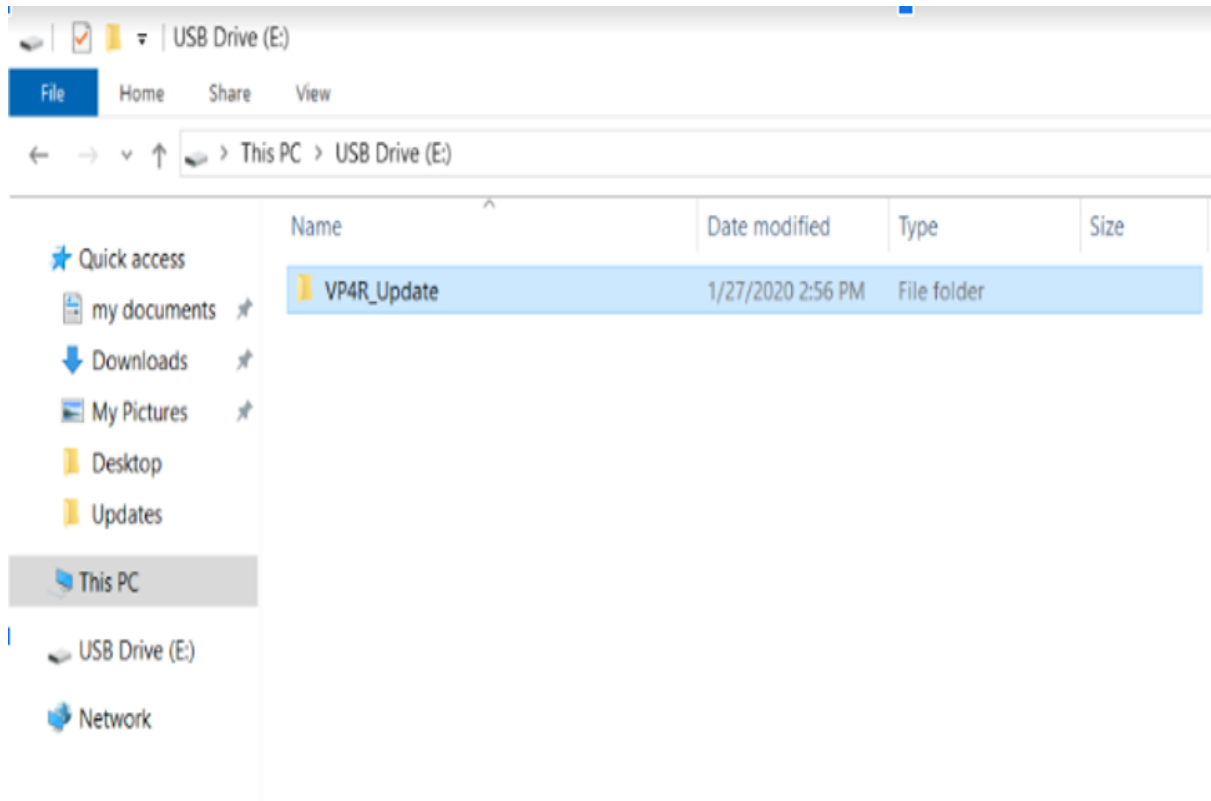
**Figure 6 – Jump Drive Mapping**

**NOTE: The jump drive should look like (Figure 6).**

16. Proceed to update the radio software file on the vehicle in section C. **Radio Software Update.**

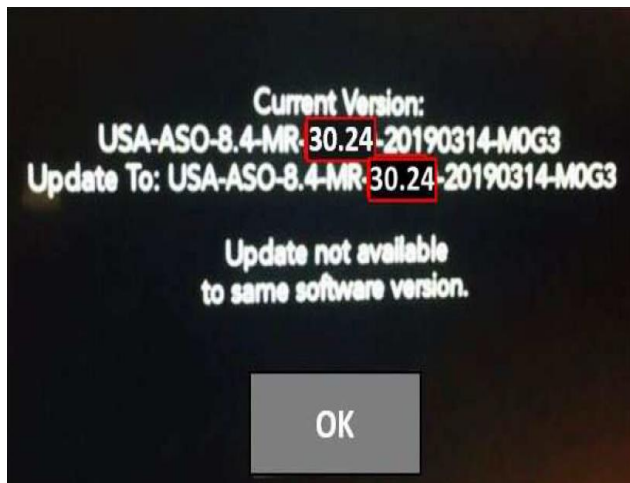
**Figure 7 – Update Screen**

2. Remove all devices (SD, USB, and AUX) from the media hub.
3. Insert the USB flash drive containing the downloaded software into the vehicle USB port.
4. Turn the ignition to the “ON” position.
5. Turn the radio to the “ON” position.
6. If the current version” and “Update To” are the same Press “OK” and remove the USB flash drive (Figure 7).

**NOTE:** The software update screen may take up to a minute before it is displayed. If the software update is not displayed, cycle the ignition to the “OFF” position and then to the “RUN” position.

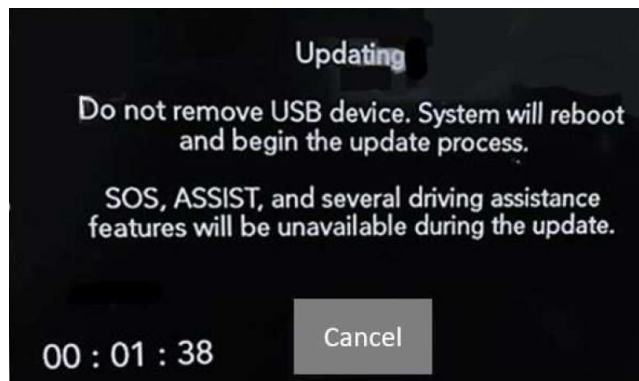
**Figure 10 – Updating Screen**

- Updating screen will be displayed (Figure 10).

**Note: If the radio update fails along the way you may receive an Error message on the screen; DO NOT remove the USB at this time. The radio will roll back to the previous software level and attempt the radio update up to three times. Please allow up to 15 minutes for the rollback to occur before the update retries.**

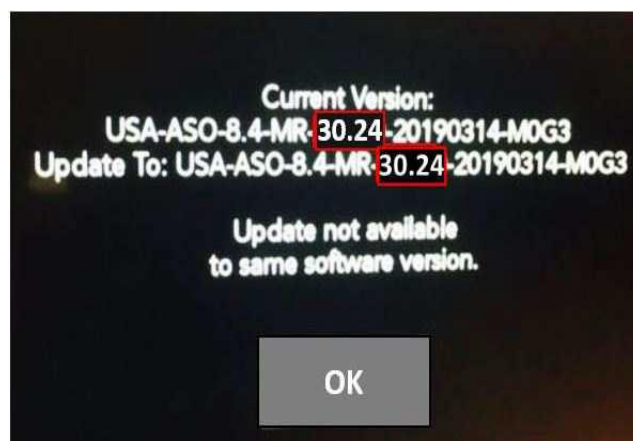
Figure 12 – Software Updated Screen

11. After the update has completed, the radio will shut down. With the USB flash drive still inserted in the USB port. If the radio has been updated correctly, the screen will be displayed. Press “OK” and remove the USB flash drive (Figure 12).

**NOTE: After performing the radio update, the radio display screen may have a ghost image that will not clear, even after turning off the ignition. This ghost image may appear on any radio screens selected. Do not replace the radio for this concern. Other features that may be unavailable would include apps, performance or off-road pages, and connectivity. Turn the vehicle off and allow the radio and vehicle to enter a full power down cycle. A full power down cycle may take between 45 to 60 minutes.**
