# Product Safety Recall

## N202303150 Chassis Harness Improperly Routed

Release Date: May 2020

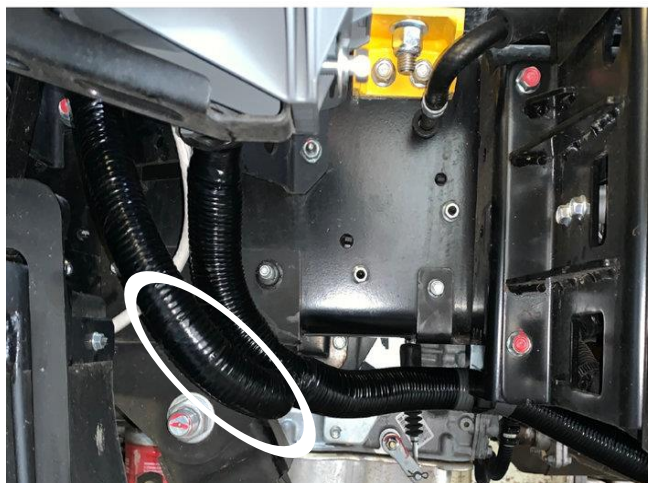
5600807

3. Inspect the Harness for contact with the Left Front, Rear Leaf Spring Hanger Bracket. Figure 1 indicates where the harness may contact the Bracket.
  - 3.1. If the harness is not contacting the spring hanger and/or there is no sign of harness damage continue to Step 4.

| <b>Correction</b> | Dealers will repair or replace the existing wire harness, as necessary, if it is damaged, and install additional clamps to ensure the undamaged or repaired/replacement wire harness is secured away from the hanger bracket. |
