## Thor Motor Coach Technical Service Bulletin

Recall #	<b>20V-339 / 2020-260</b>		
Description/Title:	LCI Frameless Windows		
Affected Product Line(s):	Certain model year 2020/2021 Ace, Axis, Compass, Delano, Four Winds, Gemini, Hurricane, Outlaw, Vegas, and Windsport motorhomes		
Service Campaign # :	<b>RC000192</b>	Released Date:	7/10/2020
Codes:	<b>Inspect Only: TMCRC80489Y</b>  <b>Inspect with Repair: TMCRC80489V</b> <i>Photos Required for Repair pre-authorization requests</i>	Document Date:	7/10/2020
Time Allowed:	<b>Inspect Only: 0.5 per VIN</b>  <b>Inspect with Repair: 0.8 (+ 0.3 for each additional window)</b>	Document Revision:	<b>A</b>

# 3000 SERIES WINDOW VENT BONDING INSPECTION

TSB Number:	TSB 15-002-19
Product:	3000 Series Windows (EPW, FV, FVD, FVSE, SEFV, SESV, SV, SVD, SVSE, VEPW)
Date:	March 6, 2020

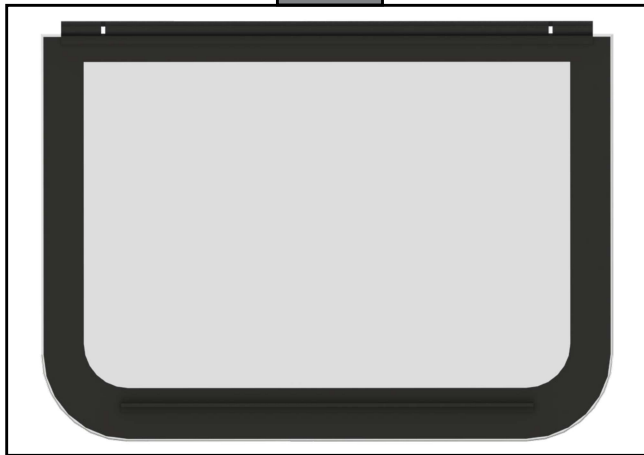
Fig. 1

This document outlines the steps for replacing the vent sash (Fig. 1) on a 3000 series window, either with or without a mullion (Fig. 2A) that is equipped with a red scissor latch.
