## Safety Recall Action Notice 584 Issue 1 - 08.2020

Subject: VIN Label Protector Fitment			
Bulletin Number	Models Affected	VIN Range	Markets Affected
584	Street Scrambler	From VIN 914448 to VIN AC6893	All Markets Except China
584	Street Twin	From VIN 914973 to VIN AC6893	All Markets Except China

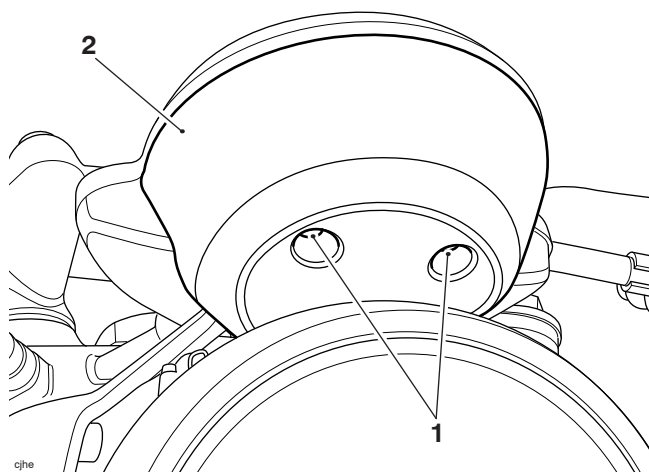
**1. Fixings**

**2. Instruments cover**

- 
- Remove the instruments cover and discard the two fixings.

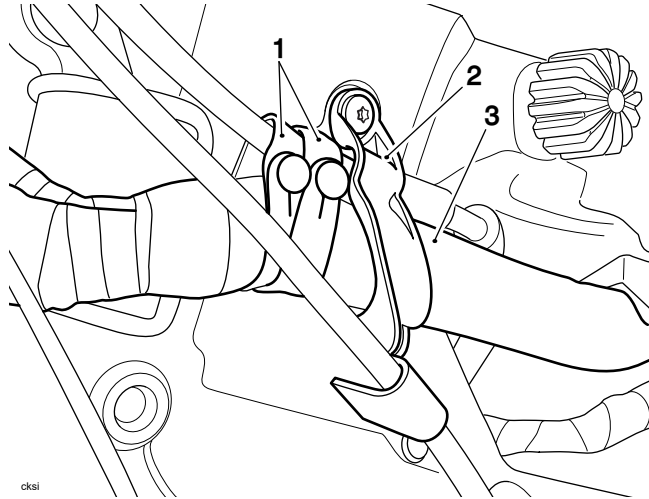
- 1. Rubber bands
- 2. Harness guide
- 3. Harness

17. Feed the harness behind the clutch cable then in between the left hand fork leg and headstock.
18. Reconnect the harness instruments connector.
19. Refit the instrument cover with two new fixings and tighten to **3 Nm**.
20. Refit the headlight and headlight bowl as described in the Service Manual.
21. Refit the harness guide with two new fixings and tighten to **1.5 Nm**.

22. Refit the two rubber bands securing the harness to the brake hose.
