# Safety Recall

## Code: 72L1

Audi

<b>Subject</b>	Front Seat Backrest Frame Welds																												
<b>Release Date</b>	September 23, 2020																												
<b>REVISION SUMMARY</b>	<p>Revised inspection procedure to clarify how to inspect the backrest frames.</p> <p>The expected failure rate is less than 1% for this Safety Recall.</p> <ul style="list-style-type: none"> <li>Some unexpected parts ordering activity was noticed early on with this action.</li> <li>With guidance and feedback from the field, it was determined that further clarification of the inspection procedure would be useful to help avoid parts ordering in cases where replacement parts are not needed.</li> <li>Please note: ordering parts for stock will create back orders, unnecessary returns, obsolescence and scrapping. DO NOT order parts unless they are absolutely needed for a repair.</li> </ul>																												
<b>Affected Vehicles</b>

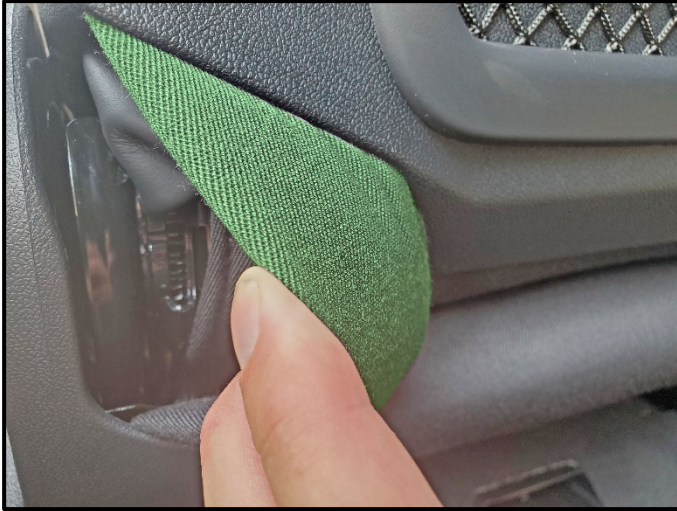
**Method 1:**

- Carefully pull the fabric away from the recline mechanism.
- If the fabric cannot be pulled away without potentially damaging the fabric, or if the recline mechanism cannot be accessed, use method 2 to access the recline mechanism.

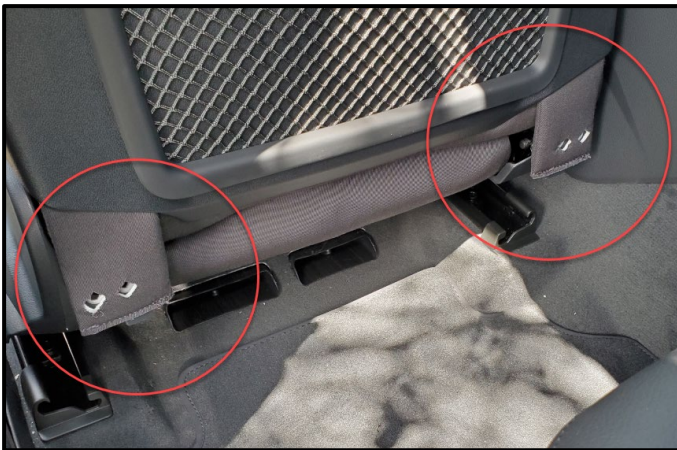
**Method 2:**

- Carefully pull away the plastic side trim from the backrest and remove the fabric trim from behind the seat trim.

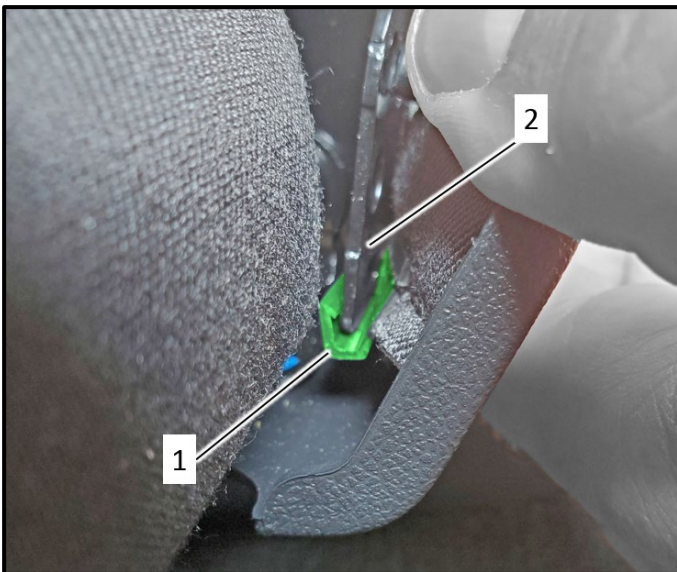
- If the fabric trim is removed, be sure to reinstall it so the bottom hook <1> is secured on the seat frame <2>.
