# Product Safety Recall

## N202316700 Starter Ground Cable Breakage – US Only

**Release Date:** October 2020

| <b>Condition</b> | Isuzu Motors Limited has decided that a defect, which relates to motor vehicle safety, exists in certain 2018-2021 model year Chevrolet 6500XD Low Cab Forward vehicles produced before August 14, 2020. In the affected vehicles, the ground cable connecting the starter motor to the vehicle frame may break at the starter-side eyelet, which can result in an engine no-crank or slow-crank condition, causing the vehicle not to start. If the driver attempts to start the engine after the cable has broken, electrical current will flow through the steel braiding of the power steering hose rather than through the broken cable, generating heat within the power steering hose. Once the cable is broken, if the driver makes repeated efforts to restart the engine or if the key is held in the engine start position for an extended period of time, enough heat may be generated to melt and potentially to rupture the power steering hose. If the power steering hose ruptures, power steering fluid may leak onto a hot engine or exhaust surface increasing the risk of a fire. |

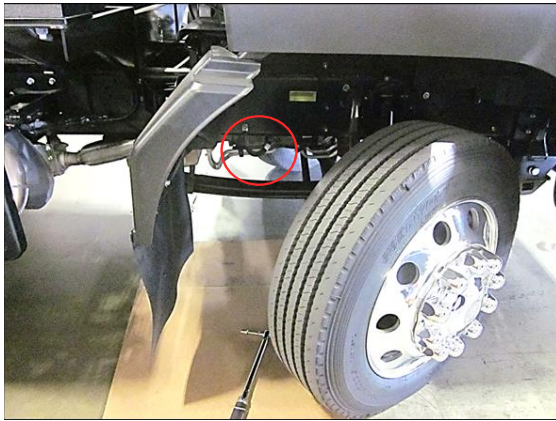
5652001

2. At right side of vehicle, close to rear of the front tire, locate starter ground cable.

4. Remove bolt from the starter end of the grounding cable.
5. Clean the area of the frame and the starter where the starter ground cable is mounted. Remove any rust or dirt that may interfere with the connection.
