David J. Johnson
 Director
 Service Engineering Operations
 Ford Customer Service Division

January 20, 2021

SUBJECT: **NEW VEHICLE DEMONSTRATION / DELIVERY HOLD**
Safety Recall 20S69 – Supplement #1
 Certain 2021 Model Year Aviator Vehicles
 Front Wheel Knuckle Inspection

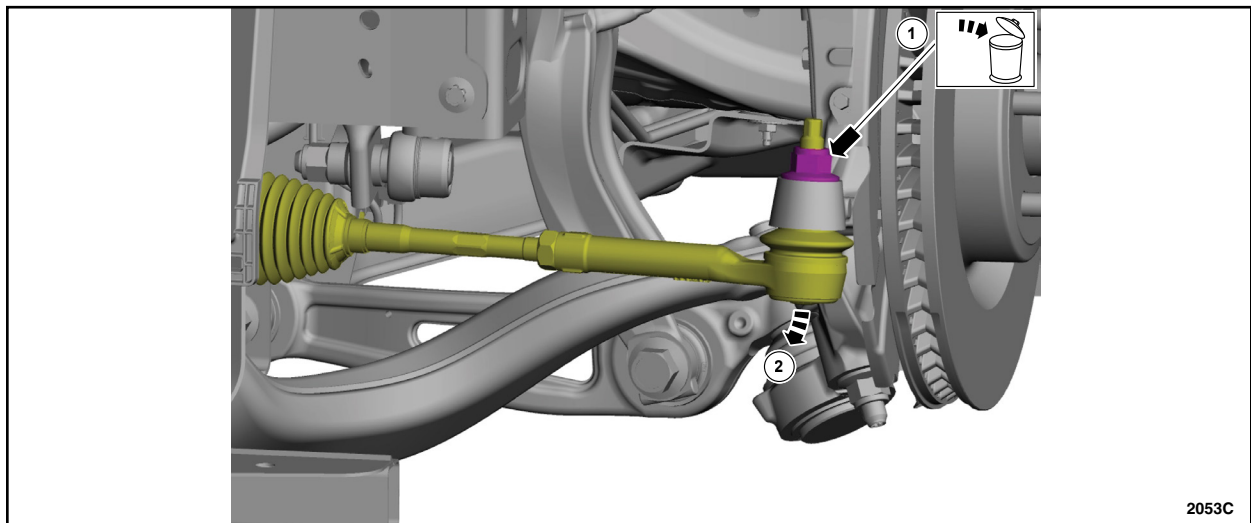
FIGURE 3

7. Remove the front wheel bearing and wheel hub. Please follow the Workshop Manual (WSM) procedures in Section 204-01A for RWD vehicles and Section 204-01B for AWD vehicles.
8. Separate the outer tie-rod end from the wheel knuckle. See Figure 3.
 1. Remove and discard the tie rod end nut.
Torque: 52 lb.ft (70 Nm)
 2. Separate the tie rod end from the wheel knuckle.
Use the General Equipment: Tie Rod End Remover

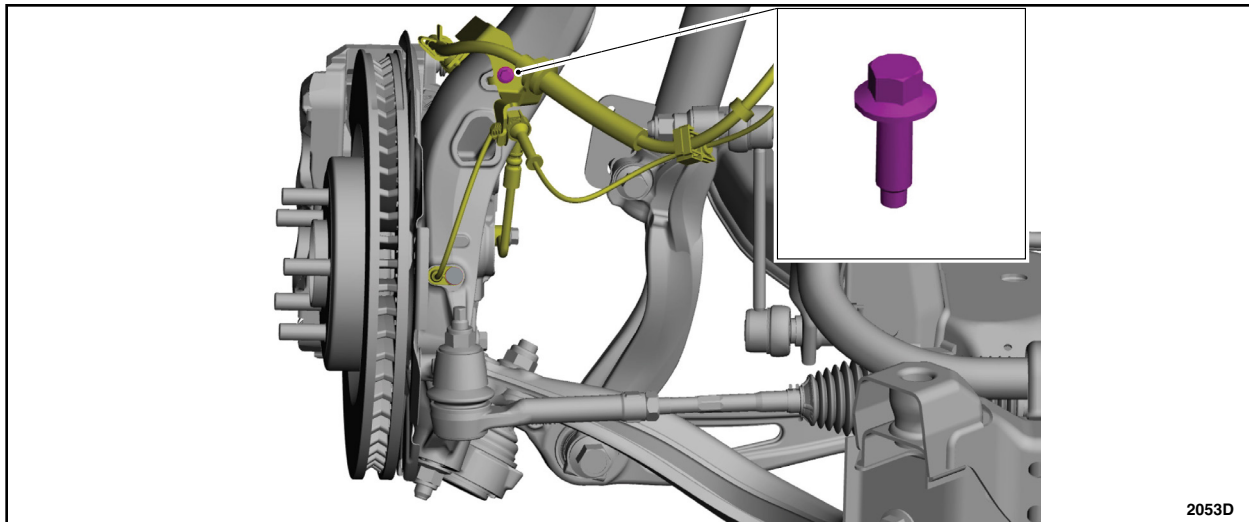
FIGURE 4

9. Remove the brake hose bracket bolt and position aside the brake hose. See Figure 4.
Torque: 133 lb.in (15 Nm)

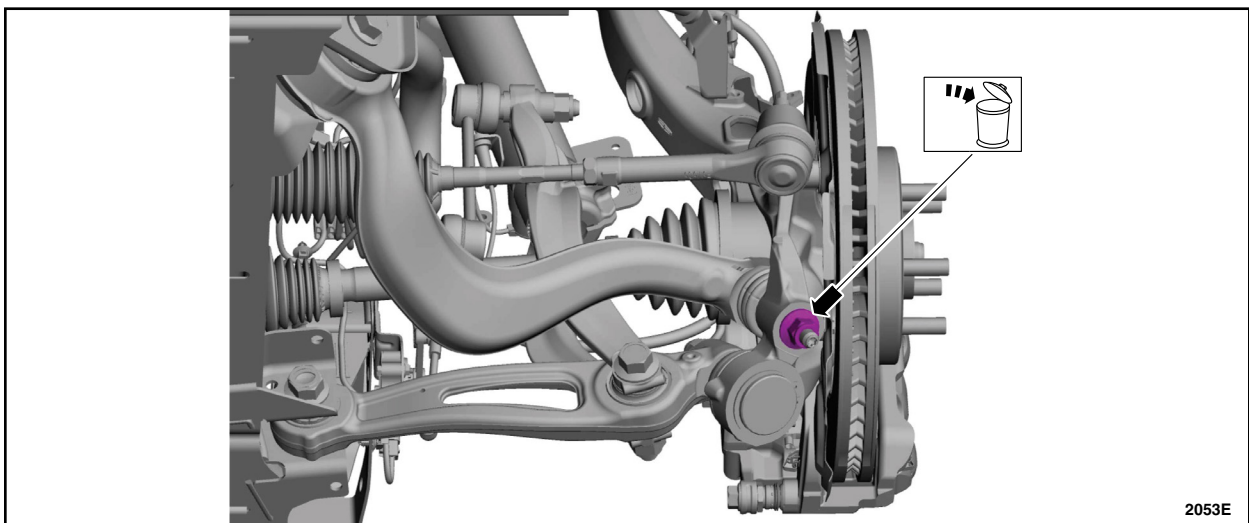
FIGURE 5

10. Remove and discard the front lower arm outboard nut. See Figure 5.
Torque: 76 lb.ft (103 Nm)

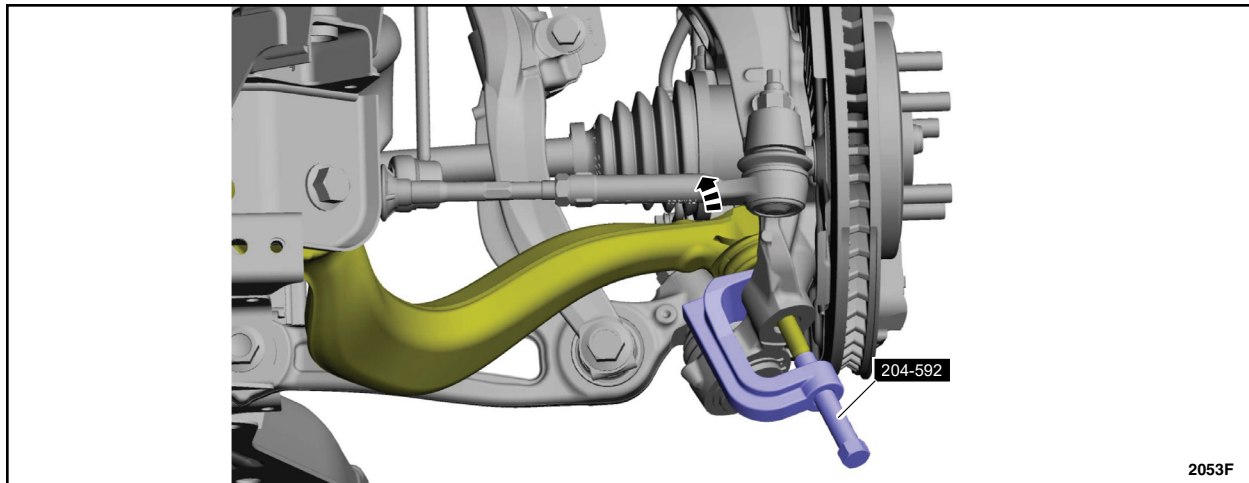
FIGURE 6

11. Separate the front lower arm from the wheel Knuckle. See Figure 6.
Use Special Service Tool: 204-592 Separator, Lower Arm Ball Joint.

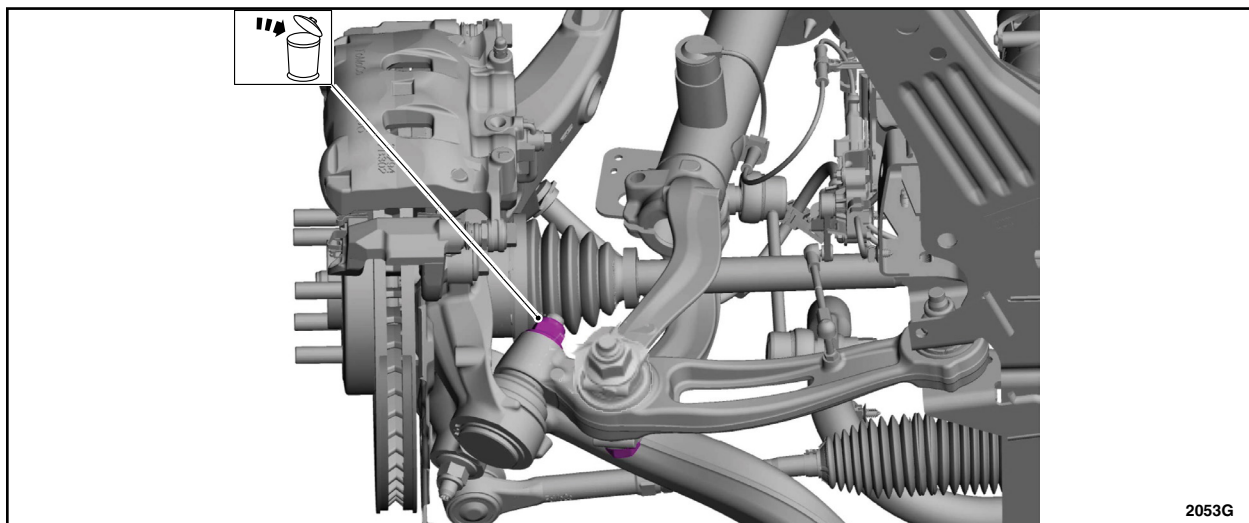
FIGURE 7

12. Remove and discard the rear lower arm outboard nut. See Figure 7.
Torque: 210 lb.ft (285 Nm)

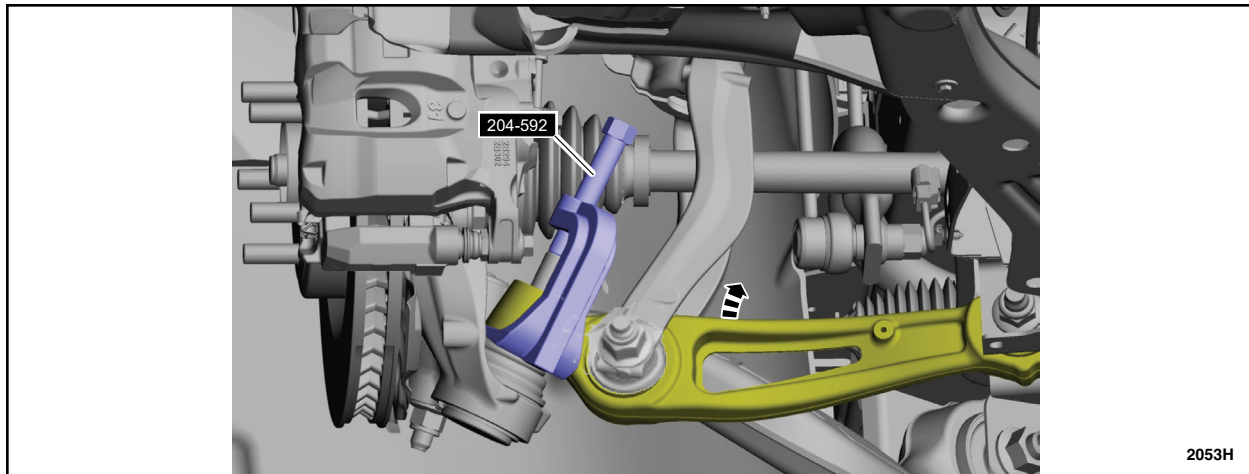
FIGURE 8

13. Separate the rear lower arm from the wheel Knuckle. See Figure 8.
Use Special Service Tool: 204-592 Separator, Lower Arm Ball Joint.

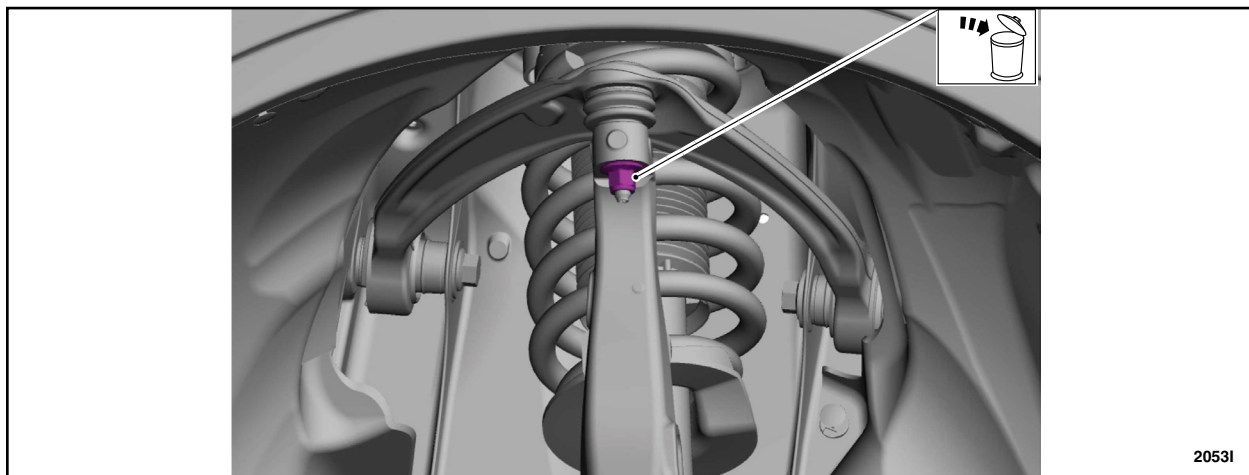
FIGURE 9

14. Remove and discard the upper ball joint nut. See Figure 9.
Torque: 41 lb.ft (55 Nm)

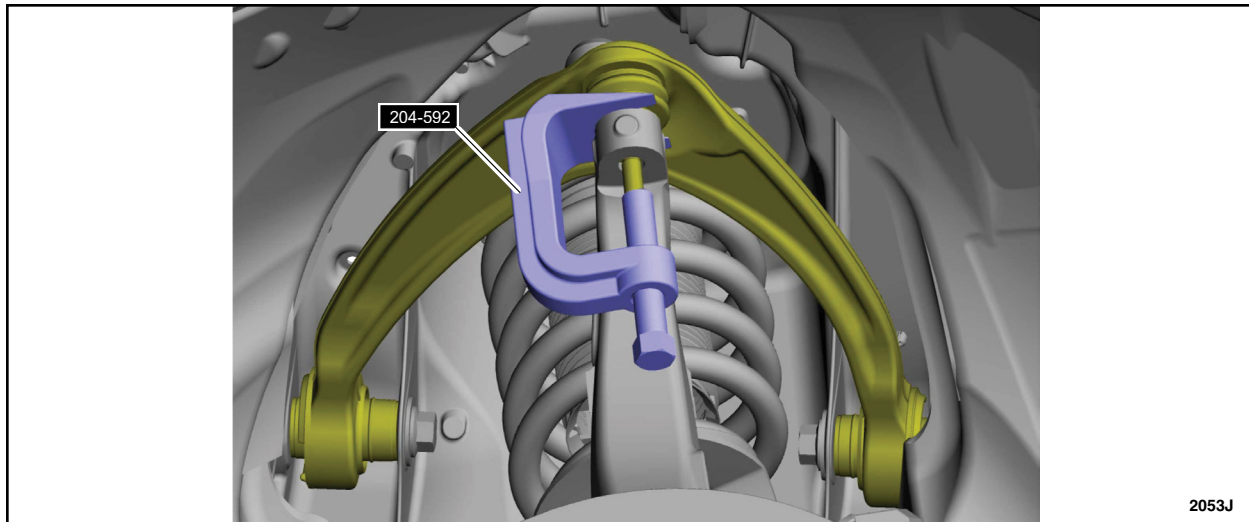
FIGURE 10

15. Separate the front upper arm from the wheel Knuckle. See Figure 10.
Use Special Service Tool: 204-592 Separator, Lower Arm Ball Joint.

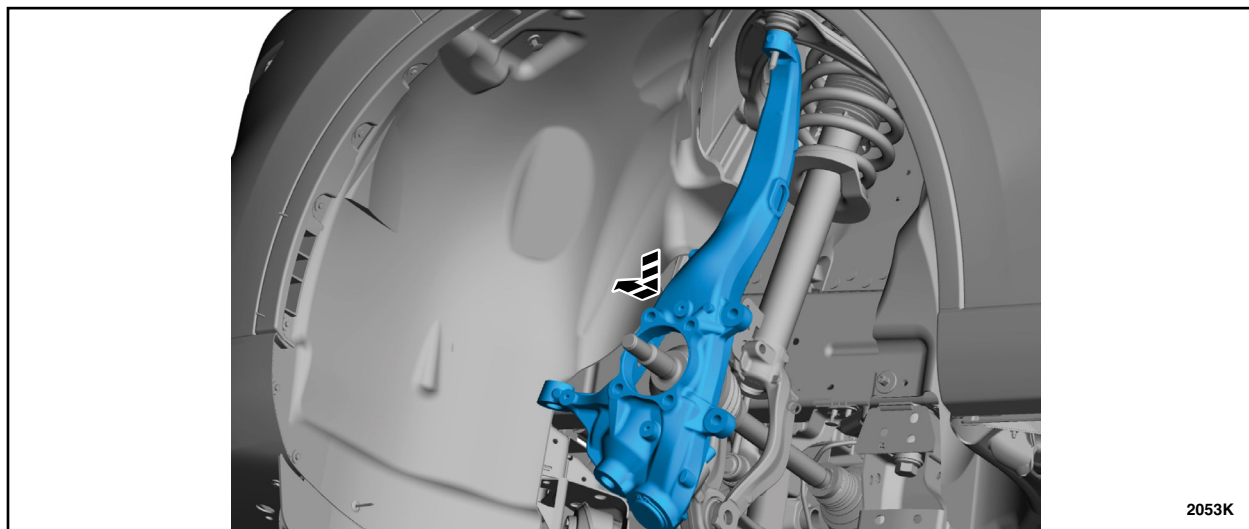
FIGURE 11

16. Remove the wheel Knuckle. See Figure 11.
