GROUP
Safety Recall Campaign

NUMBER
SC200** (Rev 1, 04/16/2021)

**SUBJECT: ENGINE BCT / OIL & FUEL LEAK INSPECTION
AND SOFTWARE INSPECTION (SC200**)**

This bulletin provides the procedure to 1) perform the Bearing Clearance Test (BCT) and 2) inspect the engine compartment for engine oil and/or fuel leaks and 3) make any necessary repairs, including engine replacement, if necessary, on the vehicles listed in the table below. Carefully follow the flowchart on page 2 for detailed instructions of the inspection procedures. In addition, check to confirm the vehicle has the latest KSDS software installed in the ECU and if necessary, apply the improved logic described in this bulletin on page 2. Before conducting the procedure, verify that the vehicle is included in the list of affected VINs.

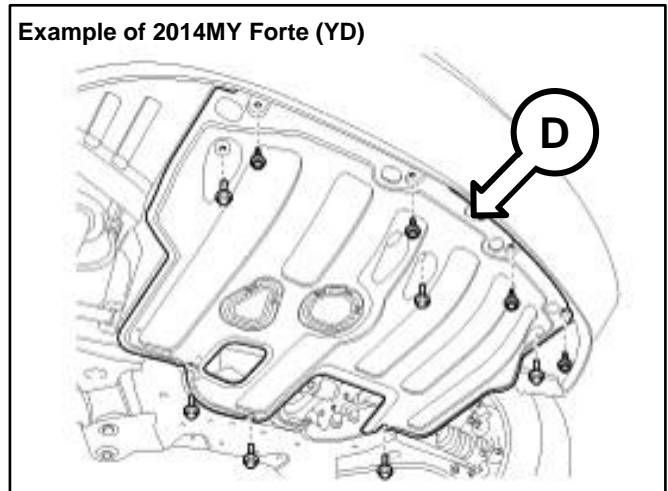
3. Raise the vehicle on a hoist and remove the undercover(s) (D).

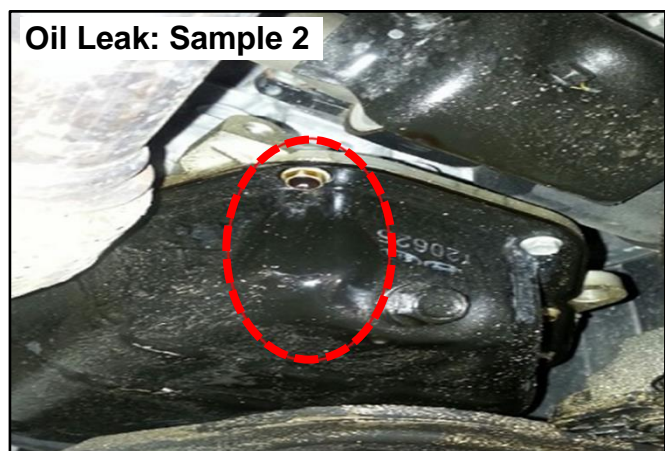
- 4a. Visually inspect for oil leaking from the oil pan seal area.
- 4b. **If oil leakage is found**, (refer to sample images shown), replace the oil pan by referring to the “Engine Mechanical System → Lubrication System → Oil Pan → Repair procedures” chapter in the applicable Shop Manual on KGIS.
- 4c. Open a Techline case and submit PWA.

For this Oil Leak Inspection, replace Oil Pan **ONLY** with a PWA's confirmation of an apparent visible oil pan leak.

- Be sure to tighten bolts to specifications found on KGIS **within 5 minutes** of sealant application.
- Wait at least 30 minutes after assembling the oil pan, to allow sealant to dry completely and refill engine oil.
