# RECALL CAMPAIGN BULLETIN

Classification: EC20-029	Reference: NTB20-089	Date: December 8, 2020
-----------------------------	-------------------------	---------------------------

## VOLUNTARY SAFETY RECALL CAMPAIGN 2020 TITAN AND TITAN XD; EGI HARNESS

**CAMPAIGN ID #:** PC773  
**APPLIED VEHICLES:** 2020 Titan and Titan XD (A61)  
**APPLIED ENGINE:** VK56VD (Gasoline V8)

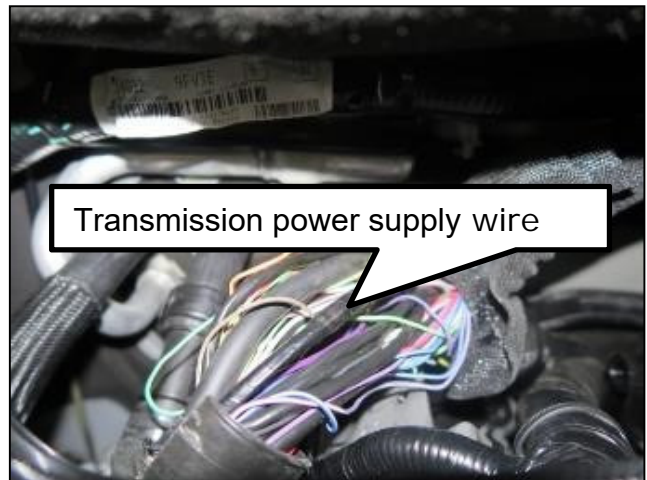
Figure 16

- Identify the transmission power supply wire for repair.

- The transmission power supply wire is located near the center of the EGI harness.
- The transmission power supply wire is completely wrapped with vinyl tape.
