Service Bulletin

20-122

December 11, 2020 Version 1

Safety Recall: 2002-06 CR-V Driver's Power Window Switch (Only VINs that start with SHS)

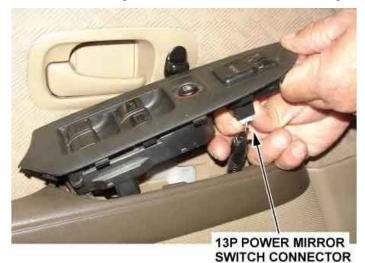
- 3. Disconnect the two connectors from the driver's power window master switch. Inspect the 20-pin power window master switch connector for any damage.
 - If no damage is found on the harness connector, go to REPAIR PROCEDURE A on page 4.
 - If there is damage found on the harness connector, go to REPAIR PROCEDURE B on page 5.
