Subject: Battery Compartment Cable Routing Inspection & Correction			
Field Change Program: Field Campaign	FCP Number: 491	Revision: A	Date: 02/22/2021
Coach Section: 07-Electrical	P/N: N/A		Type: Safety Recall

Ref. NHTSA Recall No.: 21V-063	Ref. Transport Canada Recall No.: 2021-058
--	--

1.0 Description

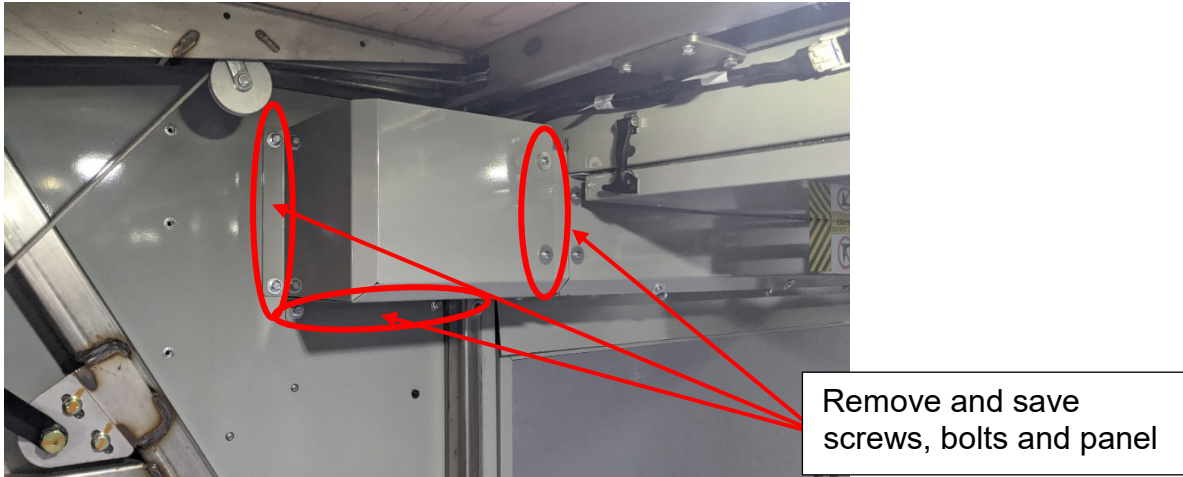
In baggage bay #3 compartment, remove and save five bolts and two screws securing the battery compartment access panel. Save the panel.
