Safety Recall Code: 69BY

Subject	Passenger Occupant Detection System (PODS)					
Release Date	February 17, 2022					
REVISION SUMMARY	Updated PODS programming information					
Affected Vehicles	Country	Beginning Model Year	Ending Model Year	Vehicle	Vehicle Count	
	USA	2015	2019	A3 CABRIOLET	11,736	
	USA	2016	2018	A3 ETRON	9,573	
	USA	2015	2020	A3 SEDAN	113,168	
	USA	2017	2020	RS3 SEDAN	4,147	
	USA	2015	2020	S3 SEDAN	14,536	
	CAN	2016	2020	A3 CABRIOLET	1,742	
	CAN	2016	2018	A3 ETRON	1,384	
	CAN	2016	2020	A3 SEDAN	10,665	
	CAN	2018	2020	RS3 SEDAN	1,610	
	CAN	2016	2020	S3 SEDAN	2,804	
Problem Description	✓ Cam ✓ If Els the s The passenge passenger a However, th	paign status mu sa shows other of same time the ve ger occupant of irbag even the e airbag sys	ist show "open open action(s), shicle is in the detection sys ough the sea tem and the	" inform your customer so that the work workshop for this campaign. stem (PODS) may detect a malfu at may be occupied. e warning strategy operate as	<i>can also be com</i> nction and swi designed. If t	ipleted at

Subject: Safety Recall 69BY – Passenger Occupant Detection System (PODS)

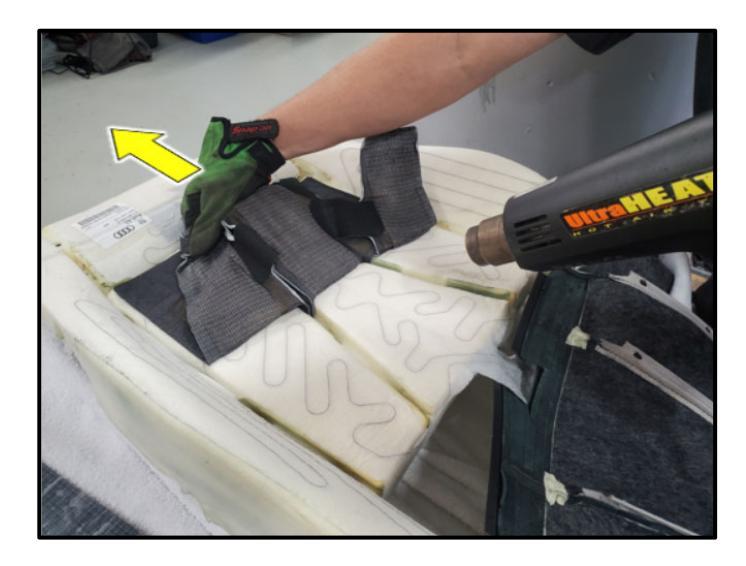
Before removing the sensor mat from the seat cushion, verify the resistance of the seat heater element (if equipped):

- Check and record the resistance between pins 3 and 4 of the T6j connector.
- Checking the resistance prior to removing the PODS sensor mat confirms the integrity of the seat heater element.
- If the seat heating element is found damaged (open circuit or high resistance) prior to replacing the PODS sensor mat, the customer must be informed.

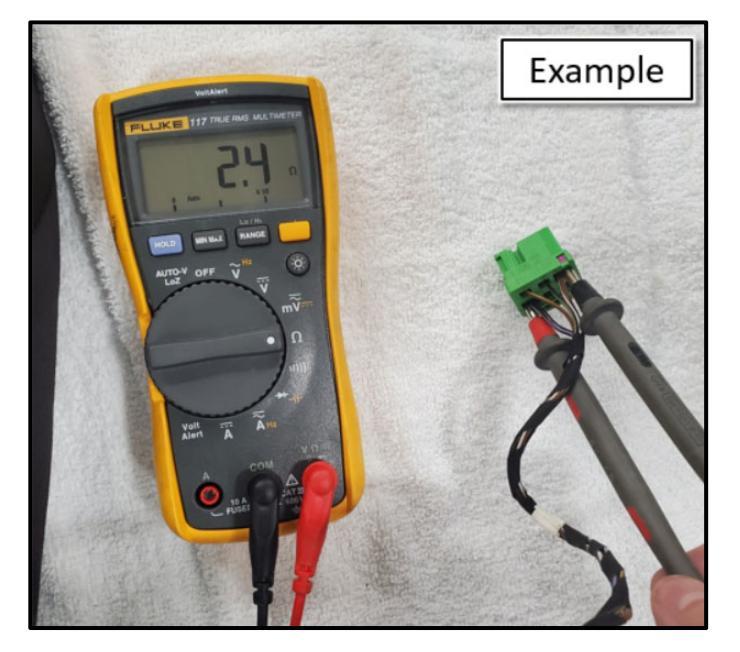
Verify seat heater resistance:

- Check and record the resistance between pins 3 and 4 of the T6j connector.
- Checking the resistance after installing the PODS sensor mat confirms the integrity of the seat heater element.

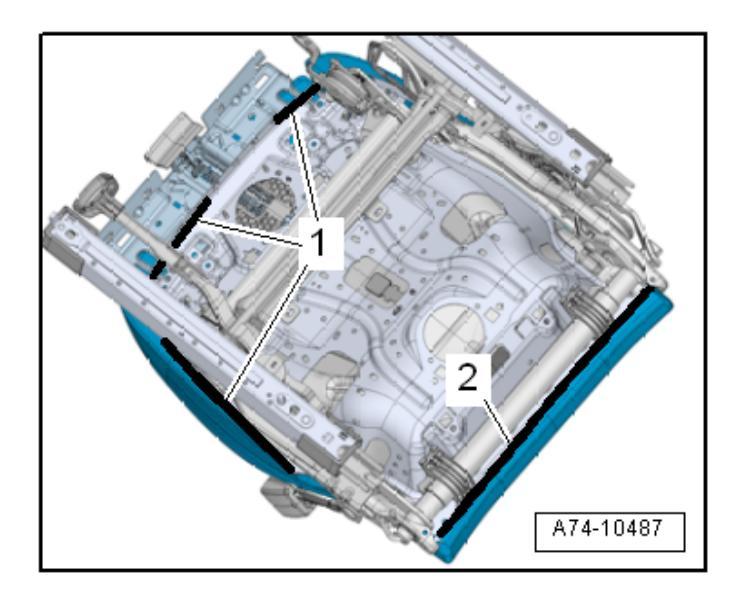
• Ensure seat foam <arrows> is fully engaged over the rear of the seat pan <1>.

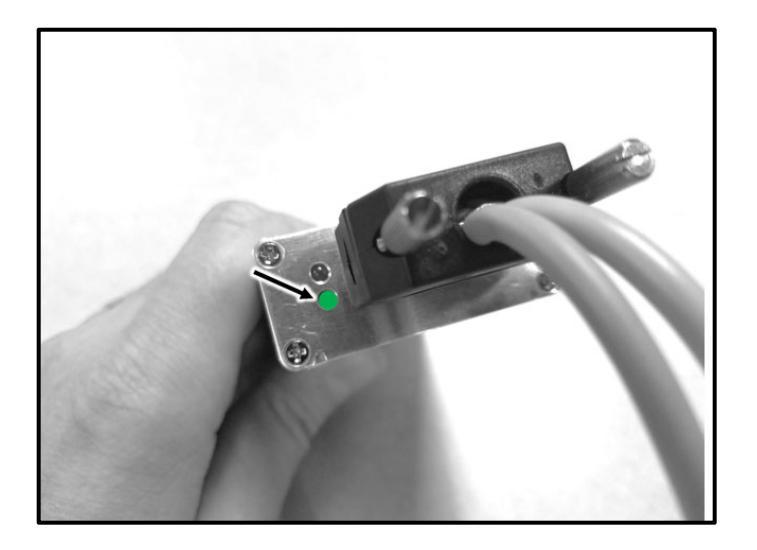
- A green flashing light <arrow> indicates successful programming. This will take about three minutes.
- Turn ignition off.
- Disconnect 12V outlet connection.
- Disconnect Programmer from PODS connector.
- Connect PODS wiring harness connector to PODS ECU.
