AMA9 – Replacing Threaded Connections on Rear Trailing Arm (Stop Delivery/Recall Campaign)

Model Line: **Cayenne (9YA)/Cayenne Coupé (9YB)**

Model Year: **2021**

Concerns: **Rear-axle trailing arms**

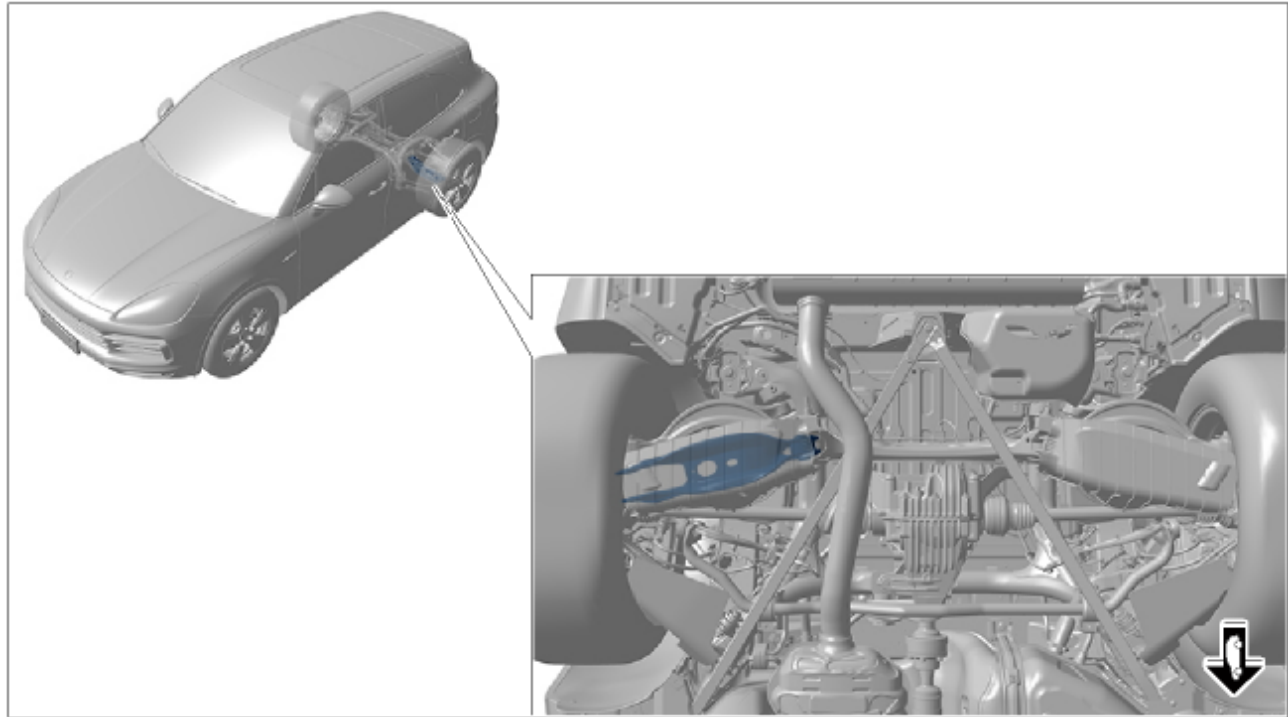
Installation position of trailing arm

Information: **There is a possibility that clamping nuts that were not manufactured within the specified parameters were installed on the rear-axle trailing arms on the affected vehicles.**

This can result in stress corrosion cracking on the clamping nuts, which may cause the clamping nuts to break over the service life of the vehicle. A broken clamping nut can result in increased play between the trailing arm and wheel carrier and as a result, vehicle handling may suddenly be impaired.

Action required: **Replace clamping nuts on the rear-axle trailing arms.**
