Safety Recall

Code: 42L1

Audi

Subject Rear Axle Trailing Arm Lock Nut

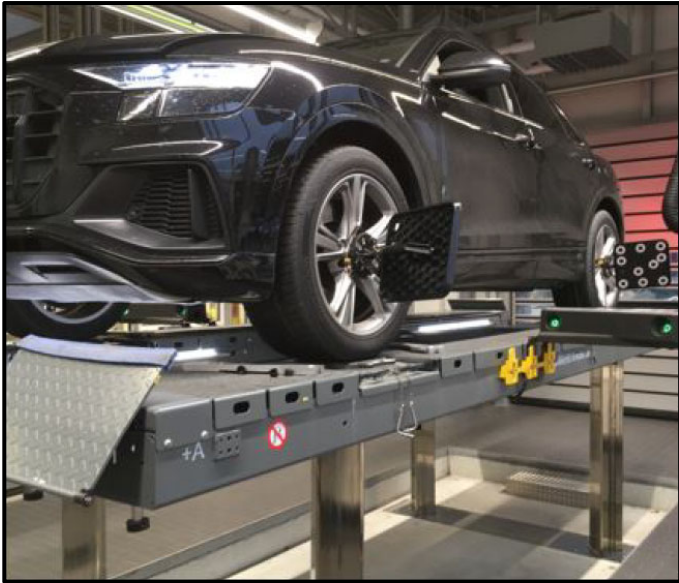
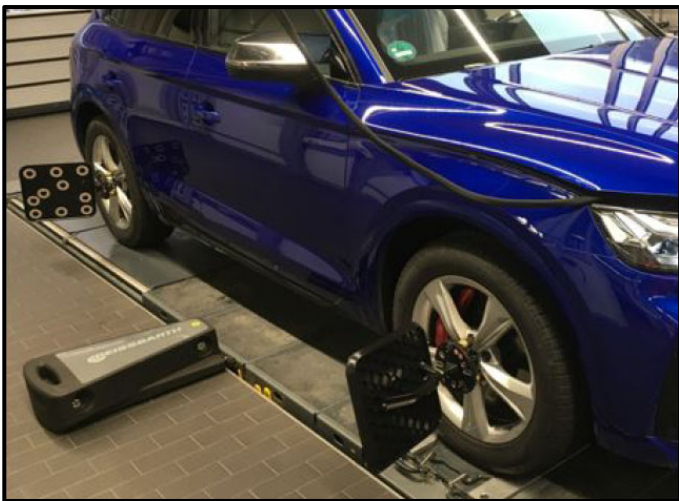
- The nuts at connection <1> of both rear lower control arms <2> will be replaced.

- Perform an initial wheel alignment measurement:
 - Refer to your Alignment Equipment Instructions and ELSA Repair Manual: *Repair manual > Chassis > Suspension, Wheels, Steering > 44 Wheels, Tires, Wheel Alignment*

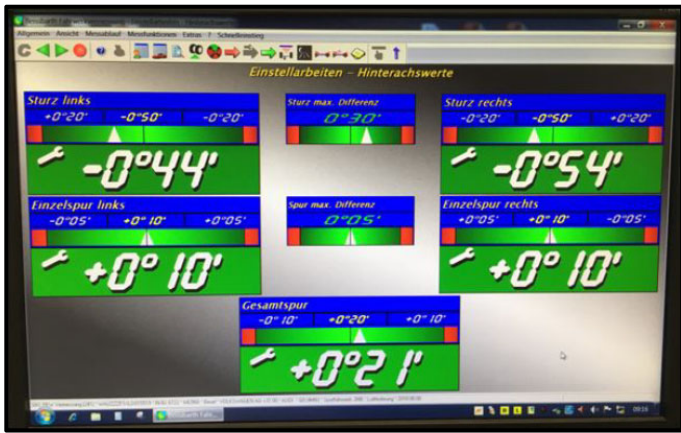
It is not normally necessary to adjust the toe setting directly.

- A record of the measurements (initial and final measurements) must be archived at the dealer.
