HYUNDAI
Technical Service Bulletin

GROUP RECALL	NUMBER 21-01-052H
DATE JUNE, 2021	MODEL(S) SANTA FE SPORT (AN)

SUBJECT: ABS MODULE INSPECTION AND MULTI-FUSE INSTALLATION
 (RECALL CAMPAIGN 205)

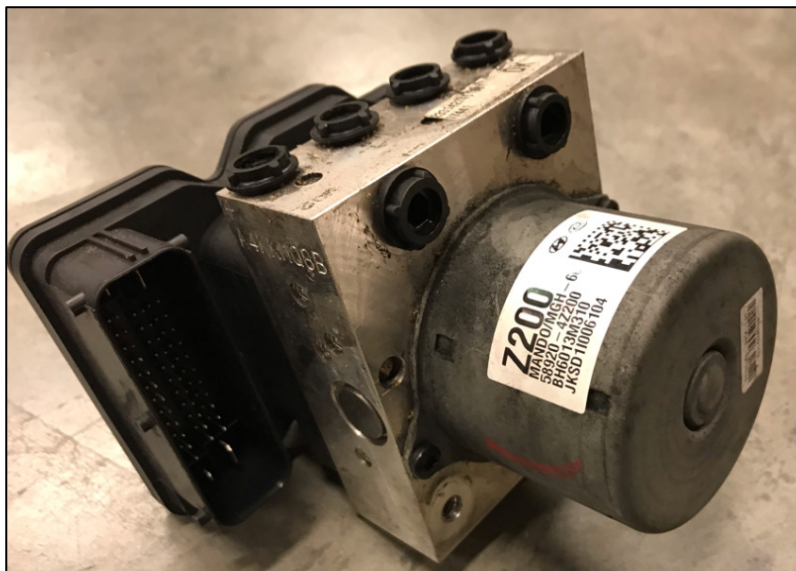
Description: Certain 2013-2015MY Santa Fe Sport (AN) vehicles equipped with Anti-lock Brake System (“ABS”) modules may leak brake fluid internally and cause an electrical short over time. An electrical short in the ABS module could increase the risk of an engine compartment fire. This bulletin describes the procedure to inspect the ABS module, replace the multi-fuse, and if necessary replace the ABS module.
