**SUBJECT: NEW VEHICLE DEMONSTRATION / DELIVERY HOLD -  
 Safety Recall 21S22**

Certain 2016 - 2019 Model Year Explorer Vehicles equipped with Painted Roof Rail Covers  
 Roof Rail Cover Detachment

## CERTAIN 2016-2019 MODEL YEAR EXPLORER VEHICLES — ROOF RACK REPAIR

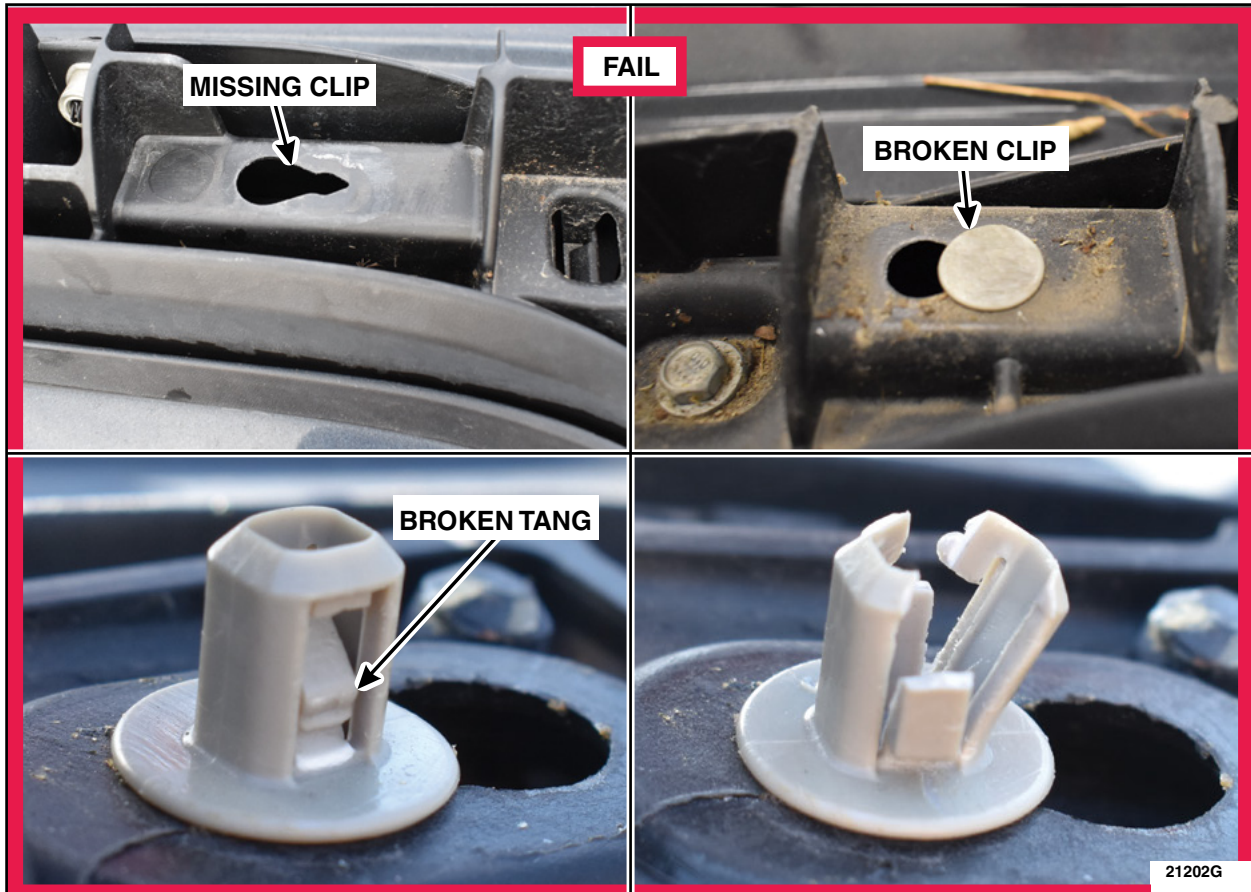
FIGURE 8

c. Inspect the retaining clips (7 per side) on the affected side without removing them from the roof rail base. See Figures 7, 8 and 9.

- Missing.
- All or partial of the top missing from the clip base.
- Broken retaining tang.
- Covered in epoxy from a previous repair.

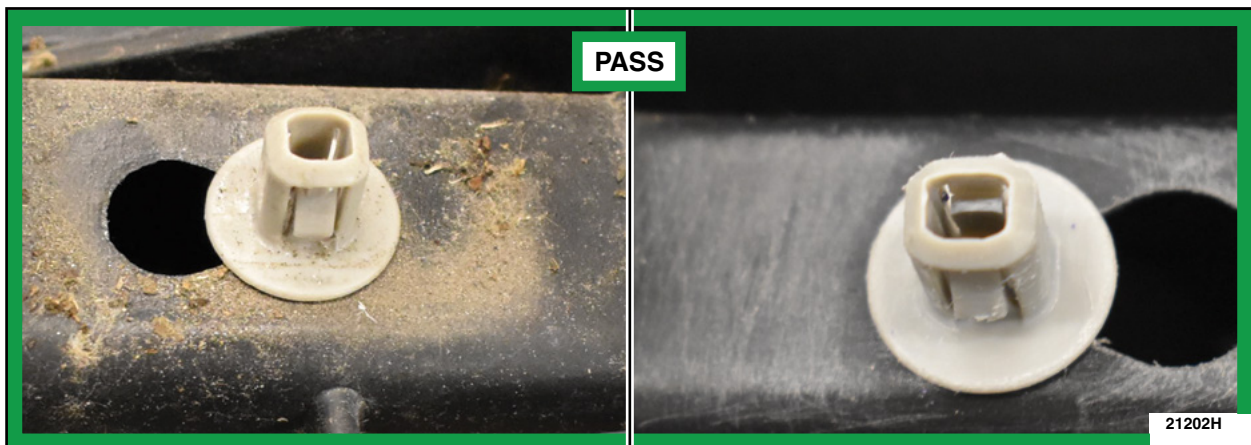
FIGURE 9

d. Inspect the retaining towers (7 each side) on the interior or underside of the affected roof rail cover(s). See Figure 9.

i. Broken tangs do not require replacement.
