RECALL CAMPAIGN BULLETIN

Classification: RS21-005A	Reference: NTB21-060A	Date: August 24, 2021
------------------------------	--------------------------	--------------------------

VOLUNTARY SAFETY RECALL CAMPAIGN 2021 ROGUE; REAR SEAT TETHER INSPECTION

CAMPAIGN ID #: PC812
APPLIED VEHICLES: 2021 Rogue (T33)

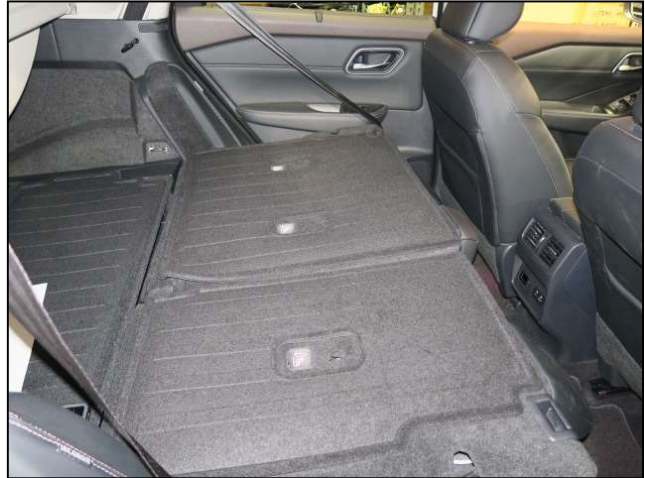
Figure 1

1. Open both rear passenger doors.
2. Lower both rear seat backs.

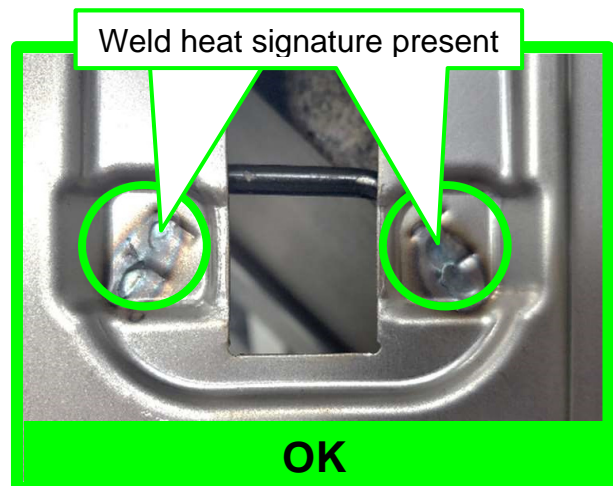
Figure 5

5. Inspect both sides of ALL 3 seat back tether wires for a weld heat signature marking.
 - If there is a tether wire that does not have a weld heat signature marking (Figure 4), the inspection result is **NG**. Proceed to step 6 to replace the affected seat back.
 - If there is a weld heat signature marking on both sides of ALL 3 tether wires (Figure 5), the inspection result is **OK**. Return both rear seats to their upright position and skip to the **CLAIMS INFORMATION** table on page 4.

6. Replace the affected seat back assembly.
 - For seat back replacement, refer to the ESM section below.
 - **BODY INTERIOR > SEAT > REMOVAL AND INSTALLATION > REAR SEAT > Removal and Installation**
