SERVICE ALERT BULLETIN

Alert Subject: R25160 Wallace Forge Adjustable Coupler

Recall 21V505 (Wallace Forge Recall 21E-051)

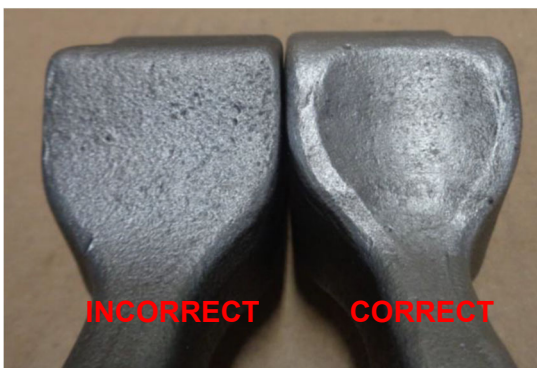
CORRECT LOCKING MECHANISM
INTERNAL LOCK HAS A RADUIS

- 4) All units that are confirmed to have a coupler with the incorrect internal locking mechanism should have the coupler replaced. Contact recall@bwisemfg.com to initiate coupler replacement. The trailer VIN number will be required.
