GROUP	MODEL
	Safety Recall Campaign	2021MY
		Sorento (MQ4a) and
		2021-2022MY
		K5 (DL3a)
		w/2.5L T-GDI
	NUMBER	DATE
	SC214	July 2021
SAFETY REC	CALL CAMPAIGN	
HIGH-PRESSURE F	UEL PIPE INSPECTION	DN,
		,)1 /)
		-14)

This bulletin provides information to inspect and, if required, replace the high-pressure fuel pipe on some 2021MY Sorento (MQ4a) and some 2021-2022MY K5 (DL3a) vehicles equipped with Theta III 2.5L T-GDI engines (refer to table below for production dates). Also, whether the fuel pipe is replaced or not, dealers are to ensure it is tightened with the proper torque. The fuel pipe connecting the high-pressure fuel pump to the fuel rail may have been installed with insufficient torque during assembly. In addition, a limited number of fuel pipes may have been manufactured out of specification for concentricity. As a result of insufficient torque or improper concentricity, fuel may leak at the pipe connections. Leaking fuel increases the risk of a fire, thereby increasing the risk of injury.

HIGH-PRESSURE FUEL PIPE INSPECTION, REPLACEMENT AND TIGHTENING (SC214)

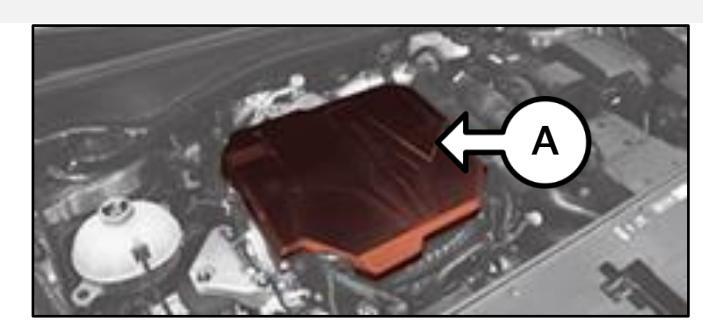
1. Open hood and remove the engine cover (A).

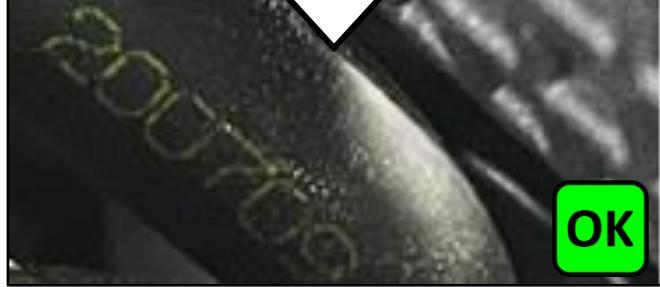
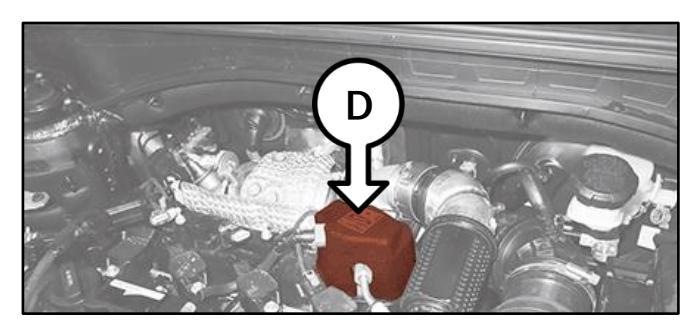
2b. <u>Check the lot number</u> printed on the highpressure fuel pipe insulator.

- 3a. If the Lot Number is 210111 (NG), replace the high-pressure fuel delivery pipe by referring to the 'Replacement Procedure' on page 4.
- 3b. If the Lot Number is NOT 210111 (OK) (as shown), then proceed to step 4 on page 3.
- 4. Remove the high-pressure fuel pump foam cover (D).

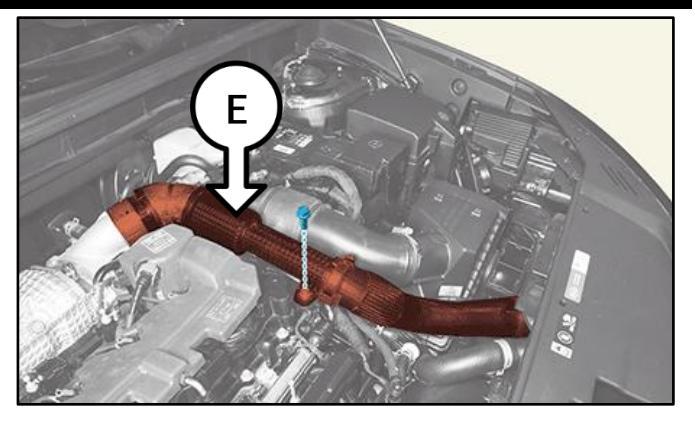
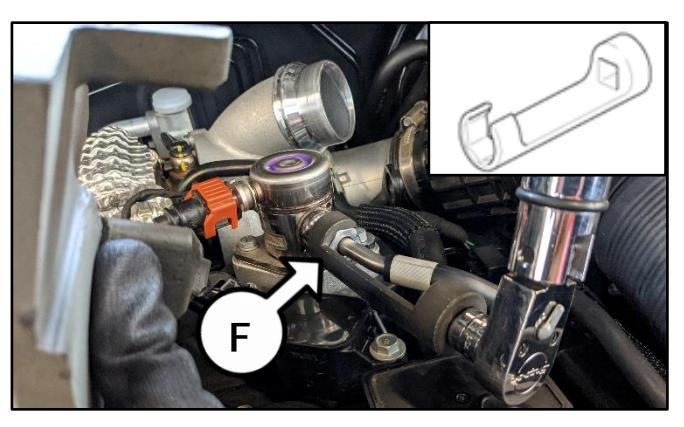
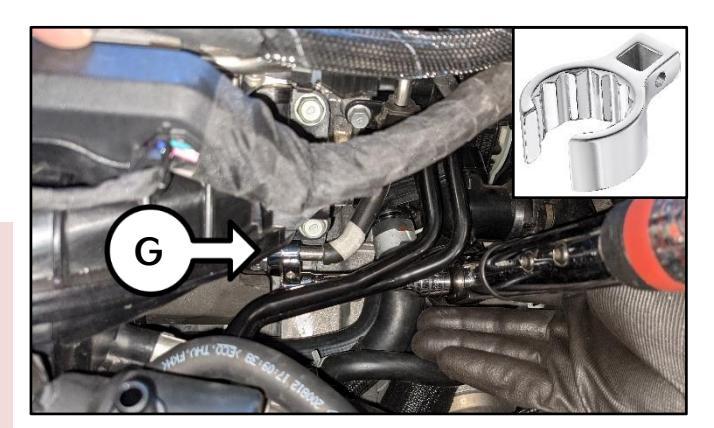
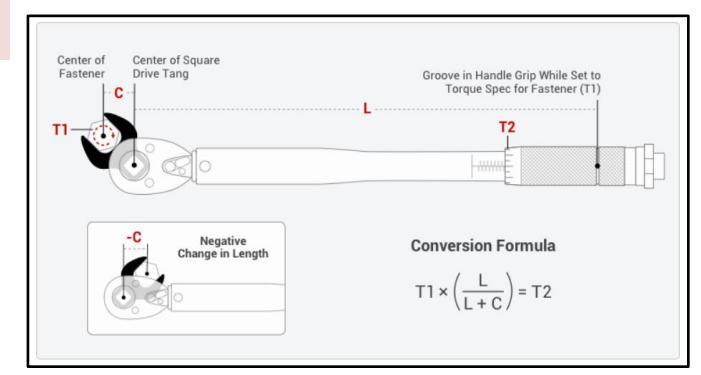
6a. Using a torque wrench <u>and</u> SST 09314 3Q100, <u>confirm that the high-pressure fuel pump flare</u> <u>nut (F) is torque to specification</u>.

> Tightening torque for flange nut F: 19.5 - 26. lb. ft. (26.5 - 32.4 Nm.)

6b. Using a torque wrench <u>and</u> a 12pt/19mm crowfoot wrench, <u>confirm that the opposite end</u> <u>high-pressure fuel delivery pipe flare nut (G) is</u> torqued to converted specification below.

Using a 15" Torque Wrench Handle Length: 18.3 - 24.4 lb. ft. (24.8 - 33.1 Nm.)

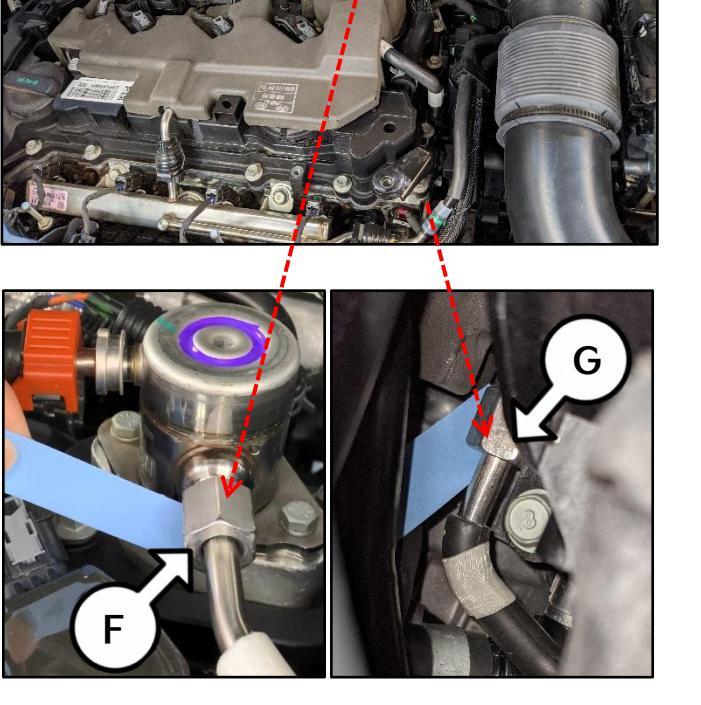
- 'Start' the engine and press the accelerator pedal, two to three (2-3) times, up to 5,000 RPMs. Then allow engine to idle.
- 8a. Inspect the high-pressure fuel delivery pipe/flare nuts (F & G) for any smell/visual fuel leaks.
- 8b. Inspect the two (2) high-pressure fuel delivery pipe flare nuts (F & G) for fuel leak using a sheet of test paper (see below). <u>Check both sides</u> (L&R) of each flare nut with test paper.

- 9a. If a fuel leak is found (NG), replace the high-pressure fuel delivery pipe by referring to the 'Replacement Procedure' on page 5.
- 9b. If no leak is found (OK), reinstall all of the removed parts in the reverse order of removal.
