## **TECHNICAL INSTRUCTIONS**

### **SAFETY RECALL 21TA07**

#### **VEHICLE MAY LOSE MOTIVE POWER WHILE DRIVING**

#### **CERTAIN 2022 MODEL YEAR PRIUS AND PRIUS PRIME VEHICLES**

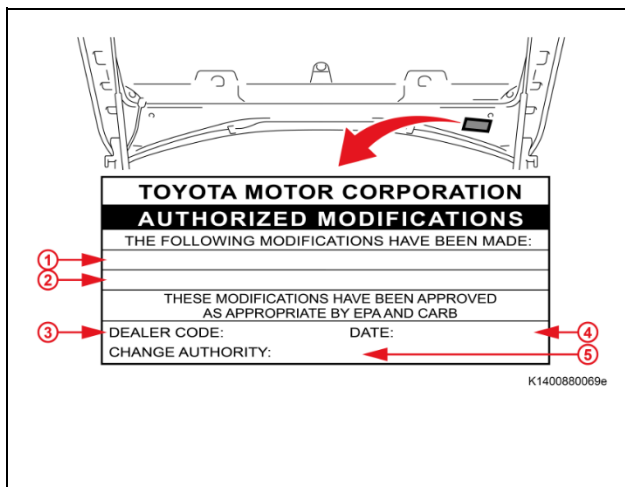
#### 5. ATTACH THE AUTHORIZED VEHICLE MODIFICATION LABEL

The authorized modification label only needs to have the Hybrid Vehicle Control ECU Information.

1	Repair ECU P/N*
	89981-#####
	89981-#####
	89981-#####
<b>Part # varies by depends on the vehicle model and specifications.</b>	
2	New Hybrid Vehicle Control ECU Calibration ID
3	Dealer Code
4	Date Completed
5	Campaign Code (xxx)

- a. Fill out the label.
- b. Affix the label to the under-side of the hood.
