Safety Recall Code: 74E3

Passenger Occupant Detection System (PODS)

April 23, 2022

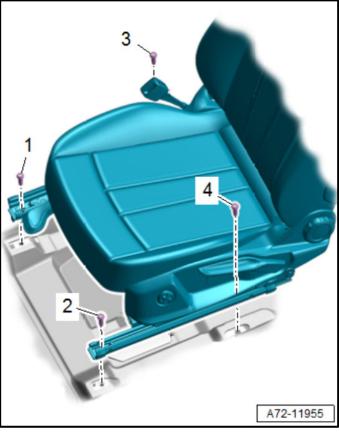
Reinstall seat trim brackets and seat trim:

- Installation is the reverse order of removal.
- Connect and secure seat adjustment electrical connectors.
- Torque fasteners for seat trim bracket to 7.5 Nm.

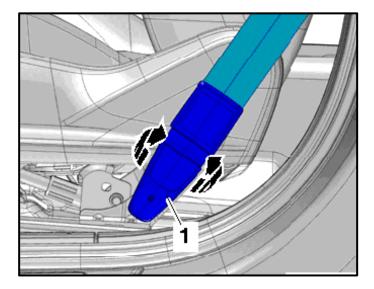
Reinstall belt end fitting:

Installation is the reverse order of removal.

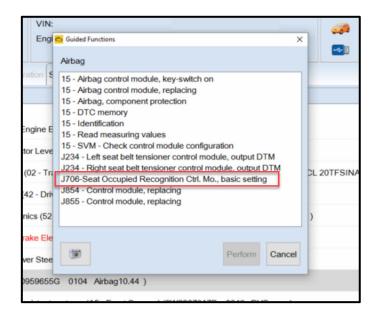
Section C – PODS Basic Settings

- Connect a battery maintainer.
- Switch the ignition ON.
- Connect the VAS tester to the vehicle.
- Using ODIS, perform a complete GFF scan of the vehicle.
- Select the Guided Functions menu for 0015 -Airbag Control Module.
- Perform the test plan "J706 Seat Occupied Recognition Ctrl. Mo., basic setting".
- Follow the on screen prompts.
- Exit GFF.

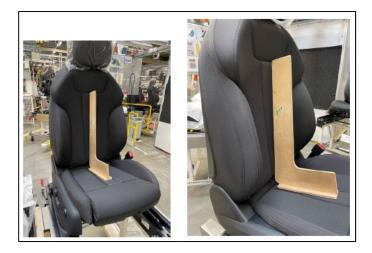
If the PODS basic setting test plan is successful, and fault B1022F0 returns when exiting ODIS, the following steps will aid in getting the fault to clear.

- Adjust the front passenger seat as described in the followign steps.
- Ensure the 12V battery maintainer is installed.
- After all adjustments have been made, run the test plan for the B1022F0 fault. The test plan will re-populate the PODS basic setting test plan.
- If the B1022F0 returns again after completing the PODS basic setting test plan, minor adjustments may need to be made to the seat backrest position or the seat front/back position.
- Set backrest angle to approximately 81°.
