## IMPORTANT SAFETY RECALL

**NHTSA Recall Number:** 21V-884

## Mounting Frame Inspection

**Units Affected:** AT200A aerial devices built on Ford F450/F550 chassis from 2012 to 2016. Verify your unit is affected by reviewing the attached list or accessing Altec Connect.

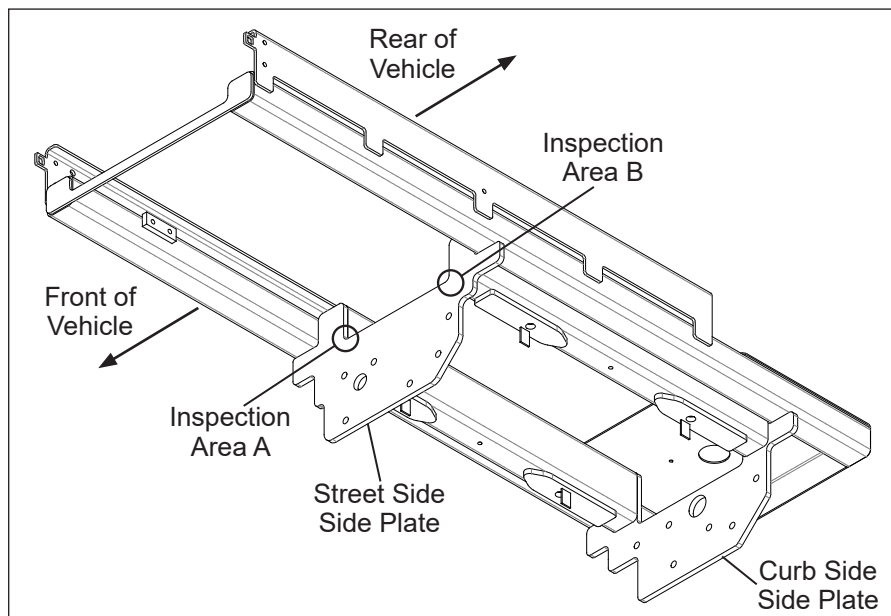
**Figure 4 — Inspection Areas A and B Locations**

3. Using a wire brush, remove any paint and rust from the side plates in inspection areas A and B on the street side (refer to Figure 4) and inspection areas C and D on the curb side (refer to Figure 5).

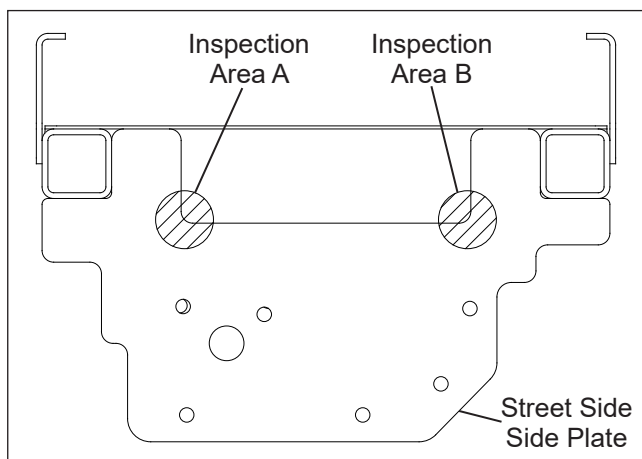
**Figure 6 — Inspection Areas A and B Details**

4. Using a flashlight, visually inspect for any cracking in the steel side plates in the cross-hatched areas shown in Figure 6 for the street side and in Figure 7 for the curb side.

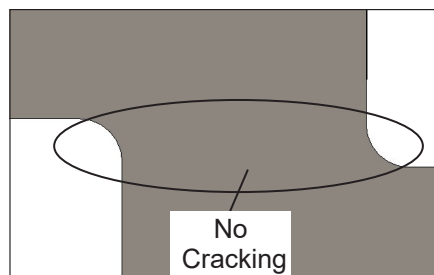
**Figure 8 — No Cracking Example**

5. If cracking is present, determine the extent of the damage as defined below.
- No cracking means no visible cracking at all in the plate (refer to Figure 8).
  - Partial cracking means a visible crack anywhere in the narrow section that extends only part way across the width or part way through the thickness of the plate (refer to Figure 9). Partial cracking may consist of one or more cracks.
  - Full cracking means a visible crack across the full width of the narrow section extending through the full thickness of the plate and causing the complete separation of the material (refer to Figure 10).

- If there is no cracking in any inspection area, put the unit back into service. Order the reinforcement kit and install it within one year of the inspection, or schedule the installation of the reinforcement kit by Altec within one year of the inspection.

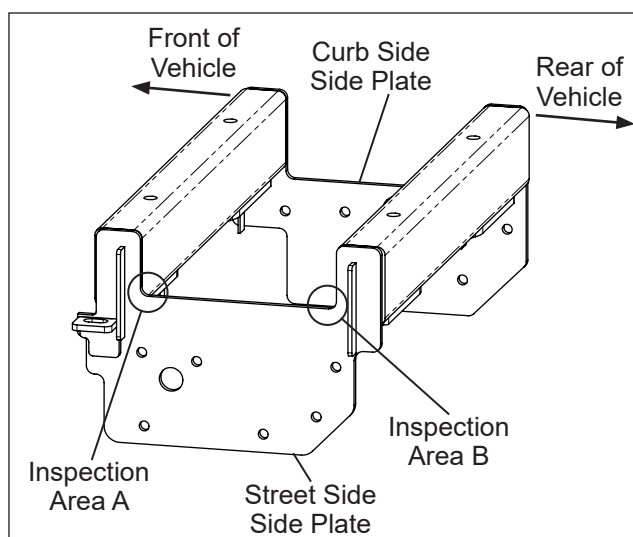
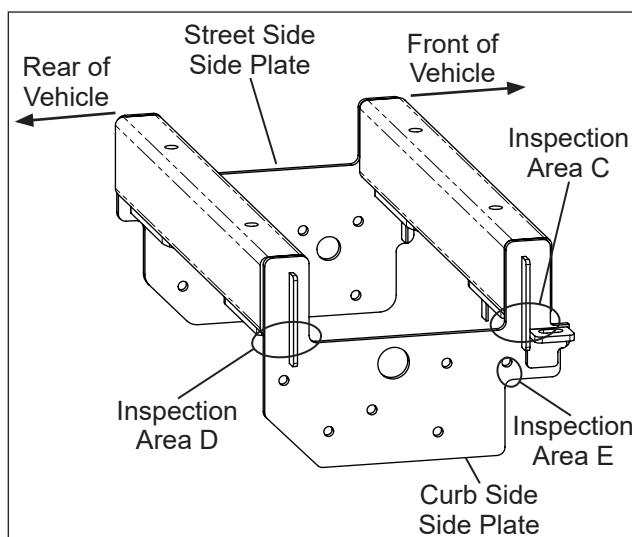
**Figure 14 — Inspection Areas A and B Locations**    **Figure 15 — Inspection Areas C, D, and E Locations**

3. Using a wire brush, remove any paint and rust from the side plates in inspection areas A and B on the street side (refer to Figure 14) and inspection areas C, D, and E on the curb side (refer to Figure 15).

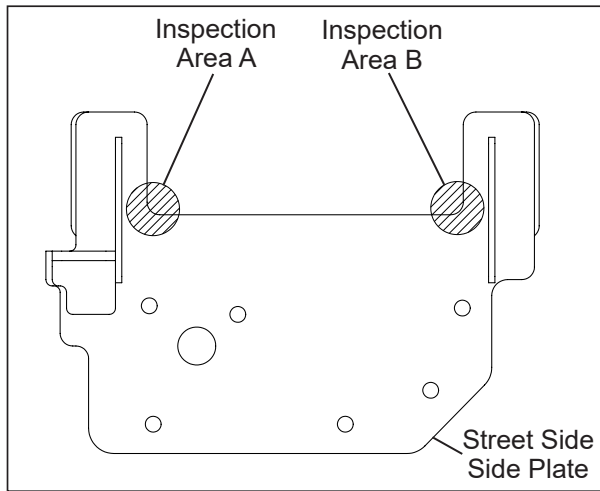
**Figure 16 — Inspection Areas A and B Details**

4. Using a flashlight, visually inspect for any cracking in the steel side plates in the cross-hatched areas shown in Figure 16 for the street side and in Figure 17 for the curb side.

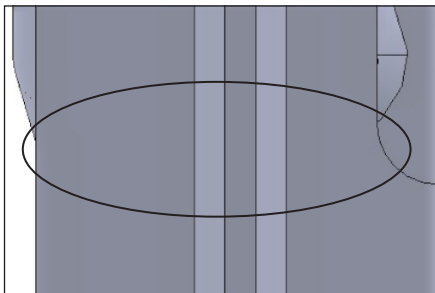
**Figure 18 — No Cracking Example**

- **No cracking** means no visible cracking at all in the plate (refer to Figure 18).
- **Partial cracking** means a visible crack anywhere in the narrow section that extends only part way across the width or part way through the thickness of the plate (refer to Figure 19). Partial cracking may consist of one or more cracks.
- **Full cracking** means a visible crack across the full width of the narrow section extending through the full thickness of the plate and causing the complete separation of the material (refer to Figure 20).
- **Terminated cracking** means a crack in Area E that extends from the inside corner in the lower edge of the side plate toward the mounting hole or all the way to the mounting hole (refer to Figure 21). If there is cracking extending in any other direction in Area E, include it in the partial cracking assessment for Area C.

- If there is no cracking in any inspection area or only terminated cracking in Area E, put the unit back into service. Order the reinforcement kit and install it within one year of the inspection, or schedule the installation of the reinforcement kit by Altec within one year of the inspection.
