Recall Service Bulletin

APPLIES TO: This Recall service bulletin applies to certain 2020, 2021, and 2022 model year, K1 and K2 model motor home chassis built within VDM range of January 2, 2019 – September 13, 2021.

NHTSA/TC Id: 21V-776

CONDITION: Certain rear suspension mounting fasteners that attach the rear drive axle to the rear suspension may not have been tightened to their proper value.

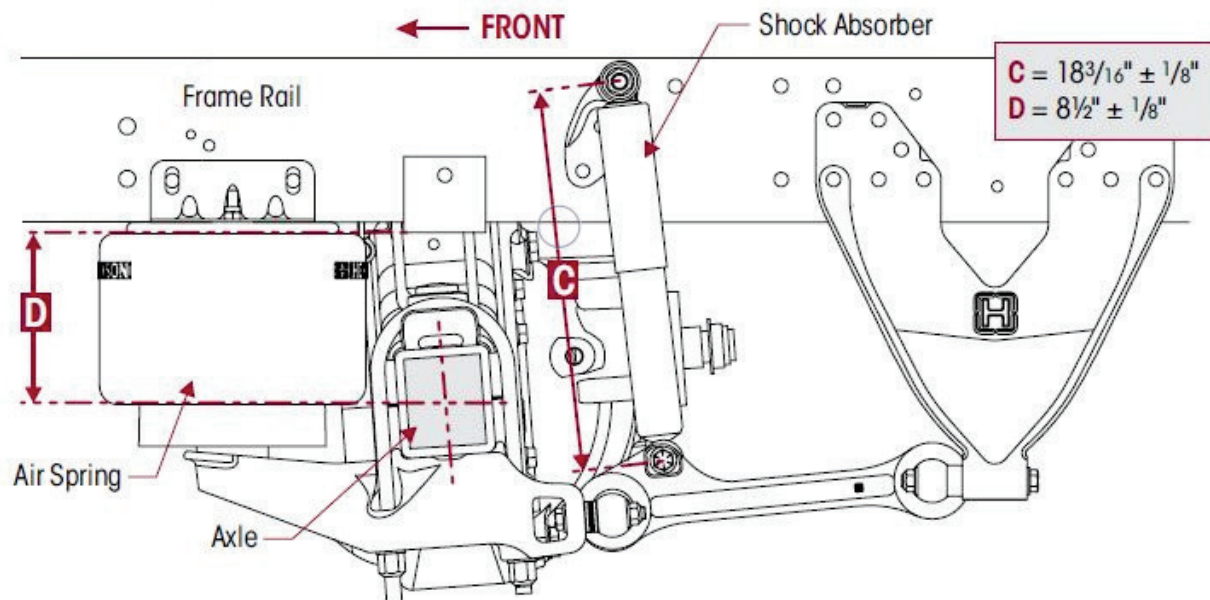
1. Use a work bay with a level surface, preferably a service pit or wheel lift to allow space to perform the Service bulletin.
2. Relax the suspension by slowly moving the vehicle back and forth several times in a straight line without using the brakes making sure the front wheels are straight when finished.
3. Do Not set the parking brake, chock front wheels at this time.
4. Verify and maintain air system at full operating pressure (125-135 psi), most units have an auxiliary air connection to plug in shop air into unit to accomplish this step.
5. Verify the vehicle is at proper ride height using dimension C or D and correct as necessary before proceeding.
