Safety Recall

Code: 87H4

Subject A/C Drain Tube

Release Date January 28, 2022

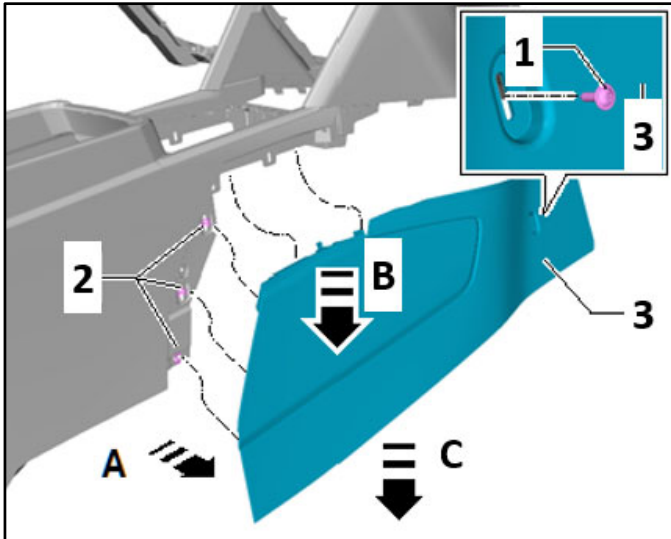
Remove passenger side center console trim panel:

- Remove the bolt <1>.
- Pull down slightly at the front on the console trim.
- Unclip the center console footwell trim panel <3> from the three center console mounts <2> <arrow A>.
- Remove the center console footwell trim panel <3> from the center console mounts <arrows B and C>.
