Safety Recall

Code: 90S9

Subject	Gateway Control Module																												
Release Date	January 18, 2022																												
Affected Vehicles

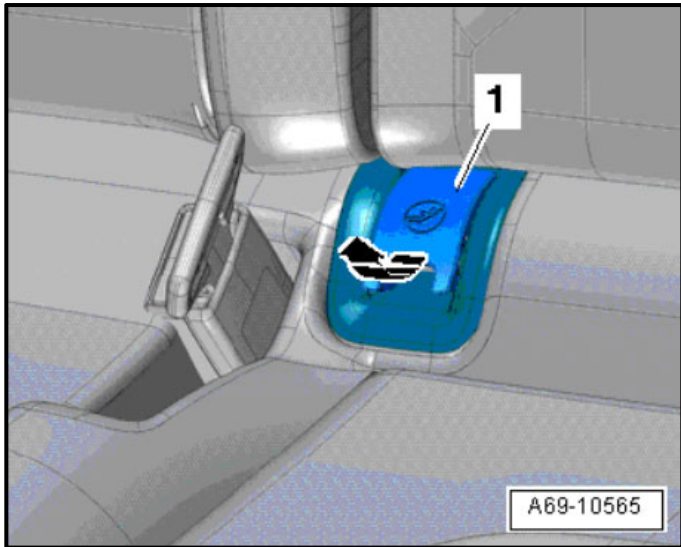
Remove child seat anchor guides from driver rear seat bench:

- Unclip the child seat anchor cover <1> from the anchor in direction of <arrow> and remove.

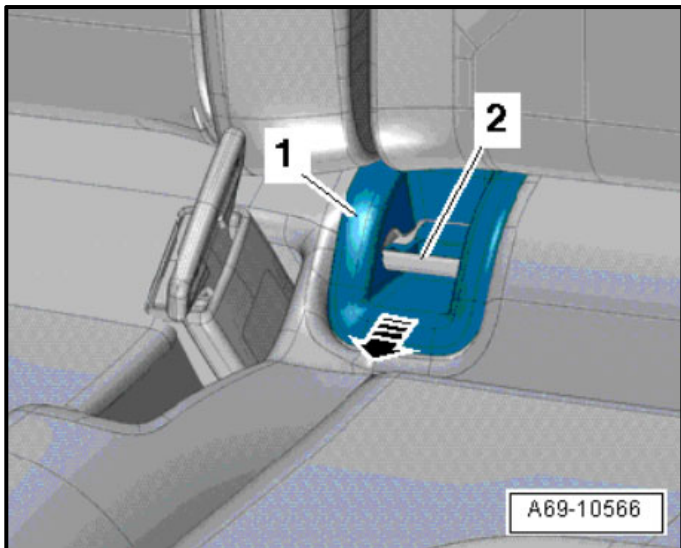
- Push the child seat anchor guide <1> downward according to the cut-out, and disengage it from the anchor <2>.
- Pull out the child seat anchor guide toward the front in direction of <arrow> and move it to the side with the strap.
- If necessary, disengage the strap and remove the child seat anchor guide.

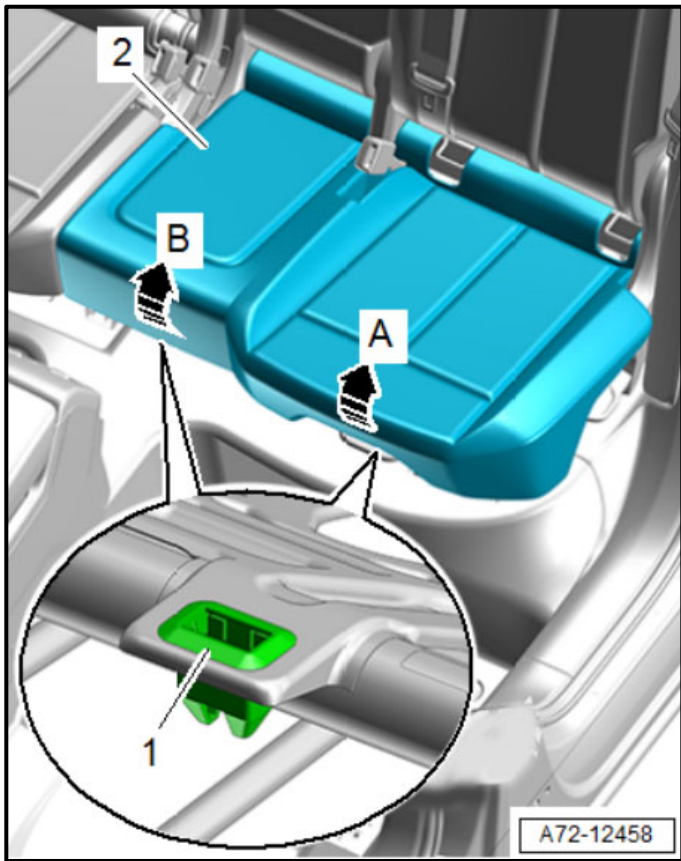
Remove driver side rear seat bench:

- Grab under the seat cushion <2> on one side with both hands.
- Using both hands, pull the seat cushion upward with force in direction of <arrow A> to release the seat cushion from the mount <1>.
- Repeat the procedure on the other side of the seat cushion in direction of <arrow B>.
- Tilt the seat cushion upward and disengage at the back of the seat frame.
- Disconnect seat heating connectors (if equipped).

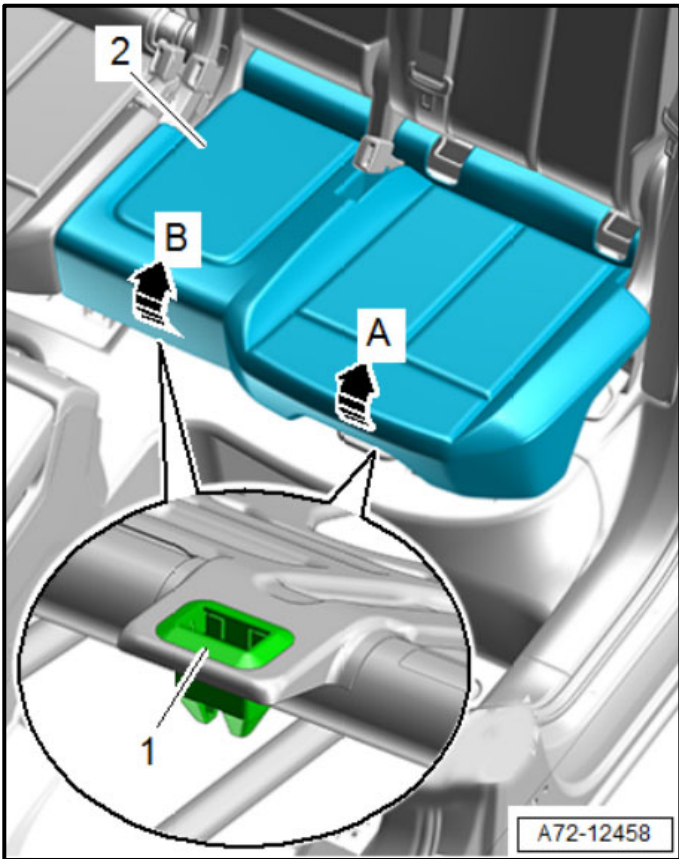
Reinstall seat bench and child seat anchor covers:

- Installation is the reverse order of removal.
- Seat grommets <1> must be replaced.

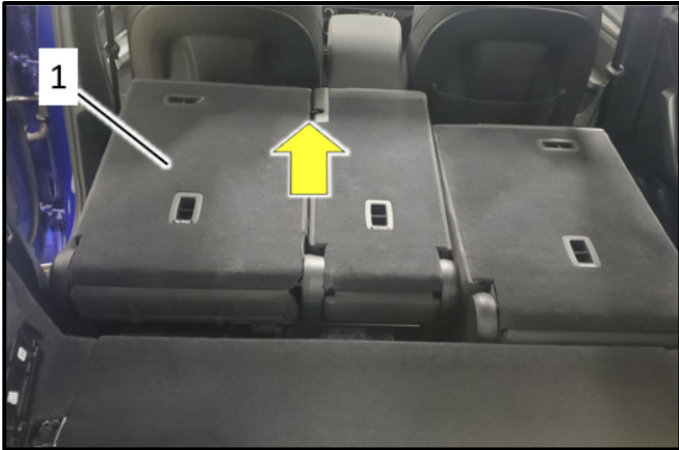
Section C – Sealing Around Stud (Criteria 02)

Position driver side rear seat:

- Slide driver side rear seat forward, as shown.
