Safety Recall

Code: 90S9

Subject	Gateway Control Module																									
Release Date	July 22, 2022																									
REVISION SUMMARY	Added examples of incorrect gateway cover installation NOTE: Updated areas in this document are indicated by an orange bar in the right margin																									
Affected Vehicles

Subject: Safety Recall 90S9 – Gateway Control Module

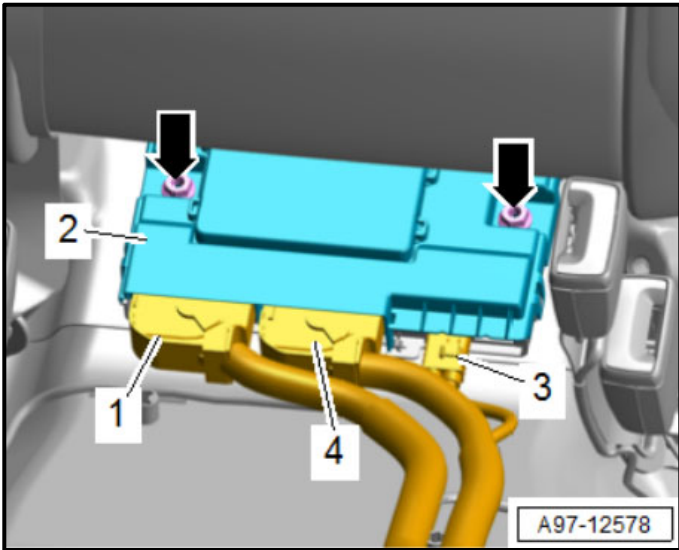
Unbolt gateway control module:

The electrical connectors remain connected.

- Remove and discard the nuts <arrows>.

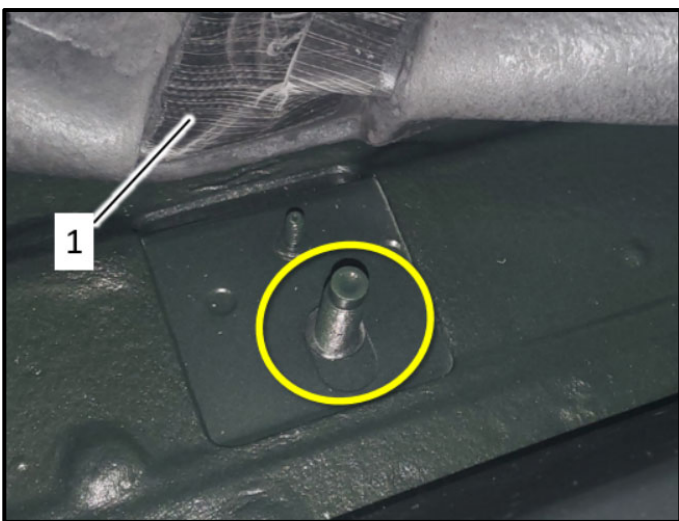
Prep area for sealant:

- The stud and area requiring sealant shown <circle>.

- Position floor insulation <1> out of the way.
- Ensure area is free of dirt and debris.
- Clean area to be sealed <circle> with isopropyl alcohol.
- Allow cleaning solution to completely dry.
