# Safety Recall

Date	Number	Release	Page
12.2021	SC0433	01	1(9)

## Park Brake Control Valve MRU, TE

## Subject: BENDIX® PP-1® & PP-8™ PARK CONTROL VALVE WEAR AND REPLACEMENT NOTICE

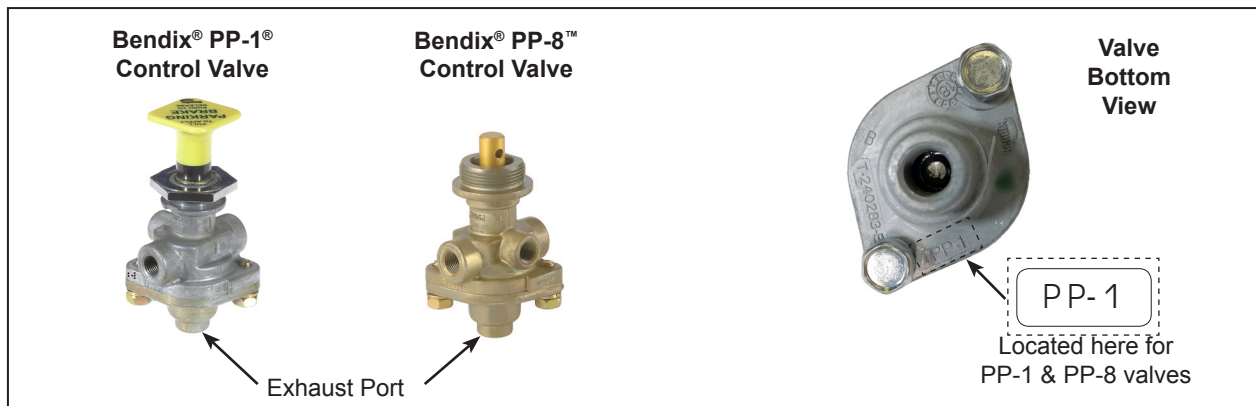
When a heavily-worn PP-1 or PP-8 control valve is combined with restrictive exhaust plumbing, the vehicle park brake force may be reduced. Valve wear may be the result of high-park-brake-cycle count and/or sideloading. Sideloading can be caused by pushing or pulling the valve button at an angle and not in line with the valve or from hanging objects from the button. See the table below for troubleshooting recommendations.

Bendix® Valve Model	Exhaust Port			Recommendation
	Port Size	Fitting	Tube	
PP-1® & PP-8™	1/8" NPT	No	No	Maintain valve per Service Data sheet SD-03-3611.
		Yes	Yes or No	Follow the procedure below.
	1/4" NPT	No	No	Maintain valve per Service Data sheet SD-03-3611.
		Yes	Less than 1/2" OD	Follow the procedure below.
