## PRODUCT CAMPAIGN BULLETIN

**APPLICABILITY:** 2019-20MY Ascent  
 2020MY Legacy 2.4L (turbo models)  
 2020MY Outback 2.4L (turbo models)

**SUBJECT:** CVT Chain Guide Breakage

**NUMBER:** WRK-21R  
**DATE:** 07/05/22  
**REVISED:** 07/06/22  
**NHTSA ID:** 21V-955

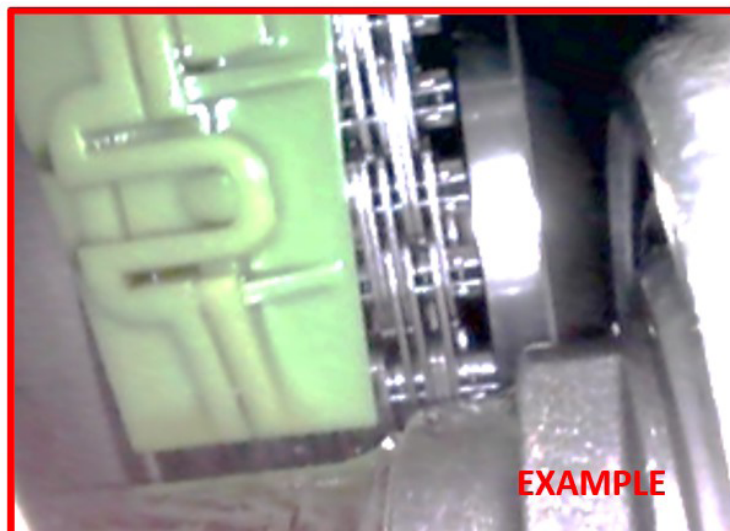
ONLY in a situation when no CVT chain slip is detected with SSM and the chain guide is found to be in the incorrect position during inspection, a clear photo or screenshot of the scope image is required to be stored and noted along with the previously mentioned items 1 through 3.

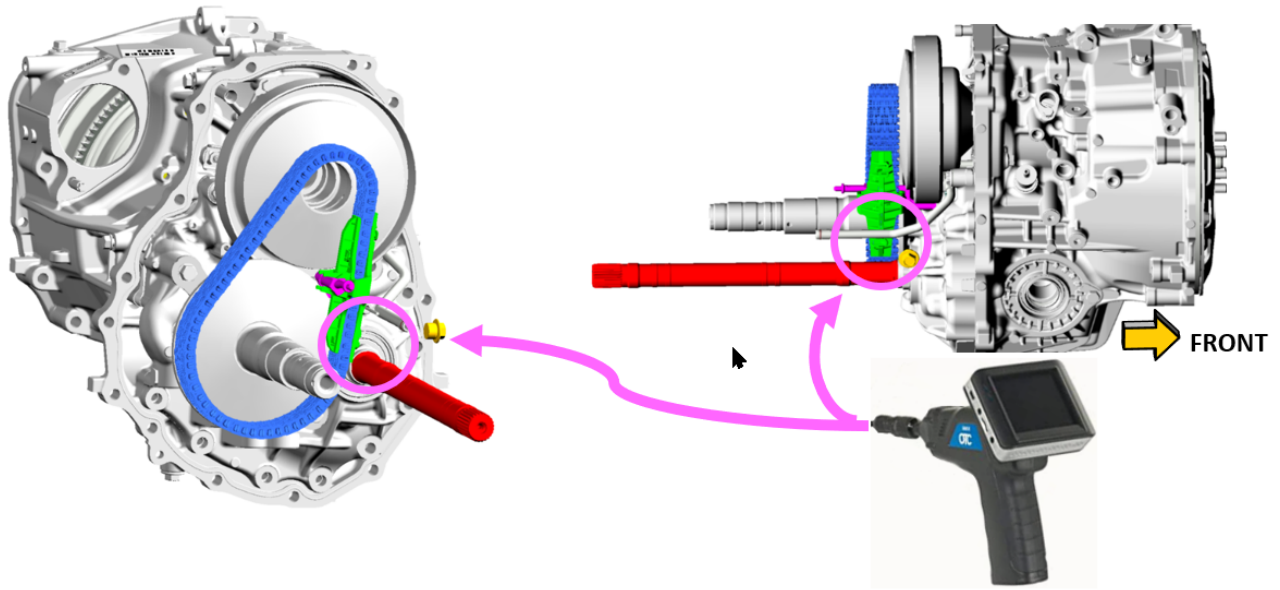
**STEP 3E:** Inspect the position of the lower end of the chain guide rail and the drive pinion shaft.
