PRODUCT CAMPAIGN BULLETIN

APPLICABILITY: 2019-20MY Ascent
 2020MY Legacy 2.4L (turbo models)
 2020MY Outback 2.4L (turbo models)

SUBJECT: CVT Chain Guide Breakage

NUMBER: WRK-21
DATE: 07/05/22
NHTSA ID: 21V-955

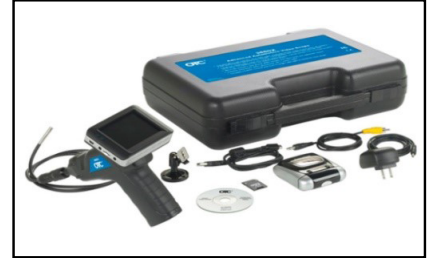
- **CRITICAL:** The Videoscope Kit **PROVIDED BY SOA** is the **ONLY** scope that can be use for this inspection. NO other scopes are to be used for chain inspection.
- The **OTC 16-3880X Videoscope:** This is the approved Videoscope kit that is to be used for chain guide inspections.

IMPORTANT: This Videoscope has a removable tip. It is suggested to add thread lock (e.g. “blue” Loctite or equivalent) to ensure the tip is not lost during inspection.

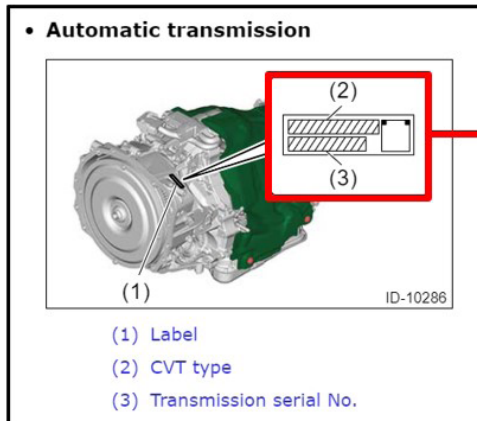
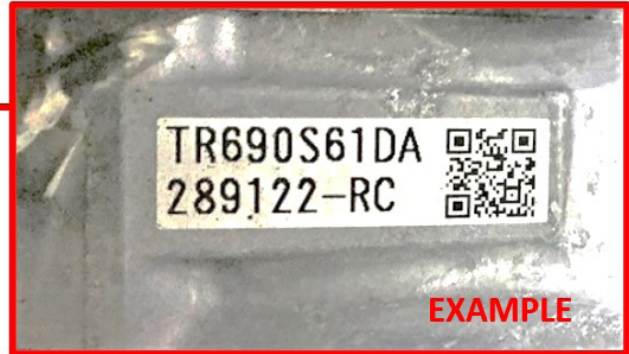
Clear photos of the transmission serial number. Required for the unit currently in the vehicle and of the replacement (if CVT is replaced).

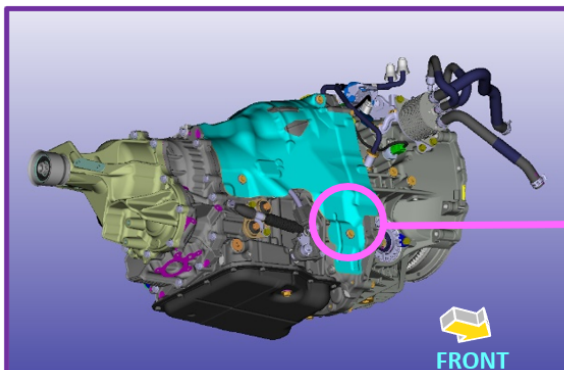
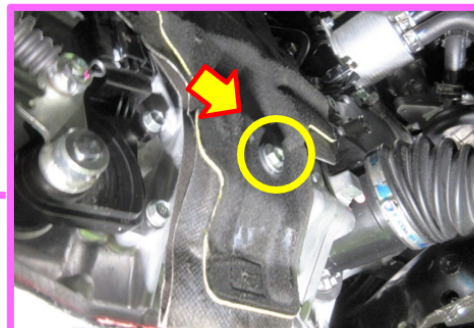
STEP 3A: Disconnect the vehicle from the SSM. Remove the 10mm bolt retaining the insulator cover on the right side of the CVT.

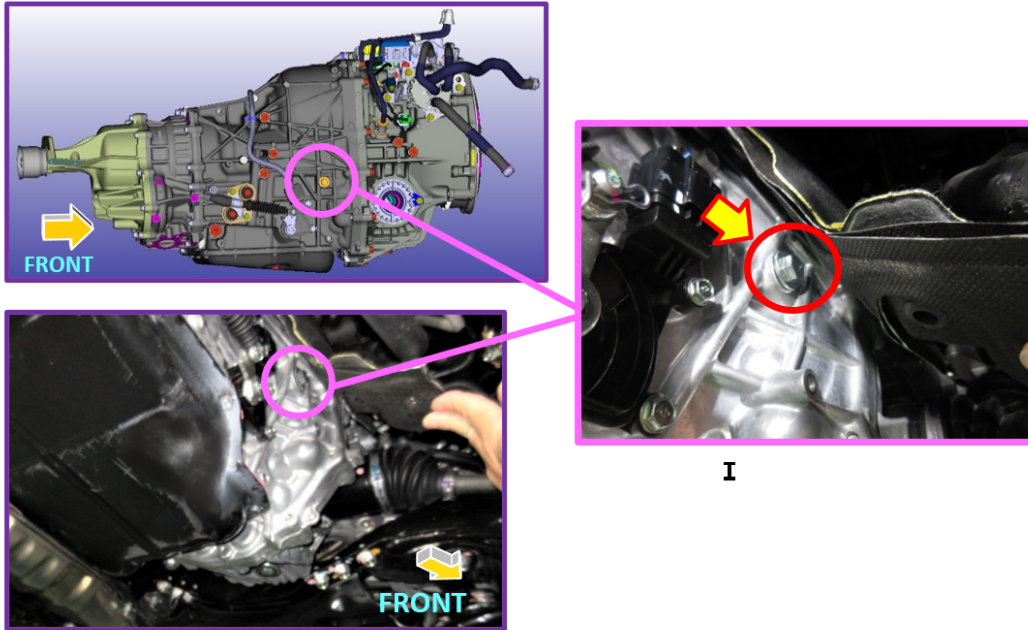
STEP 3B: **CAREFULLY** lift the insulation **only as far as necessary** to expose the plug as shown below.

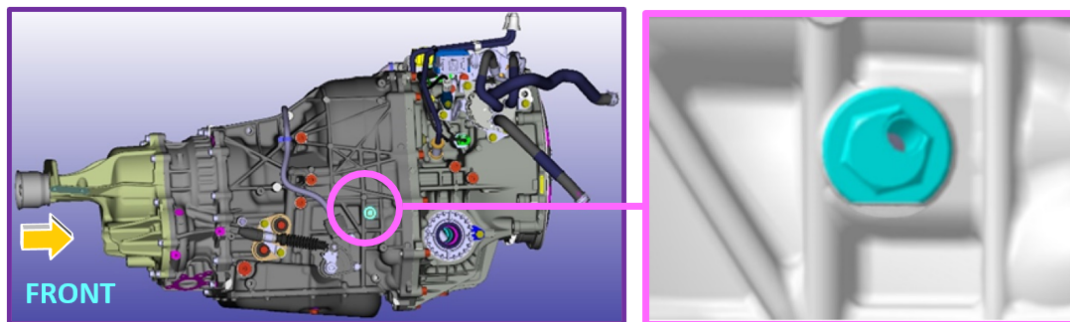
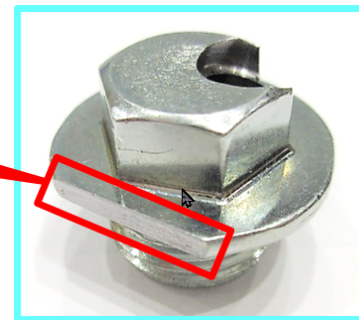
**Flat Section of the Holder
18361AA090**

STEP 3C: Install and align the specialty plug / holder (**18361AA090**) as shown below.

- The holder is designed to provide the proper insertion angle for the videoscope camera.
- Install the tool by tightening the holder down **BY HAND ONLY**.
- Slightly loosen the holder so the flat section of the tool is facing downward (parallel to the floor). See the example illustrations below.

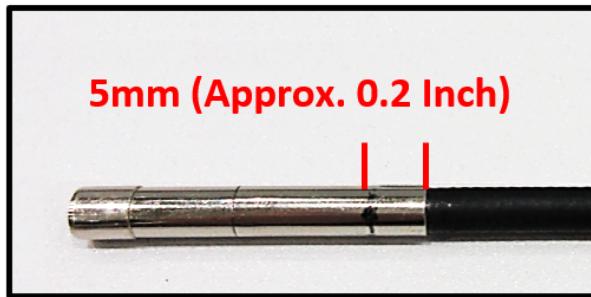
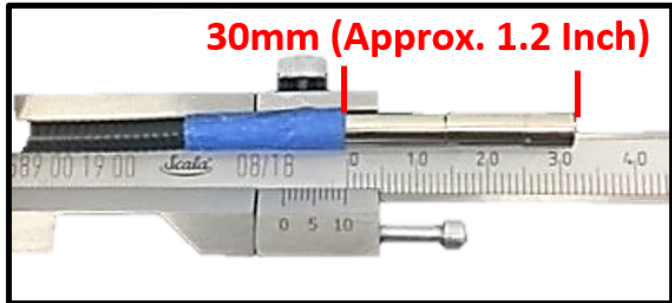
- Make sure the OTC videoscope's threaded camera tip is screwed on tight prior to usage. Prepare the videoscope camera by measuring and marking approximately 5mm (0.2inch) from where the metal section of the scope tip meets the flexible portion. This section can be marked using a marker or tape. Use the example photos below as a guide.
