For Subaru Field Service Engineer Use ONLY

Supplemental work procedures for 2019MY Ascent updated with the PAK file released April 12th, 2022.

STEP 1-A: Reprogram the Transmission Control Module (TCM) with the **TEMPORARY** PAK file.

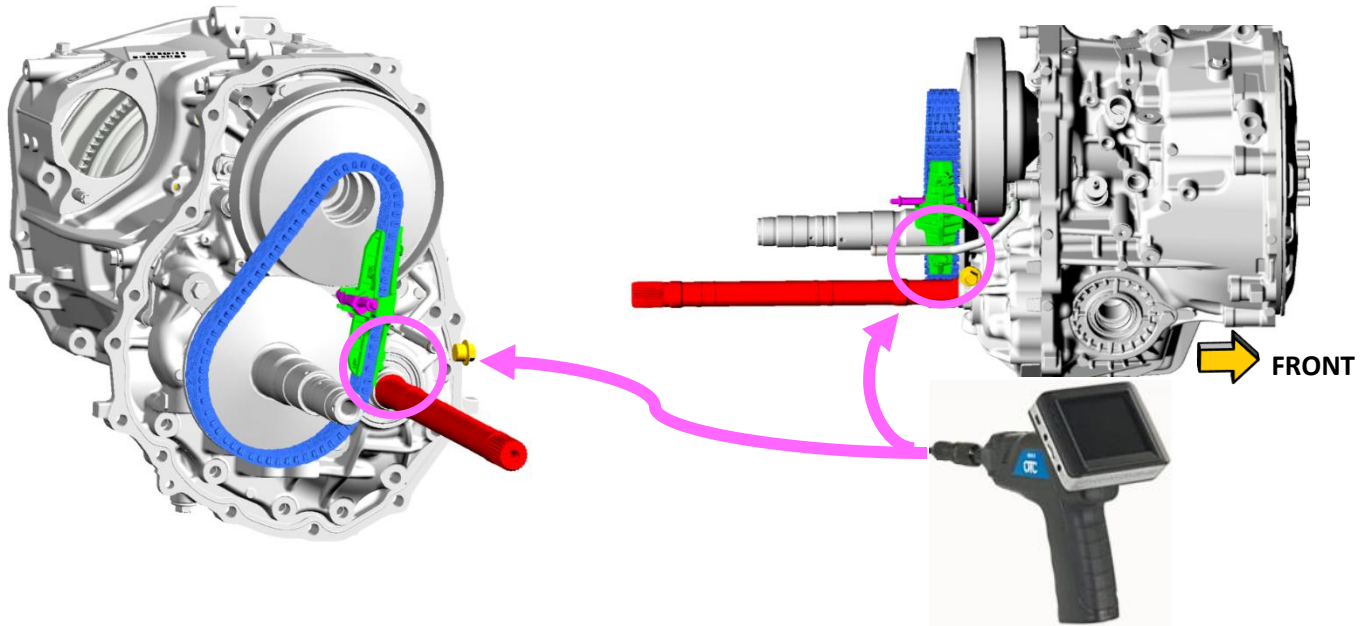
STEP 3E: Inspect the position of the lower end of the chain guide rail and the drive pinion shaft.

CORRECT GUIDE POSITIONING:

The chain guide is properly engaged with the guide pin.
