**SUBJECT: NEW VEHICLE DEMONSTRATION / DELIVERY HOLD -  
 Safety Recall 21S56 – Supplement #4**

Certain 2021 - 2022 Model Year F-150 Vehicles Equipped with Crew Cab, 145" Wheelbase, 4x4, 302a & Above Option Package, and One-Piece Aluminum Driveshaft  
 Loose/Sagging Underbody Insulators

In some of the affected vehicles, underbody insulators may loosen and contact the aluminum driveshaft, resulting in marking or scoring of the driveshaft. Over time, the aluminum driveshaft may fracture, which can result in loss of motive power while driving, unintended vehicle movement while the vehicle is in park if the parking brake is not applied, and secondary damage to surrounding components. A fractured driveshaft may also contact the ground which may cause loss of control of the vehicle while driving. A fractured driveshaft increases the risk of injury or crash.

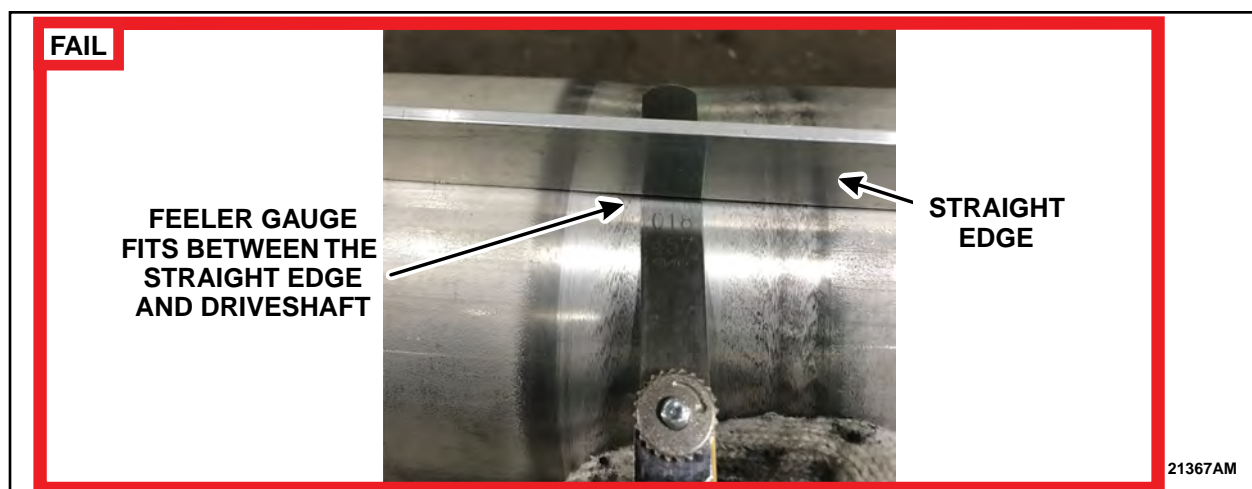
**FIGURE 4**

**11. Place a straight edge along the driveshaft over the wear mark and attempt to fit a 0.018in (0.45mm) feeler gauge between the flat edge and the wear mark. Can the feeler gauge fit between the straight edge and anywhere along the wear mark? See Figures 3 and 4.**

**Yes – Does not pass inspection. Contact the SSSC and provide a picture of the driveshaft with the feeler gauge fitting between the straight edge and wear mark. Once approved, rear driveshaft replacement will be required, but do not install at this time. Proceed to step 14.**

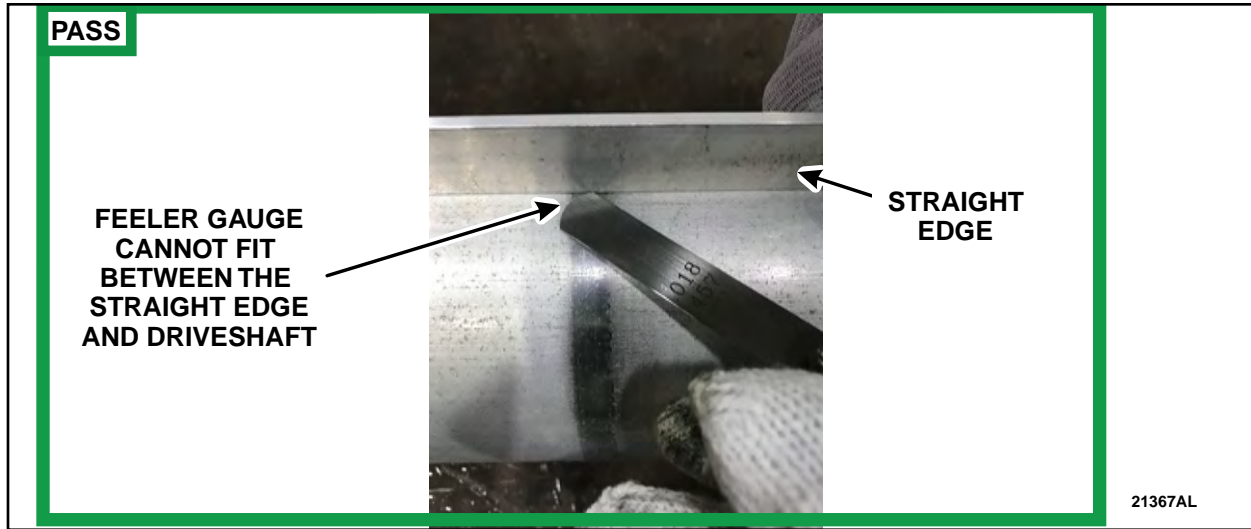
**FIGURE 3**

8. **Place a straight edge along the driveshaft over the wear mark and attempt to fit a 0.018in (0.45mm) feeler gauge between the flat edge and the wear mark. Can the feeler gauge fit between the straight edge and anywhere along the wear mark? See Figures 3 and 4.**

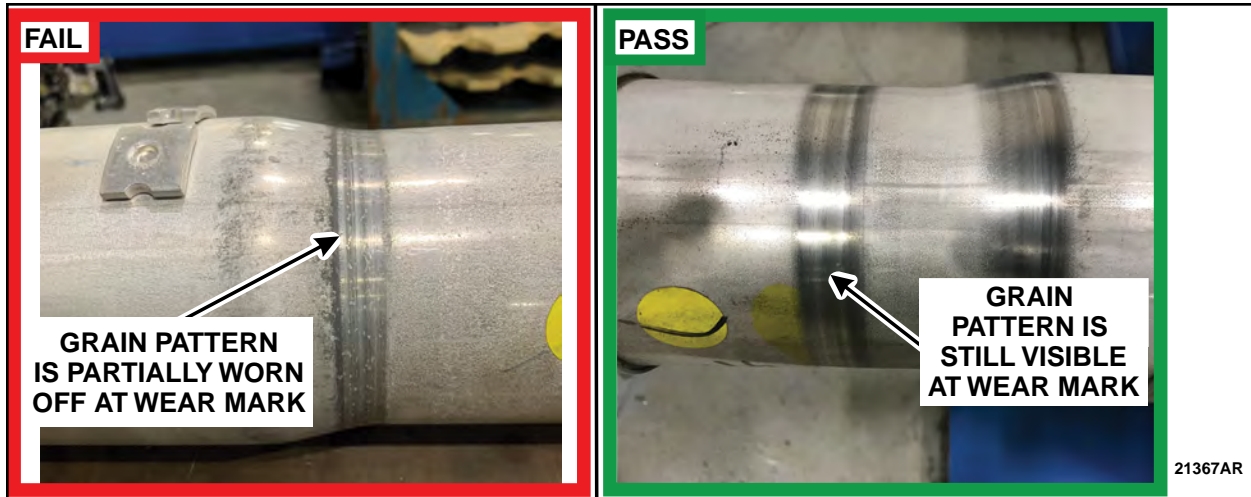
**FIGURE 6**

9. Inspect the marks found on Zone 2. Is the aluminum tube surface grain pattern worn off, completely smooth, or have an appearance of necking? See Figures 6 through 9.

**Yes – Does not pass inspection. Contact the SSSC and provide a picture of the driveshaft with the grain pattern worn off. Be sure to show a clear image of the grain pattern missing. Once approved, rear driveshaft replacement will be required, but do not install at this time. Proceed to step 10.**

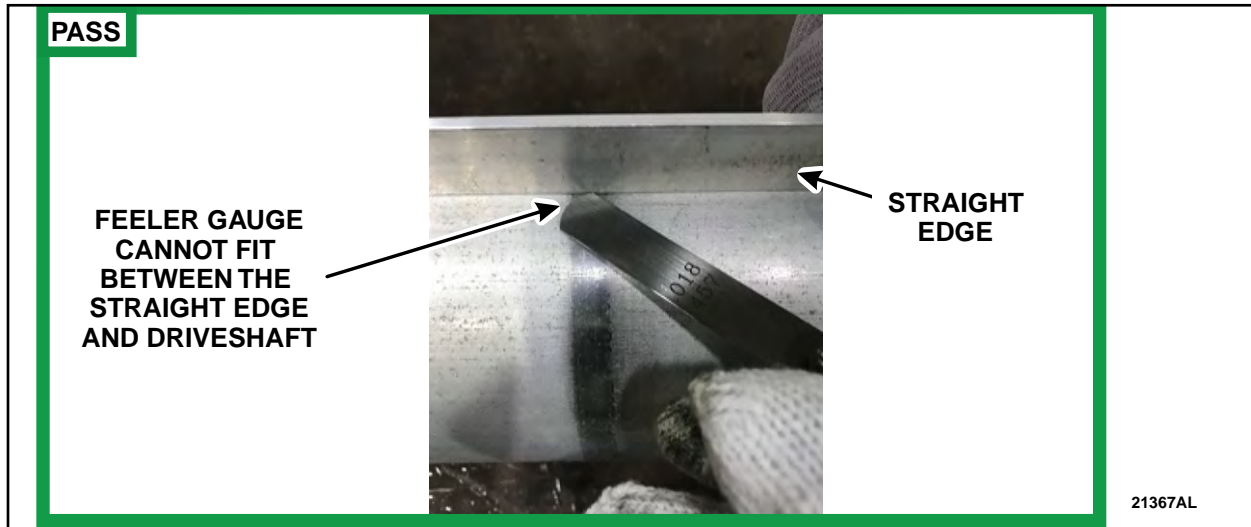
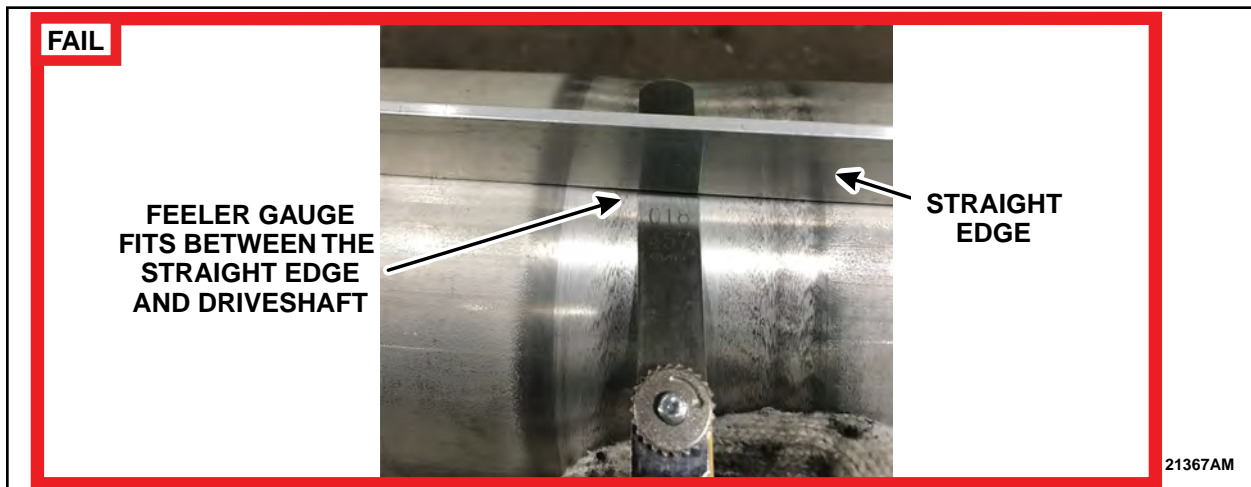
9. Place a straight edge along the driveshaft over the wear mark and attempt to fit a 0.018in (0.45mm) feeler gauge between the flat edge and the wear mark. Can the feeler gauge fit between the straight edge and anywhere along the wear mark? See Figures 3 and 4.

**Yes** – Does not pass inspection. Contact the SSSC and provide a picture of the driveshaft with the feeler gauge fitting between the straight edge and wear mark. Once approved, rear driveshaft replacement will be required, but do not install at this time. Proceed to step 12.

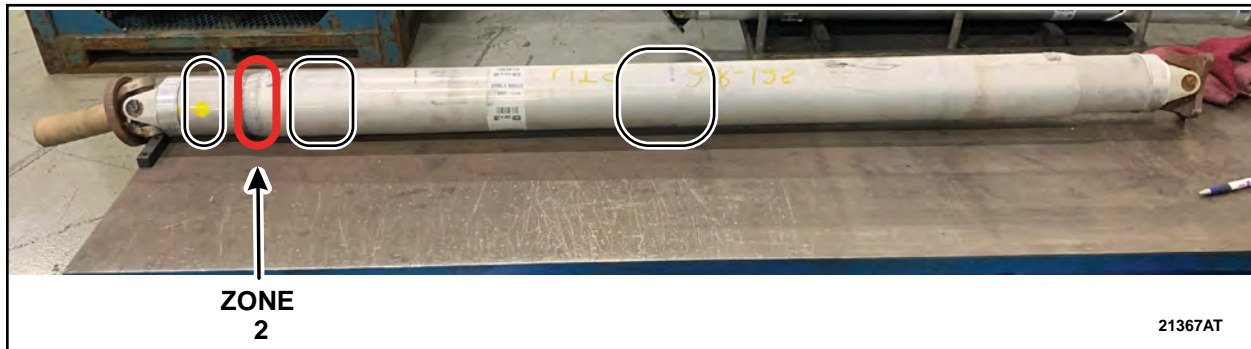
**FIGURE 5**

**10. Inspect Zone 2 (transition from larger tube diameter to smaller diameter section) of the driveshaft tube for any marks caused by the front edge of the passenger side insulator. Are there any marks present? See Figure 5.**

**Yes – Does not pass inspection. Proceed to step 11.**

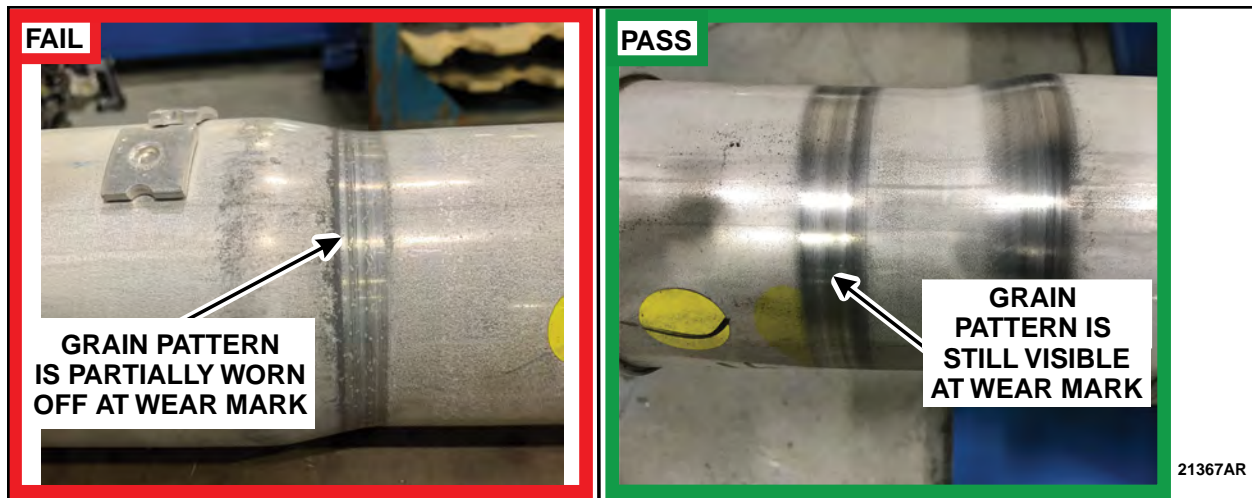
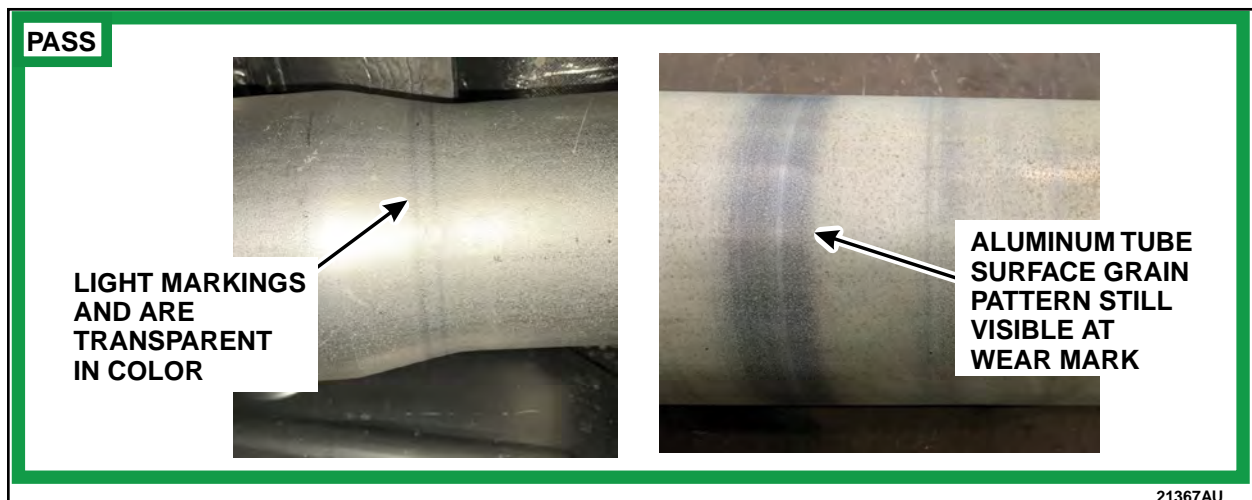
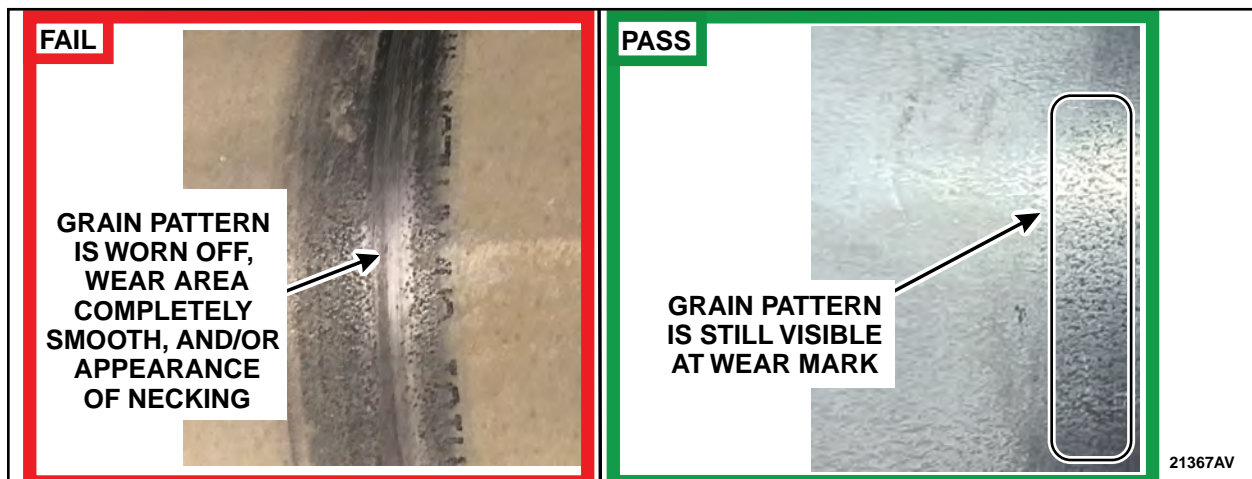
**11. Inspect the marks found on Zone 2. Is the aluminum tube surface grain pattern worn off, completely smooth, or have an appearance of necking? See Figures 6 through 9.**

**Yes – Does not pass inspection. Contact the SSSC and provide a picture of the driveshaft with the grain pattern worn off. Be sure to show a clear image of the grain pattern missing. Once approved, rear driveshaft replacement will be required, but do not install at this time. Proceed to step 12.**
