**SUBJECT: NEW VEHICLE DEMONSTRATION / DELIVERY HOLD -
 Safety Recall 21S56 – Supplement #1**

Certain 2021 - 2022 Model Year F-150 Vehicles Equipped with Crew Cab, 145”
 Wheelbase, 4x4, 302a & Above Option Package, and One-Piece Aluminum Driveshaft
 Loose/Sagging Underbody Insulators

In some of the affected vehicles, underbody insulators may loosen and contact the aluminum driveshaft, resulting in marking or scoring of the driveshaft. Over time, the aluminum driveshaft may fracture, which can result in loss of motive power while driving, unintended vehicle movement while the vehicle is in park if the parking brake is not applied, and secondary damage to surrounding components. A fractured driveshaft may also contact the ground which may cause loss of control of the vehicle while driving. A fractured driveshaft increases the risk of injury or crash.

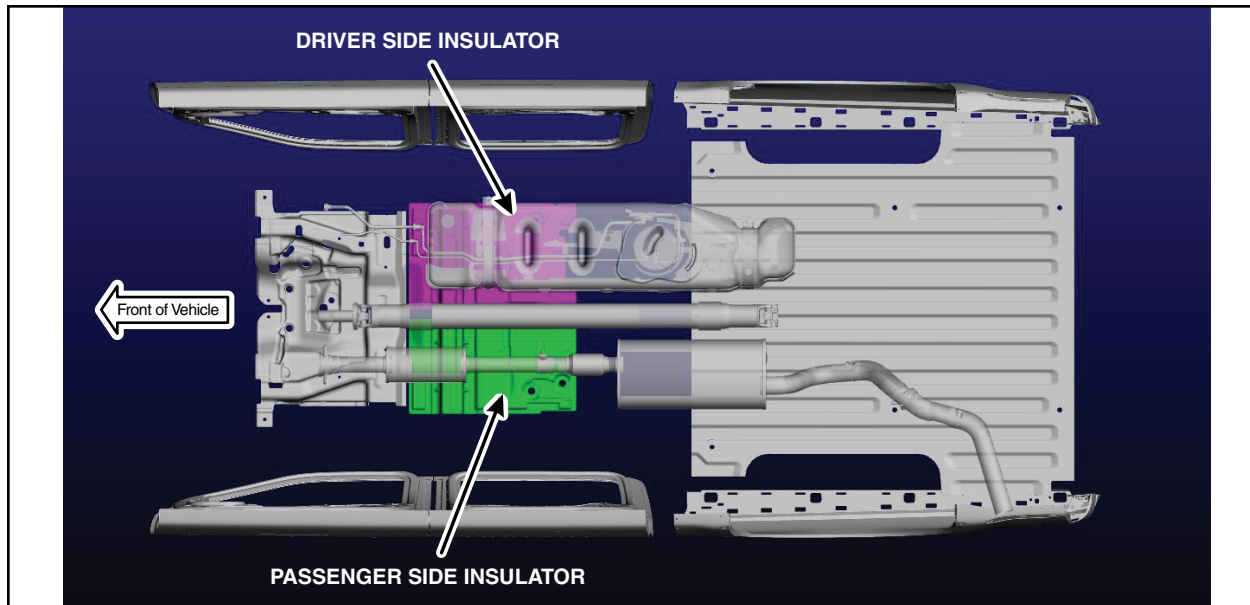
FIGURE 1

NOTE: The passenger side insulator is located directly above the exhaust.

NOTE: Insulators are highlighted for illustration purposes only.

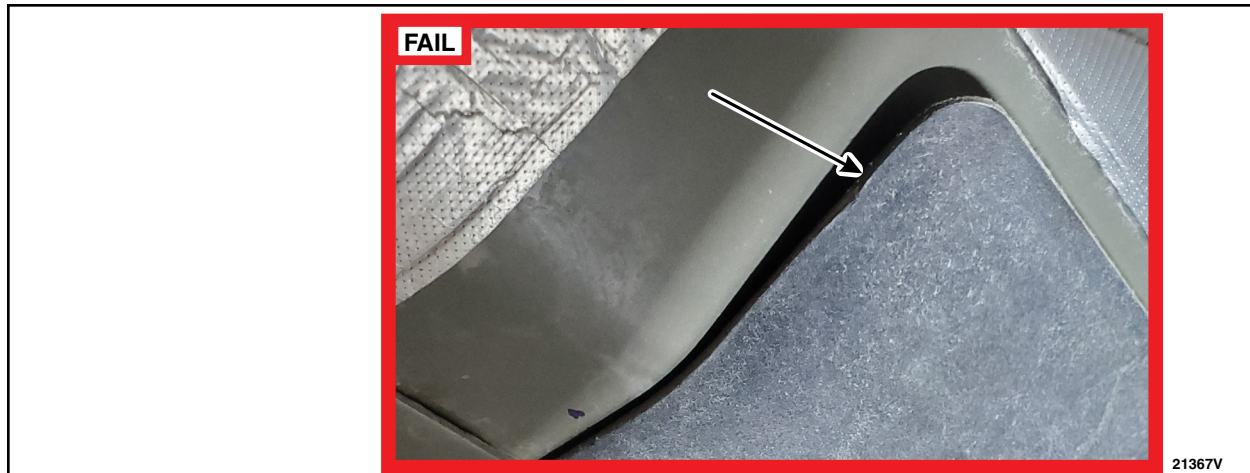
FIGURE 4

5. Inspect the driver side insulator for any edges hanging down or touching the fuel tank. Is the insulator hanging down or touching the fuel tank? See Figure 4.

Yes – Does not pass inspection. Proceed to step 6.

6. Remove the fuel tank to gain access to the vapor line. Please follow WSM procedures in Section 310-01.
7. Inspect the vapor line for any damage caused by the driver side insulator. Is there any damage to the line? See Figures 5 through 7.
