# AWNING INSPECTION AND WELD/SEAM REPAIR

Recall Number:	22E-055		
Product:	Awnings		
Date:	Original: July 15, 2022	Labor Rate:	.30 hours inspection only     .30 hours repair only 1.5 hours fabric replacement only
	Current: Sept. 1, 2022

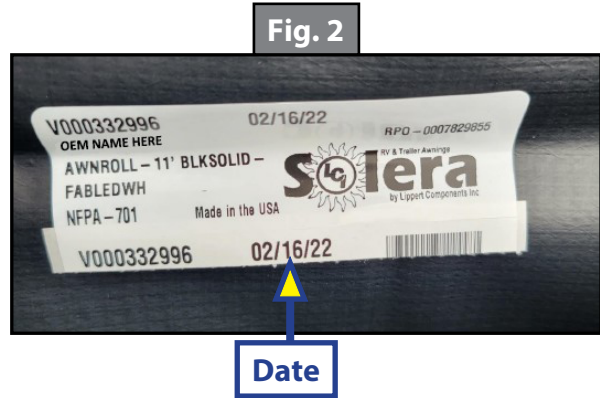
**Fig. 2**

The purpose of this document is to provide guidance, as well as visual aides, to dealers performing inspection on units that may have insufficient awning weld(s). The inspection point is at the awning fabric seam at the awning rail at the wall of the unit (Fig. 1). This only affects awnings manufactured January 17, 2022 – June 14, 2022. The date of manufacture can be located on the variant code label (Fig. 2) located on the awning.
