## IMPORTANT SAFETY RECALL

**NHTSA Recall Number:** 22V058

## Rotation Bearing Washer Inspection

**Units Affected:** LS60 aerial devices built from October 2017 to October 2021. Verify your unit is affected by reviewing the attached list or accessing Altec Connect.

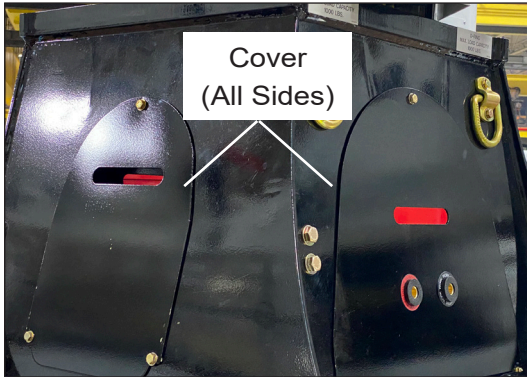
**Figure 1 — Pedestal Covers**

1. Position the unit on a level surface, apply the parking brake, and turn off the engine. Remove the key from the ignition, and secure it following your employer’s vehicle lockout/tagout procedure. Chock the wheels.
2. Remove the four pedestal covers to access the inside of the pedestal (refer to Figure 1).
3. Locate the rotation bearing outer race mounting cap screws and washers under the top plate of the pedestal (refer to Figure 2).
