May 2022
FL921A
NHTSA #22V-153

Subject: Thomas Built Buses EFX Seat Bolts

Models Affected: Specific model years 2020-2023 Thomas Built Saf-T-Liner EFX school buses manufactured June 6, 2019, through November 30, 2021.

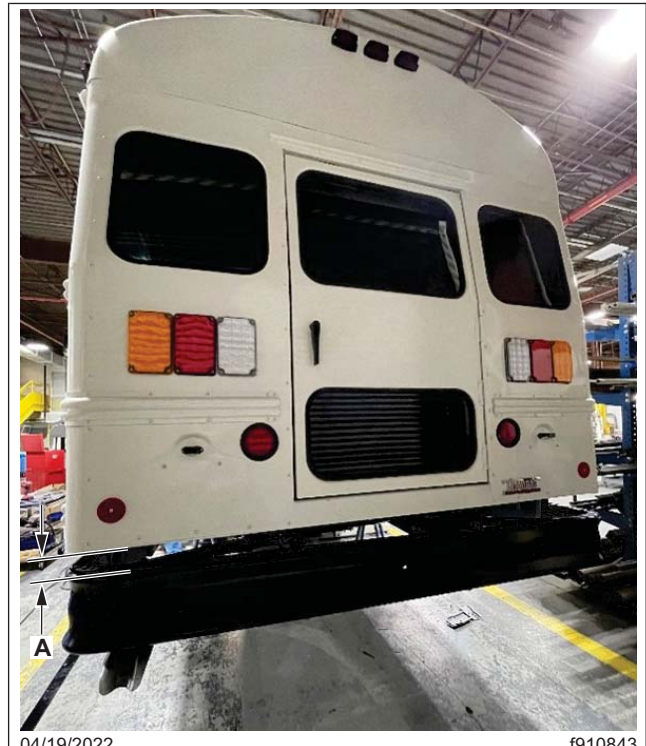
Fig. 5, Gap Between the Bumper and the Body

- A. Maintain a clearance of 4 to 6 inches between the bumper and the body.

- Using two jack stands and heavy gage square stock tubing, support the bus body on the left-hand side and the right-hand side behind the rear axle, as shown in [Fig. 4](#).
- With the body now supported, gently lower the chassis to gain approximately 4 to 6 inches of clearance between the top of the rear bumper and the body, as shown in [Fig. 5](#).
