# Safety Recall

## Code: 42L8

<b>Subject</b>	<b>Rear Suspension Knuckles</b>																									
<b>Release Date</b>	June 7, 2022																									
<b>Affected Vehicles</b>

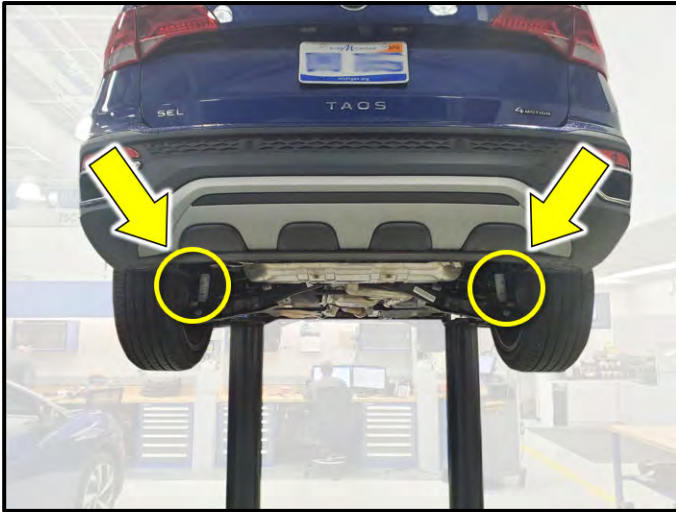
## Section B – Rear Wheel Bearing Housing Inspection

- Both rear wheel bearing housings must be inspected.
- Check the build date on each wheel bearing housing from the rear of the vehicle.

- The wheel bearing build date is read in the example shown.
- The build dates vary by model.

- If the build date of the wheel bearing housing matches the chart of affected build dates:
  - The wheel bearing housing must be replaced.
  - See Section C for wheel bearing housing replacement.
- If the build date does not match the chart:
  - The wheel bearing housing is OK.
  - Proceed to Section D if both wheel bearing housings are OK.
