Bentley Bulletin

22-032

Subject: RECALL CAMPAIGN – Bentley Continental GT, Continental GT Convertible and Flying Spur Incorrect Seat Belt Fitted Recall (RE22/08)

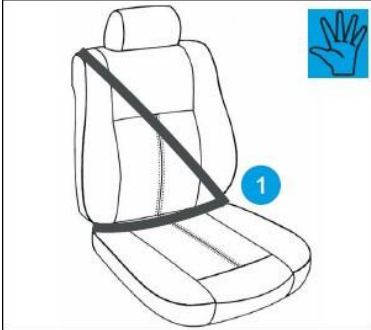
Figure 6

6) Put the seatbelt across the empty passenger seat and insert the metal tongue of the belt into the buckle (Figure 6)

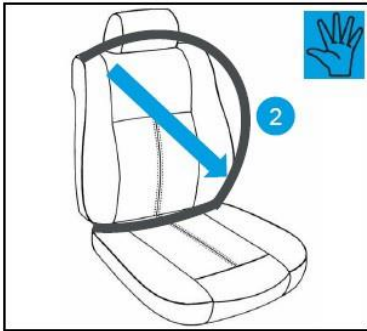
7) Referring to Figure 7 - Pull the passenger seatbelt all the way out of the retractor to activate the Automatic Locking Retractor (ALR).

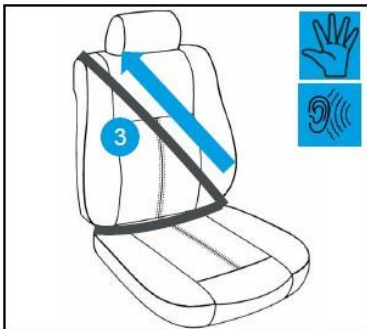
8) Referring to Figure 8 - Carefully allow the seatbelt to retract fully within the retractor whilst the belt remains buckled over the empty seat, this simulates a restrained child seat

IMPORTANT: You will notice that when in ALR mode, there is a ratcheting/clicking noise from the retractor, this is normal

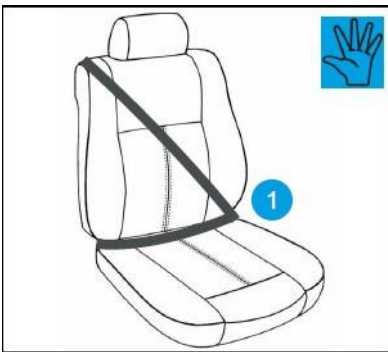
Figure 10

12) Put the seatbelt across the empty driver's seat and insert the metal tongue of the belt into the buckle (Figure 10)

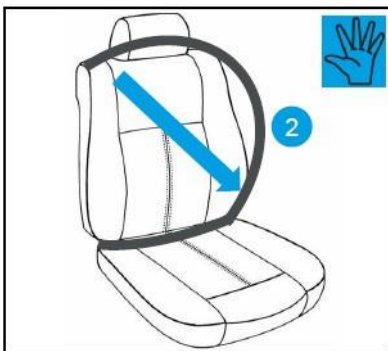
13) Referring to Figure 11 - Pull the driver's seatbelt all the way out of the retractor

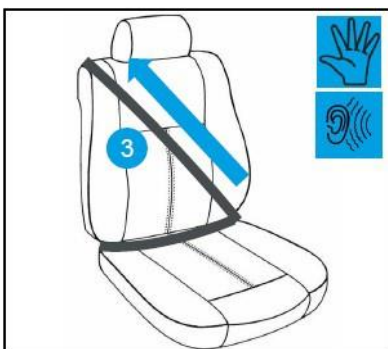
14) Referring to Figure 12 - Carefully let the seatbelt retract fully into the retractor whilst the belt remains buckled over the empty seat

On the driver's side seat there should not be a ratcheting/clicking noise from the retractor, this is normal as there is no ALR function on the driver's seat

Yes: The seatbelt MUST be replaced Refer to Rep.Gr 69 IMPORTANT: please ensure a photograph of the replacement seat belt identification is taken and saved as this will be required later in the process - Referring back to Figure 1 locate the identification label (Depending on model year see Figure 2 for label location)
