# Technical Service Bulletin

GROUP <b>RECALL</b>	NUMBER <b>22-01-035H</b>
DATE <b>APRIL 2022</b>	MODEL <b>SANTA FE (TMA) SANTA CRUZ (NXT)</b>

<b>SUBJECT:</b>	TURBO OIL FEED PIPE REPLACEMENT (RECALL 222)
-----------------	--

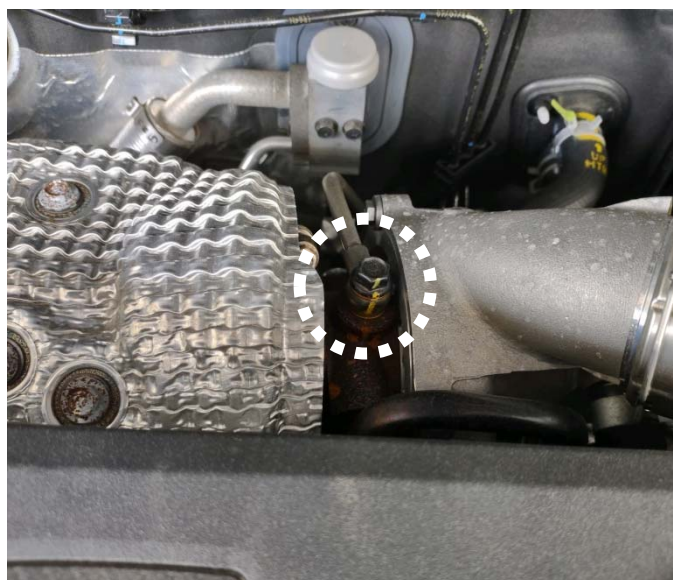
2. The indicated area is the oil feed pipe fitting portion of the turbocharger.

**NOTE:** During reassembly, be sure to position the copper gasket (A and B) above and below the new oil feed pipe banjo fitting as shown below.
