TO: Mercedes-Benz Dealer Principals, General Managers, Sales Managers, Service Managers, Parts Managers	FROM: Gregory Gunther, Department Manager, Vehicle Compliance and Analysis, Engineering Services
RE: Updated Recall Campaign Launch Notification STOP DRIVE Inspect and Replace Brake Booster with Pedal Rework MY06-12 GL-Class, ML-Class, R-Class (X164, W164, V251 platform)	UPDATE: March 24, 2023

Campaign No. 2022050014, May 2022

SUBJECT: **Model GL-Class, ML-Class, and R-Class (X164, W164 and 251 platform)
Model Year 2007-2008**

Inspect Brake Booster – with Pedal Rework

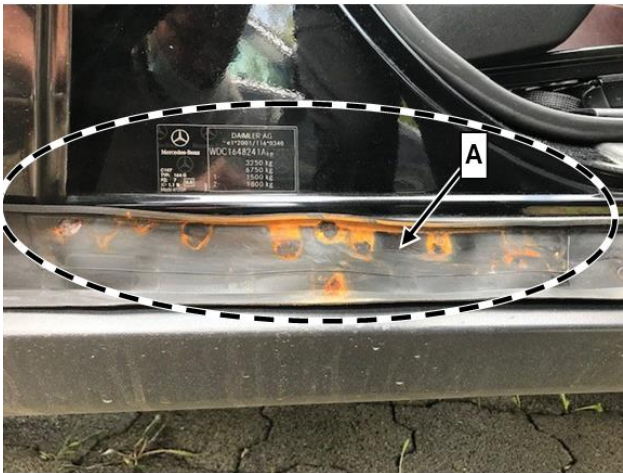
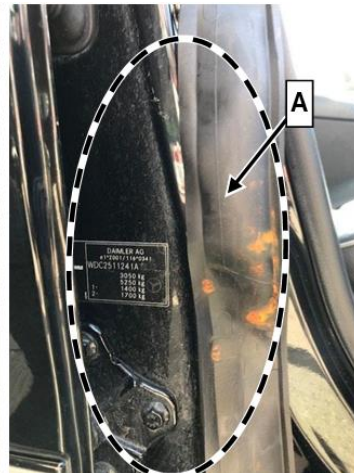
Figure 3

3. Take a photo of the rubber sleeve with the VIN label of the B-pillar (A, Figures 3 and 4) and store to a local HDD/computer storage location with the vehicle service file and attach it to the warranty claim in EVA.

i These pictures serve as documentation of the current condition of the brake booster.

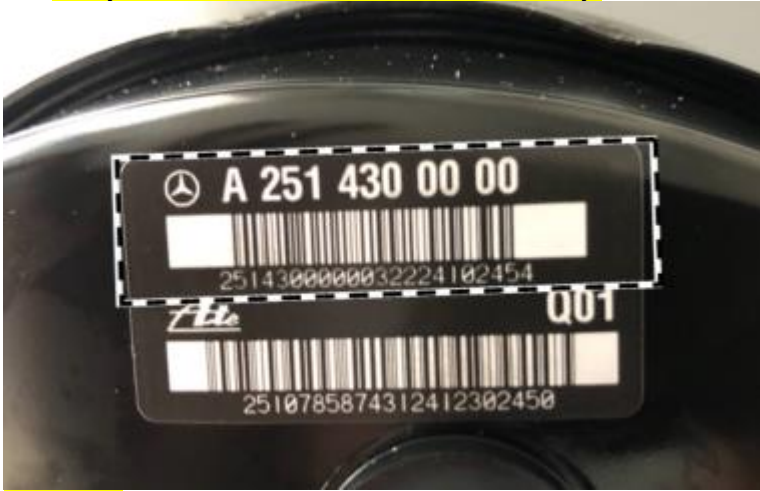
Figure 12

5. Read out serial number (**Figure 12**) using the **Mercedes-Benz PartScan** app.
