IMPORTANT RECALL CAMPAIGN UPDATE

Recall Campaign Launch Notification			March 10, 2023
Campaign No. :	NHTSA ID	Campaign Desc. :	Inspect Brake Booster Without Pedal Rework
2022050014	22V315	22P4290006	
<p>This is to notify you of an update to the Recall Campaign Launch to inspect the brake booster on 14,123 Model Year (“MY”) 2006-2012 GL-Class, ML-Class, and R-Class (X164, W164 and V251 platform) vehicles. The recall campaign will be visible on the www.safercar.gov website and may generate questions from customers. Affected VINs were flagged in VMI as “OPEN” on May 28, 2022.</p>			
Background			
Issue	<p>Mercedes-Benz AG (“MBAG”), the manufacturer of Mercedes-Benz vehicles, has determined that on certain Model Year (“MY”) 2006-2012 ML-Class, GL-Class (W164/X164 platform) and R-Class (V251 platform) vehicles, the function of the brake booster might be affected due to advanced corrosion in the joint area of its housing. After extended time in the field and in conjunction with prolonged water exposure, this corrosion might lead to a vacuum leak at the brake booster. If this were to occur, the brake force support might be reduced, leading to an increase in the brake pedal forces require

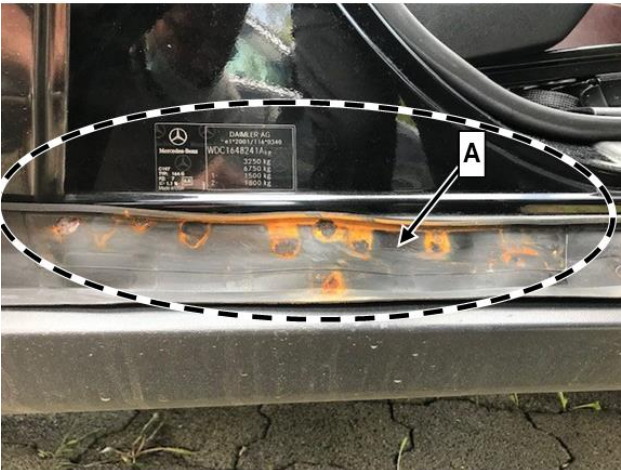
Figure 3

3. Take a photo of the rubber sleeve with the VIN label of the B-pillar (**A, figures 3 and 4**) and store to a local HDD/computer storage location with the vehicle service file and attach it to the warranty claim in EVA.
i These pictures serve as documentation of the current condition of the brake booster.
