| RE: Updated Recall Campaign Launch Notification STOP DRIVE Inspect and Replace Brake Booster without Pedal Rework MY06-12 GL-Class, ML-Class, R-Class (X164, W164, V251 platform) | UPDATE: March 24, 2023 |

| Recall Campaign Launch Notification | | | March 24, 2023 |
|--|---|---|---|
| Campaign No. : | NHTSA ID | Campaign Desc. : | Inspect and Replace Brake Booster Without Pedal Rework |

Recall Campaign Bulletin

Inspect Brake Booster – without Pedal Rework

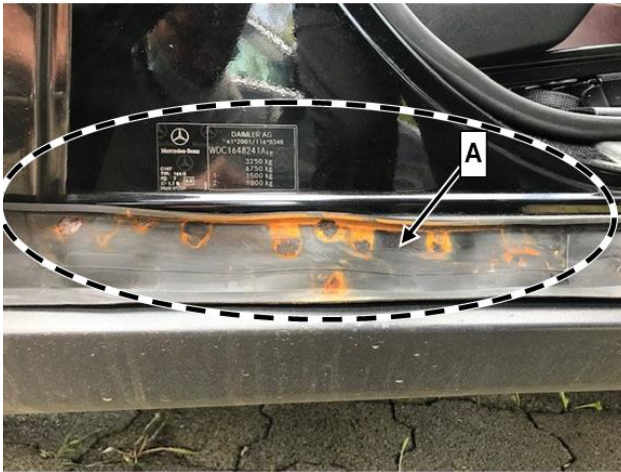
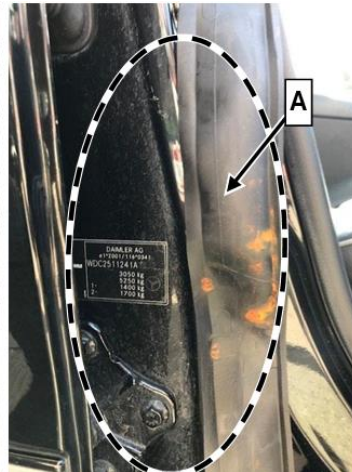
3. Take a photo of the rubber sleeve with the VIN label of the B-pillar (**A, Figures 3 and 4**) and store to a local HDD/computer storage location with the vehicle service file and attach it to the warranty claim in EVA.
 - i** These pictures serve as documentation of the current condition of the brake booster.

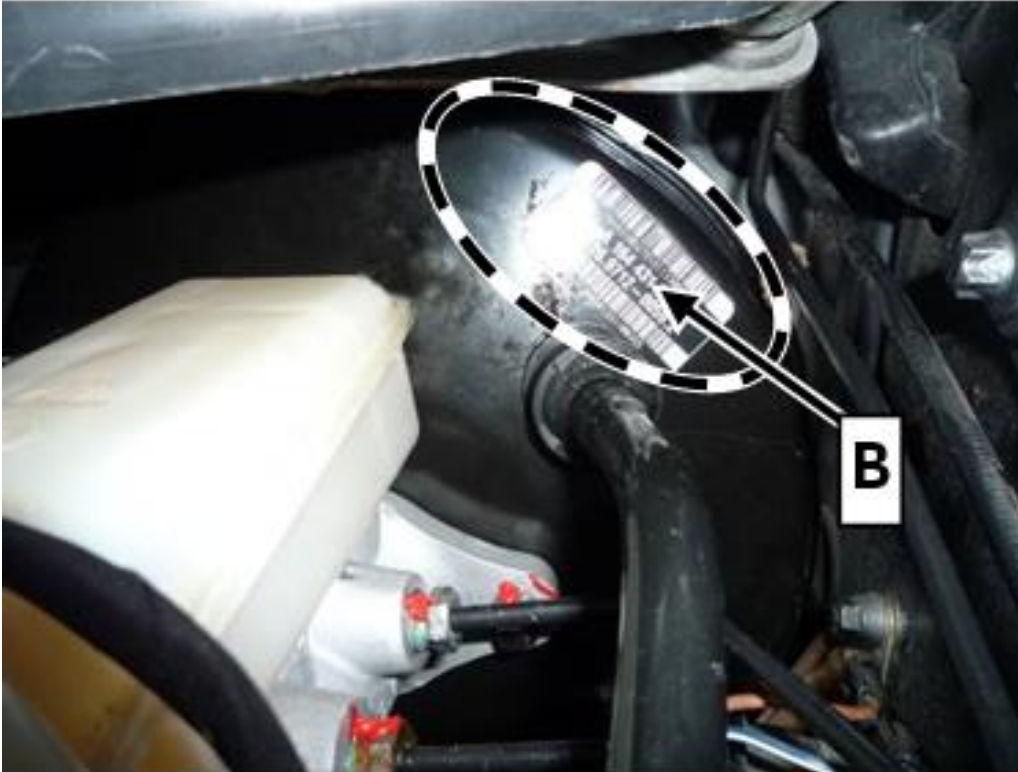
Figure 8

1. Take a photo of the barcode label (**B, Figure 8**) on the brake booster and store to a local HDD/computer storage location with the vehicle service file and attach to the warranty claim in EVA.

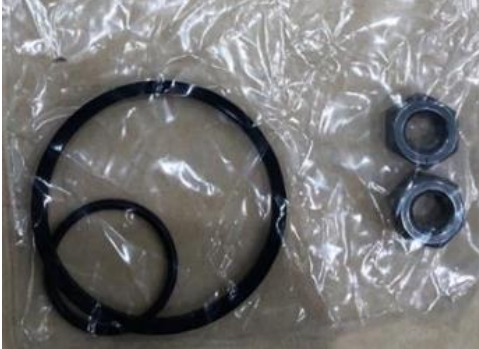
Figure 11

i The new brake booster contains a small parts kit (**Figure 11**).

1. Replace brake booster.

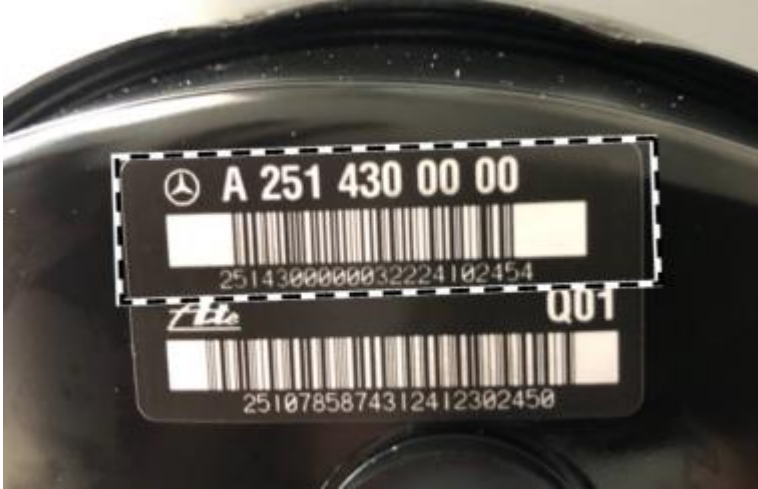
Figure 12

4. Read out serial number (**Figure 12**) using the *Mercedes-Benz PartScan* app.
