TO: Mercedes-Benz Dealer Principals, General Managers, Sales Managers, Service Managers, Parts Managers	FROM: Gregory Gunther, Department Manager, Vehicle Compliance and Analysis, Engineering Services
RE: <b>Updated Recall Campaign Launch Notification – STOP DRIVE</b> <b>Inspect Brake Booster without Pedal Rework MY06-12 GL-Class, ML-Class, R-Class (X164, W164, V251 platform)</b>	UPDATE: March 10, 2023

Campaign No. 2022050015, May 2022

SUBJECT: **Model GL-Class, ML-Class, and R-Class (X164, W164 and 251 platform)  
Model Year 2006-2012**

## **Inspect Brake Booster – without Pedal Rework**

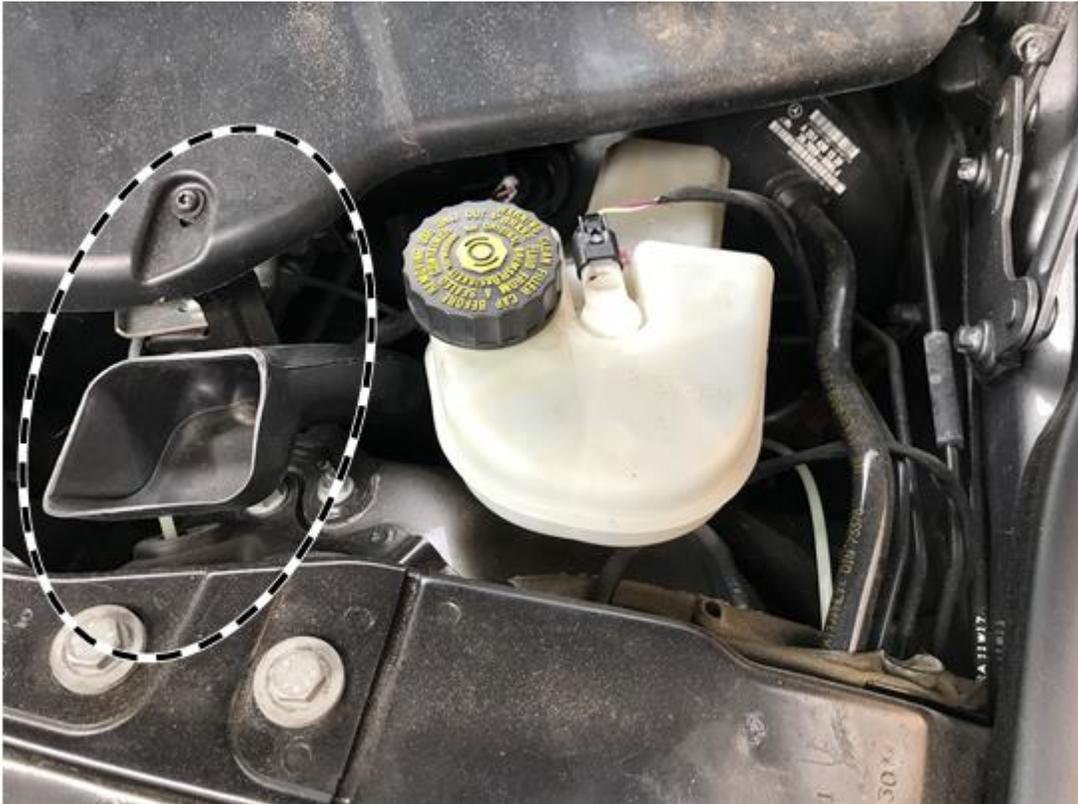
**Figure 1**

1. Open the hood and check the water drains (**marking, figure 1**) for correct installation and ability to drain.

**i** Clean and correctly install water drains if necessary.

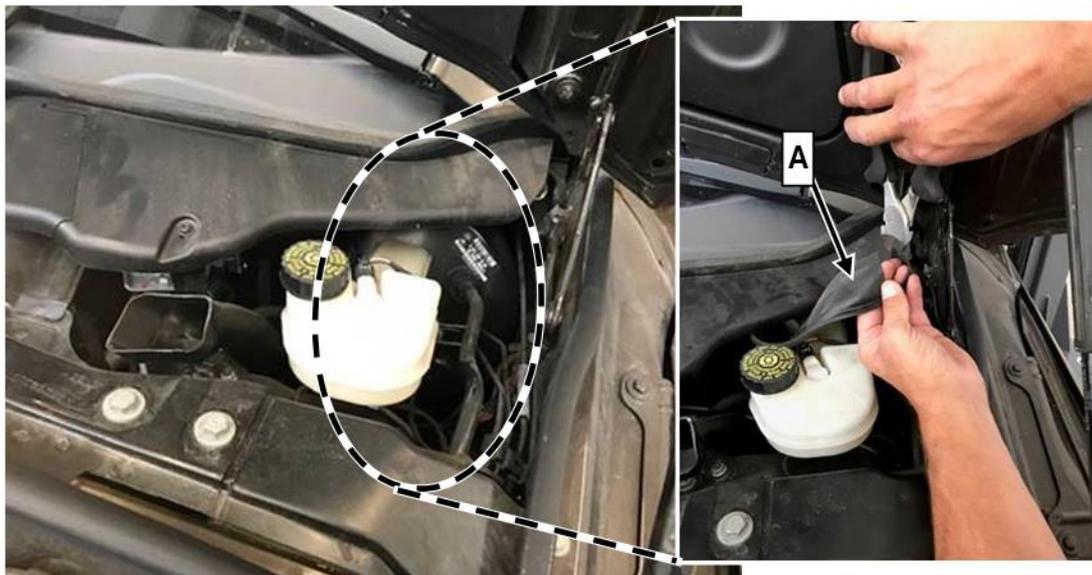
Figure 2

2. Remove the rubber sleeve wrapped around the brake booster (A, figure 2) with a suitable tool (hook and side cutting pliers). If the rubber sleeve is not present, please proceed to check/test procedure A1.  
**i** The rubber sleeve should be separated above the barcode label on the brake booster as seen in (A, figure 2 and B, figure 4.1).

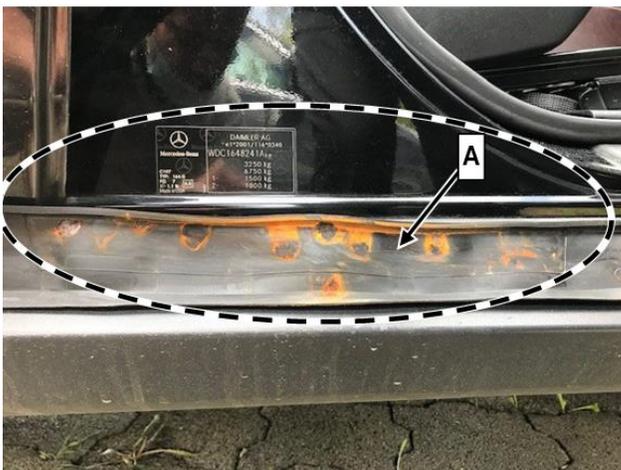
Figure 3

3. Take a photo of the rubber sleeve with the VIN label of the B-pillar (A, figures 3 and 4) and store to a local HDD/computer storage location with the vehicle service file and attach it to the warranty claim in EVA.  
**i** These pictures serve as documentation of the current condition of the brake booster.

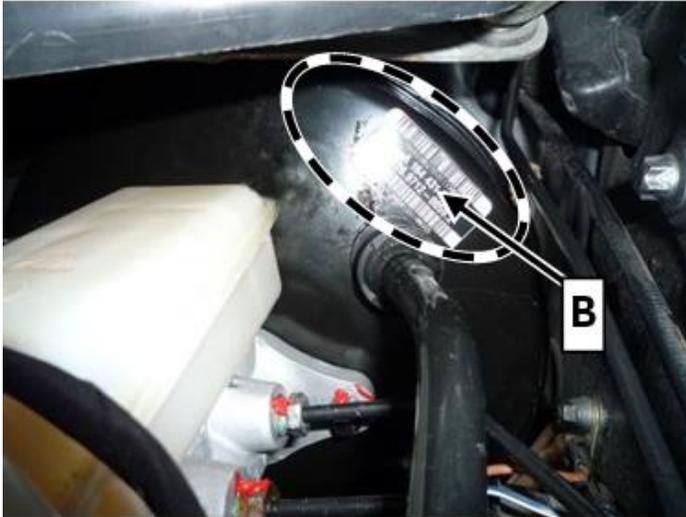
Figure 8

1. Take a photo of the barcode label (B, figure 8) on the brake booster and store to a local HDD/computer storage location with the vehicle service file and attach to the warranty claim in EVA.

**i** If the measure is ended, **do not** re-install a new rubber sleeve. Apply marking with **white touch-up paint pen (1, figure 8)** to the brake booster checked.
