IMPORTANT RECALL CAMPAIGN UPDATE

Recall Campaign Bulletin

Campaign No. 2022050015, May 2022

Inspect Brake Booster – without Pedal Rework

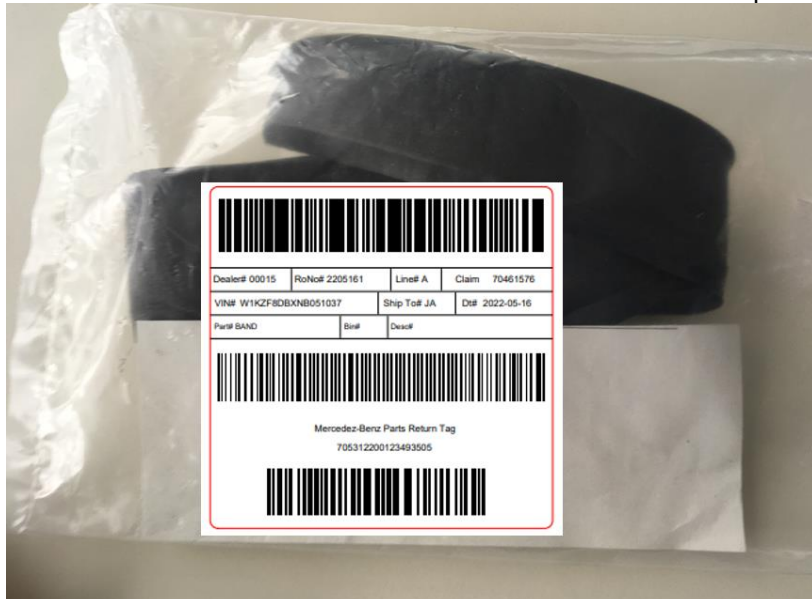
All rubber sleeves should be individually tagged with a warranty parts return barcode and bagged. Recommend that bulk sleeve shipments are placed into a single overpack bag and then packaged in a small box with a copy of the Load List affixed to the box. Failure to return the rubber sleeve within the pre-defined time period will result in a non-return part debit.

- For each vehicle processed, print out the part return barcode from the NetStar Parts Disposition application
- Pack the rubber sleeve with the part return barcode in a plastic bag and seal securely with barcode **visible from the outside** (see figure 1).
- For Dedicated Delivery Service (DDS) dealers, please forward parts in bulk (10-20 pcs per Load List unless time does not permit) to your facing PDC using the normal DDS warranty parts return process. Please ensure you include a Dealer Return slip marked for Warranty.
- For non-DDS dealers, please forward parts in bulk (10-20 pcs per Load List unless time does not permit) directly to the QEC using the normal FedEx Ground warranty parts return process.
