TO: Mercedes-Benz Dealer Principals, General Managers, Sales Managers, Service Managers, Parts Managers	FROM: Gregory Gunther, Department Manager, Vehicle Compliance and Analysis, Engineering Services
RE: <b>Updated Recall Campaign Launch Notification – STOP DRIVE</b>  <b>Inspect Brake Booster with Pedal Rework MY07-08 GL-Class, ML-Class, R-Class (X164, W164, 251 platform)</b>	UPDATE: June 22, 2022

Campaign No. 2022050014, May 2022

SUBJECT: **Model GL-Class, ML-Class, and R-Class (X164, W164 and 251 platform)  
Model Year 2007-2008**

## **Inspect Brake Booster – with Pedal Rework**

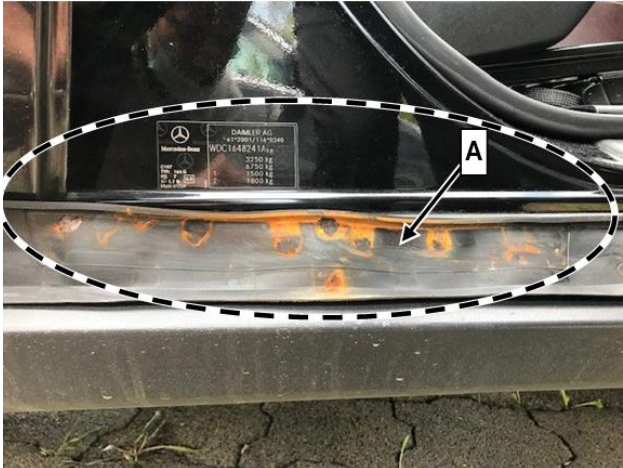
Figure 3

3. Take a photo of the rubber sleeve with the VIN label of the B-pillar (**A, figures 3 and 4**) and store to a local HDD/computer storage location with the vehicle service file and attach it to the warranty claim in EVA.
  - i** These pictures serve as documentation of the current condition of the brake booster.

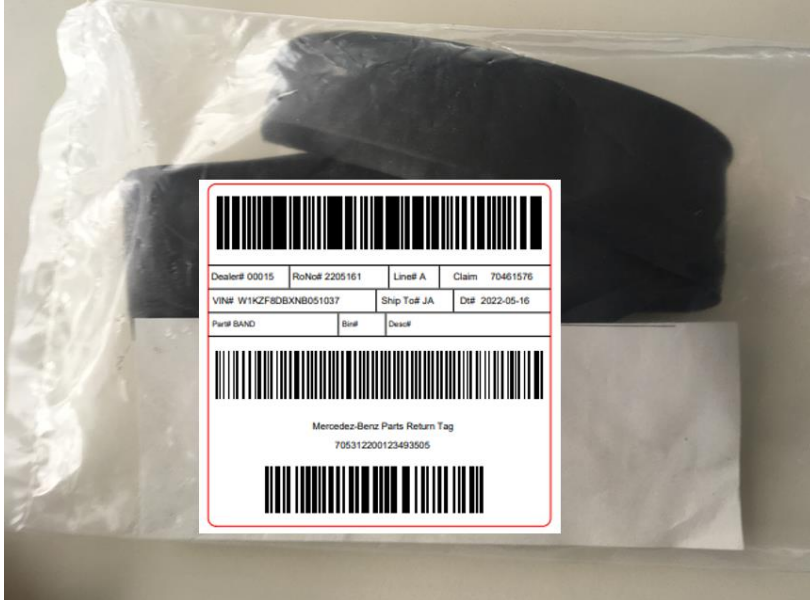
- For each vehicle processed, print out the part return barcode from the NetStar Parts Disposition application
- Pack the rubber sleeve with the part return barcode in a plastic bag and seal securely with barcode **visible from the outside** (see figure 1).
- For Dedicated Delivery Service (DDS) dealers, please forward parts in bulk (10-20 pcs per Load List unless time does not permit) to your facing PDC using the normal DDS warranty parts return process. Please ensure you include a Dealer Return slip marked for Warranty.
- For non-DDS dealers, please forward parts in bulk (10-20 pcs per Load List unless time does not permit) directly to the QEC using the normal FedEx Ground warranty parts return process.

All rubber sleeves should be individually tagged with a warranty parts return barcode and bagged. Recommend that bulk sleeve shipments are placed into a single overpack bag and then packaged in a small box with a copy of the Load List affixed to the box. Failure to return the rubber sleeve within the pre-defined time period will result in a non-return part debit.
