Recall Campaign Bulletin

Campaign No. 2022050015, May 2022

SUBJECT: **Model GL-Class, ML-Class, and R-Class (X164, W164 and 251 platform)
Model Year 2006-2012**

Inspect Brake Booster – without Pedal Rework

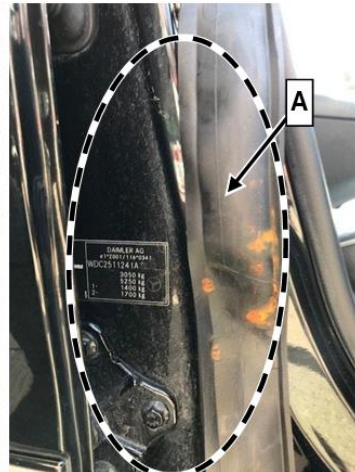
Figure 4

3. Take a photo of the rubber sleeve with the VIN label of the B-pillar (**A, figures 3 and 4**) and store to a local HDD/computer storage location with the vehicle service file and attach it to the warranty claim in EVA.

i These pictures serve as documentation of the current condition of the brake booster.
