Recall Campaign Bulletin

Campaign No. 2022050014, May 2022

SUBJECT: **Model GL-Class, ML-Class, and R-Class (X164, W164 and 251 platform)
Model Year 2007-2008**

Inspect Brake Booster – with Pedal Rework

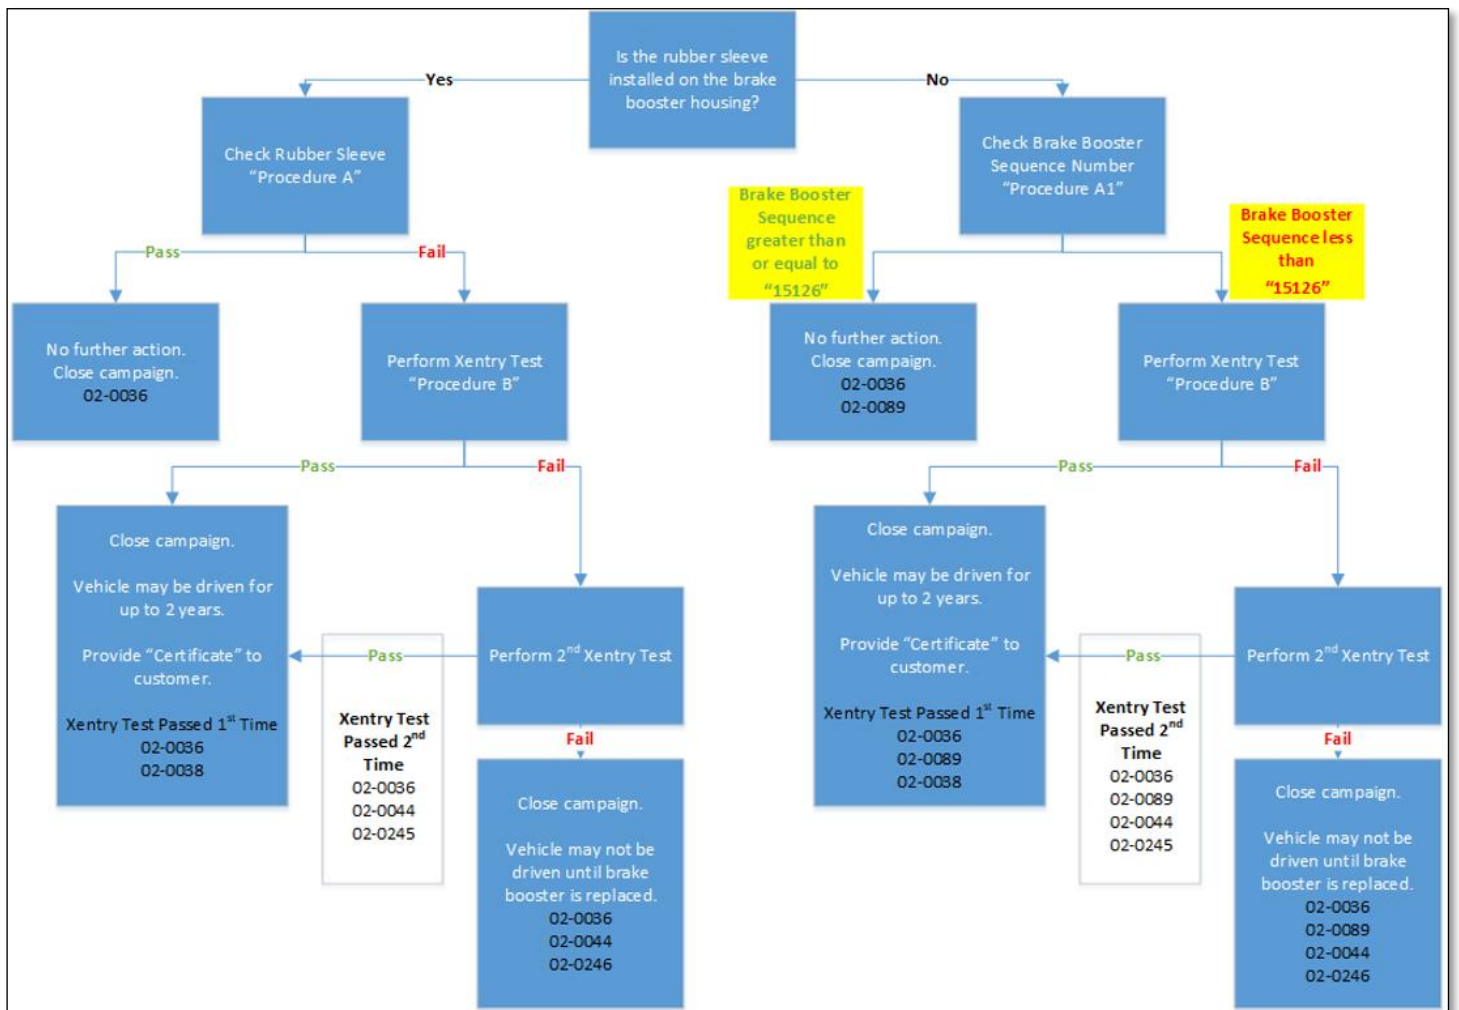
1. Flow chart with allowable labor operation codes when submitting a warranty claim.

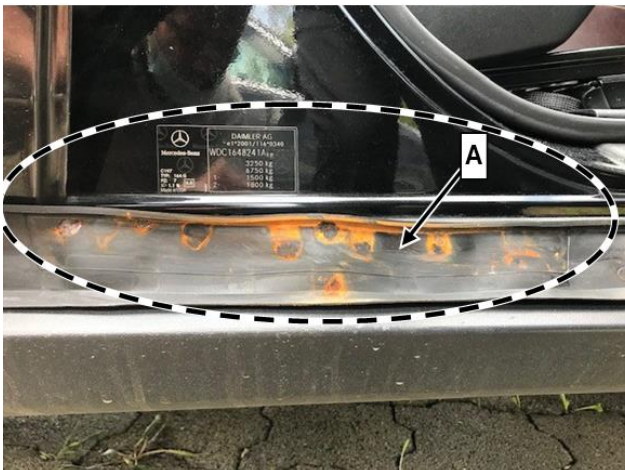
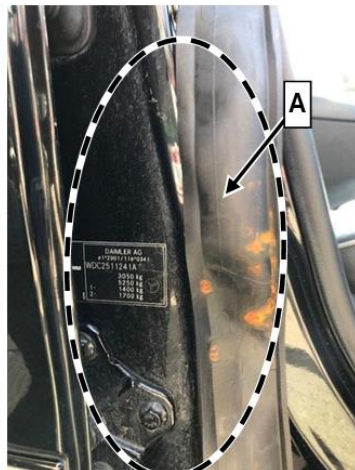
3. Take a photo of the rubber sleeve with the VIN label of the B-pillar (A, figures 3 and 4) and store to a local HDD/computer storage location with the vehicle service file and attach it to the warranty claim in EVA.
- i** These pictures serve as documentation of the current condition of the brake booster.
