David J. Johnson
 Director
 Service Engineering Operations
 Ford Customer Service Division

August 5, 2022

**SUBJECT: NEW VEHICLE DEMONSTRATION / DELIVERY HOLD –
 Safety Recall 22S36 – Supplement #4**
 Certain 2021 Model Year Expedition and Lincoln Navigator Vehicles equipped with a
 Standard Duty Cooling Fan
 Underhood Fire

**REF: NEW VEHICLE DEMONSTRATION / DELIVERY HOLD –
 Safety Recall 22S48 – Supplement #2**
 Certain 2021 Model Year Expedition and Lincoln Navigator Vehicles equipped with a Heavy
 Duty Cooling Fan
 Underhood Fire

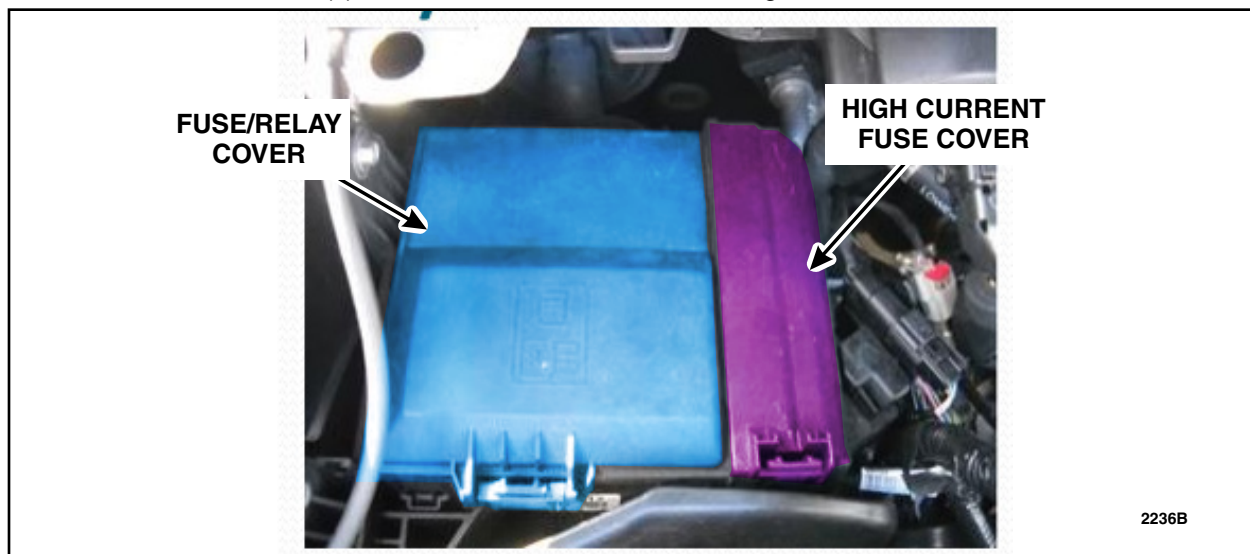
FIGURE 2

1. Position vehicle to be placed on a hoist.
2. Are both the fuse/relay cover and the High Current fuse cover present. See Figure 2.
Yes - Proceed to Step 3.
No - Install new cover(s). Proceed to Step 3.

IMPORTANT: New cover(s) can be ordered WITHOUT ordering a new BJB.

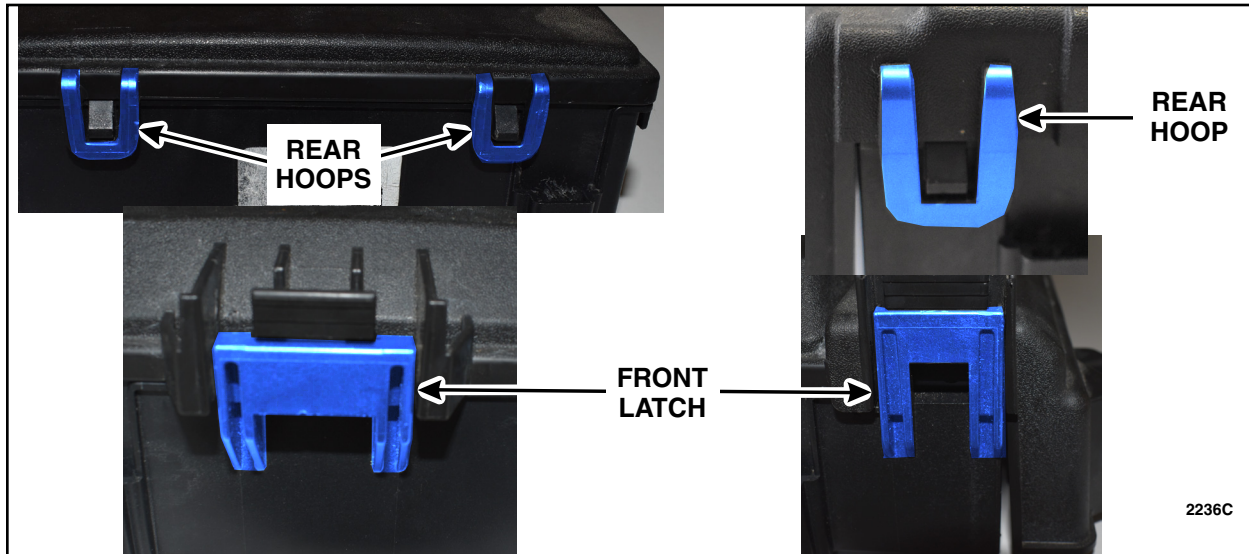
FIGURE 3

3. Check to make sure that the covers are properly installed. On the fuse box cover there are three attachment features securely engaged, two hoops in the rear and one latch in the front. On the High Current cover there are two attachment features securely engaged, one hoop in rear fully engaged and one latch in the front fully engaged. See Figure 3. Are both covers properly installed?

No - Ensure that the covers latch and install properly. Proceed to Step 4.

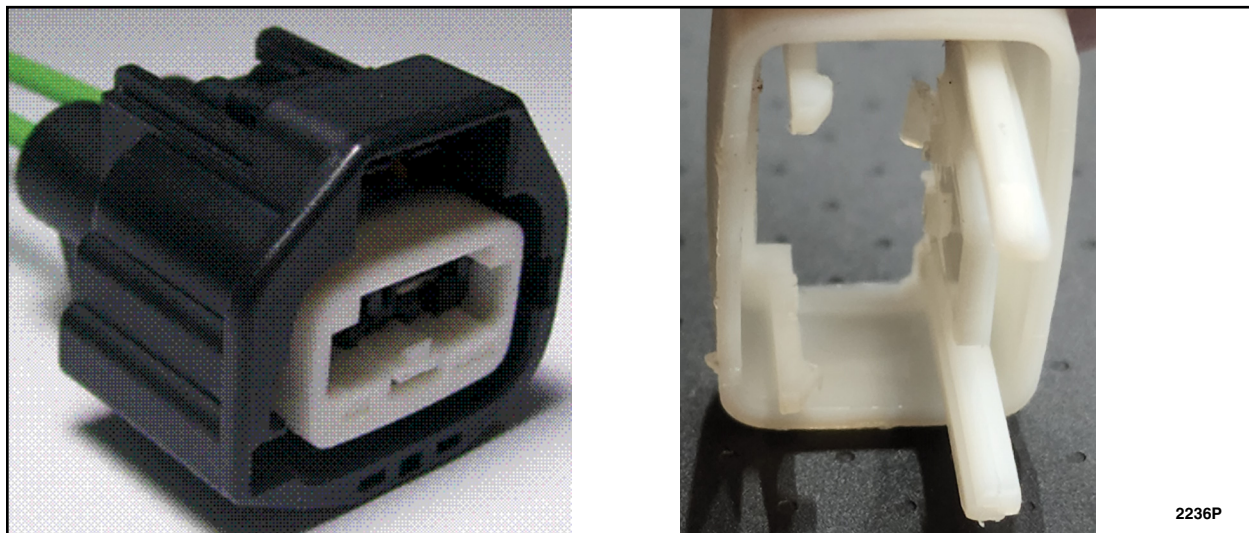
FIGURE 22

26. Remove connector cover to the C1074 connector to access the terminal. See Figure 22.

CAUTION: Connector cover cannot be ordered individually if broken. The only way to replace this cover is with the cooling fan pigtail repair kit.

NOTE: If connector cover is broken during removal contact the SSSC.
