David J. Johnson
 Director
 Service Engineering Operations
 Ford Customer Service Division

SUBJECT: **NEW VEHICLE DEMONSTRATION / DELIVERY HOLD – Safety Recall 22S36 – Supplement #3**
 Certain 2021 Model Year Expedition and Lincoln Navigator Vehicles equipped with a Standard Duty Cooling Fan
 Underhood Fire

REF: **NEW VEHICLE DEMONSTRATION / DELIVERY HOLD – Safety Recall 22S48 – Supplement #1**
 Certain 2021 Model Year Expedition and Lincoln Navigator Vehicles equipped with a Heavy Duty Cooling Fan
 Underhood Fire

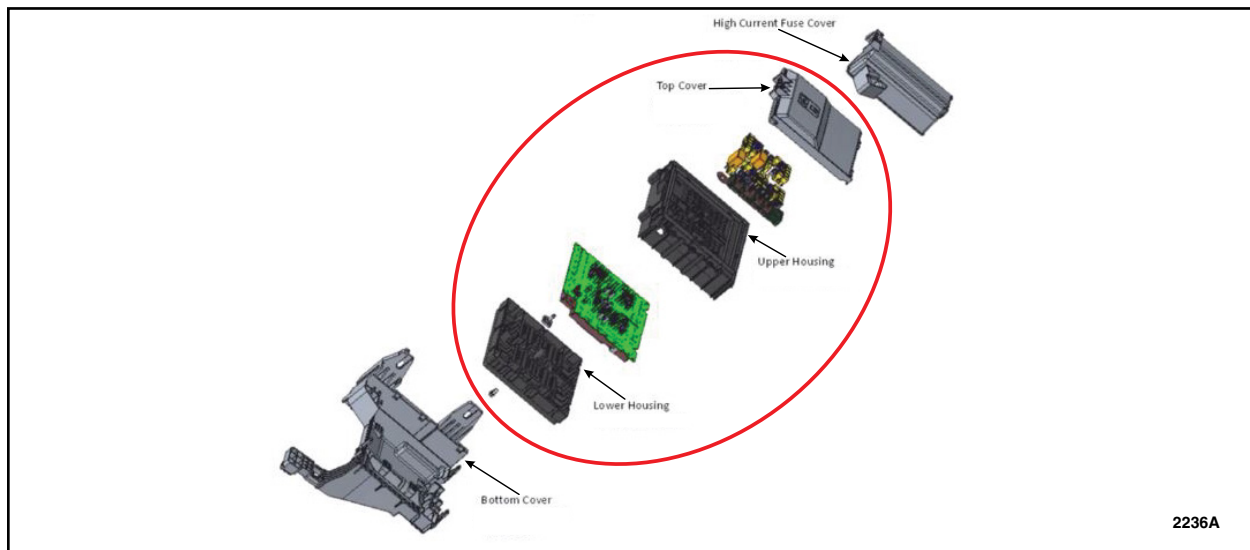
FIGURE 1

Figure 1 is a breakdown of the Battery Junction Box (BJB).

NOTE: Items circled in red are included with a new BJB. Covers can be ordered independently of the BJB.

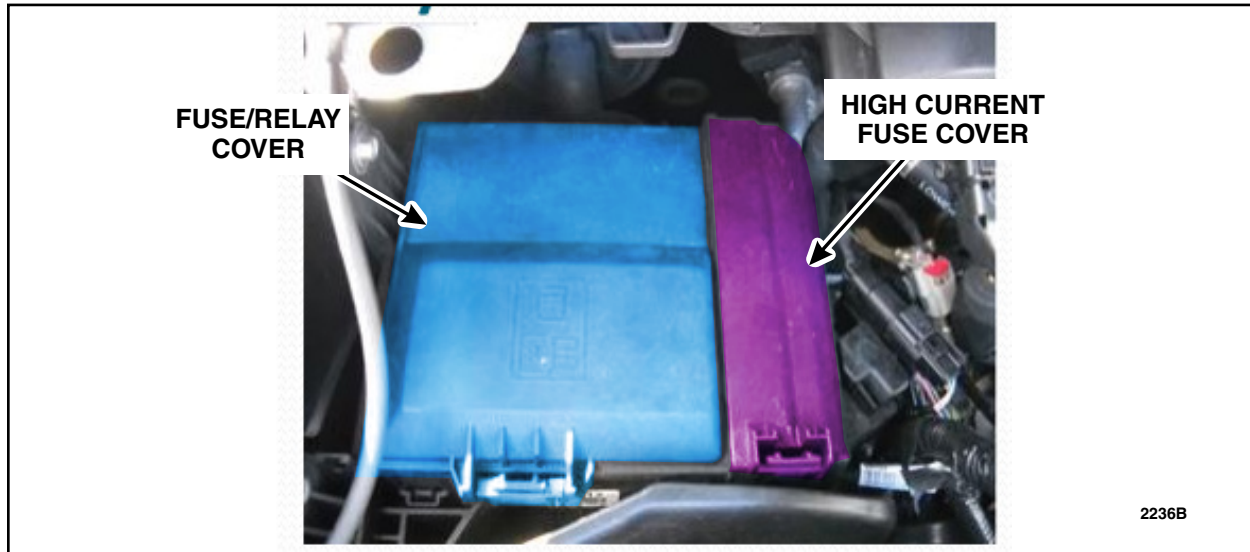
FIGURE 2

1. Position vehicle to be placed on a hoist.
2. Are both the fuse/relay cover and the High Current fuse cover present. See Figure 2.
Yes - Proceed to Step 3.
No - Install new cover(s). Proceed to Step 3.

⚠ IMPORTANT: New cover(s) can be ordered WITHOUT ordering a new BJB.

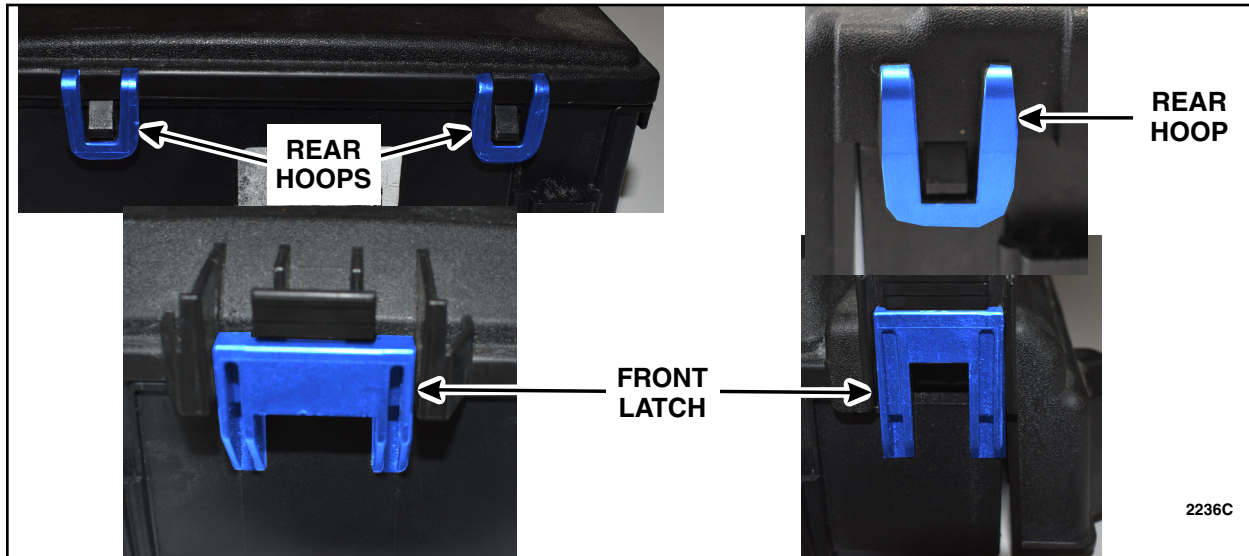
FIGURE 3

3. Check to make sure that the covers are properly installed. On the fuse box cover there are three attachment features securely engaged, two hoops in the rear and one latch in the front. On the High Current cover there are two attachment features securely engaged, one hoop in rear fully engaged and one latch in the front fully engaged. See Figure 3. Are both covers properly installed?

No - Ensure that the covers latch and install properly. Proceed to Step 4.

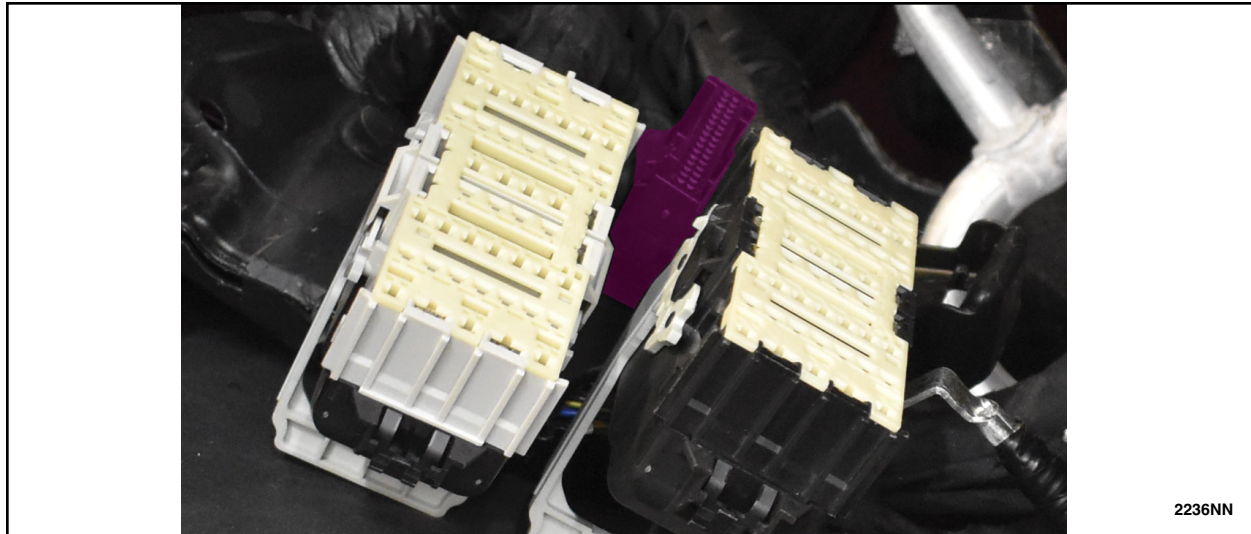
FIGURE 45

NOTE: Connector has been highlighted purple to aid in identification.

55. Identify connector C1035C. See Figure 45. If needed wire covering can be pulled back.

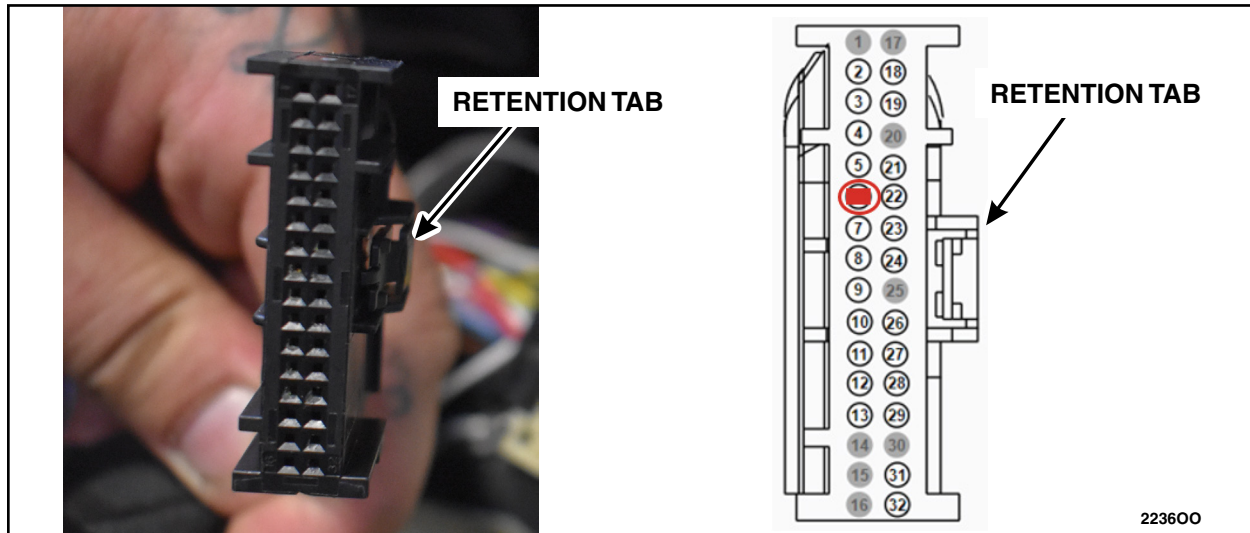
FIGURE 46

NOTE: Ensure that the direction of the retention tab matches to Figure 46.

WARNING: Ensure that the proper cavity has been identified as there is more than one white-blue wire.

56. In connector C1035C identify cavity 6 which contains a white-blue wire. Ensure that the cavities in the connector are being counted and not wires. Do NOT remove wire from connector. See Figure 46.

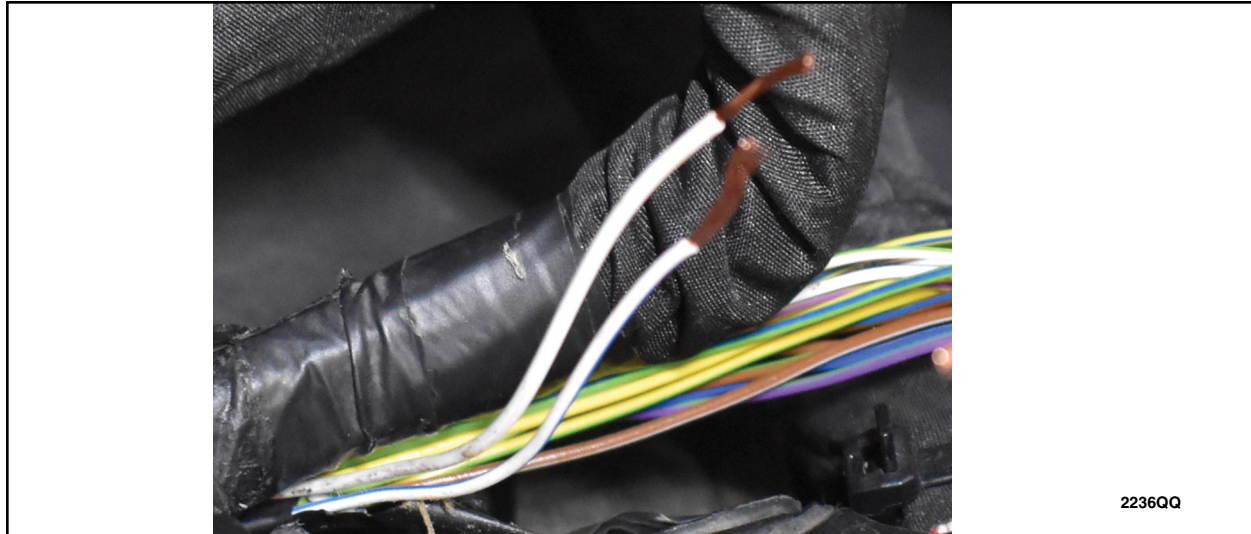
FIGURE 48

NOTE: If the label on the white wire is interfering with the splice site, this label can be pulled down on the wire.

58. Strip 1" of insulation from the white/blue wire and the white wire, and terminal end. Put dual wall heat shrink tubing over white/blue wire and white wire. See Figure 48.

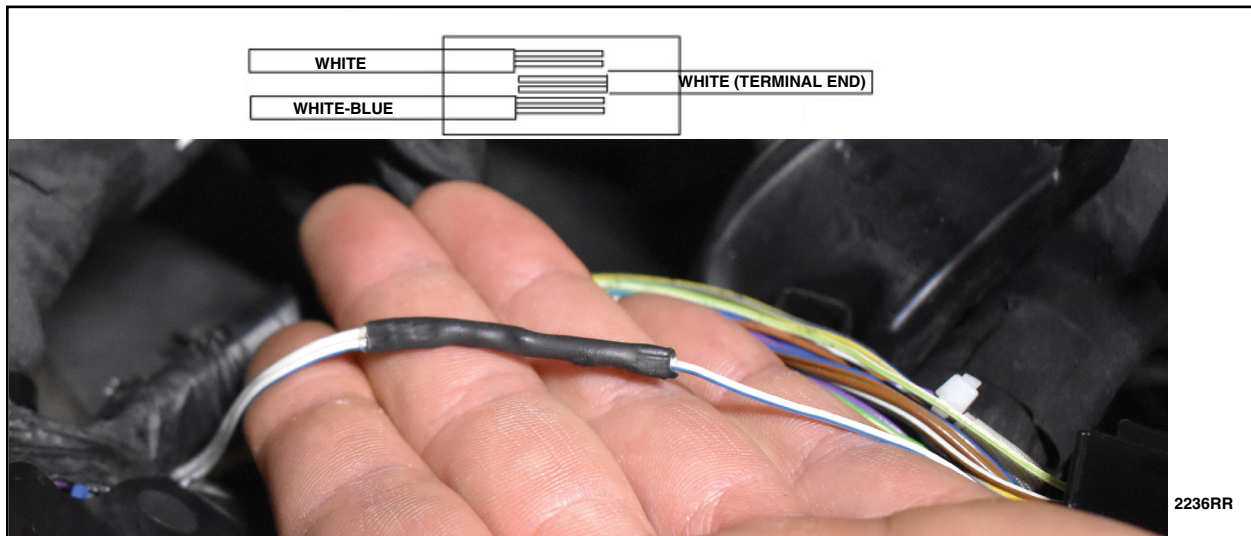
FIGURE 49

NOTE: If there is excess white wire it can be cut off.

59. On the white/blue terminal end fold the exposed wire in half before placing in splice butt connector. This will allow good contact with the butt splice connector. Place wires in splice butt connector. See Figure 49.

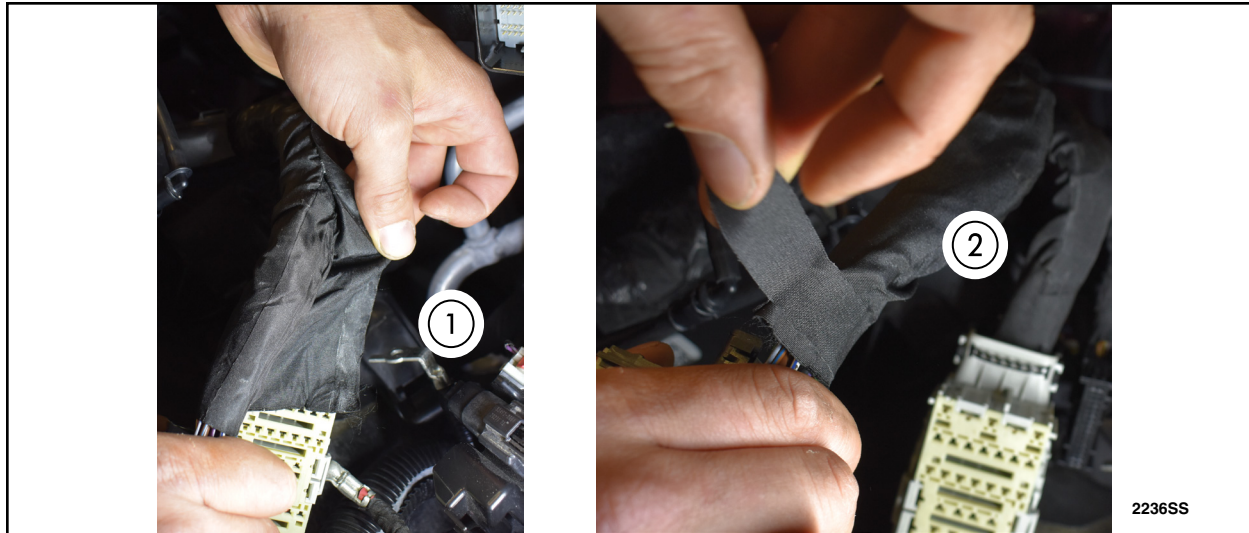
FIGURE 50

NOTE: If there are any tears in the wire covering, it will still be reused. Using Coroplast tape, secure wire covering.

60. Put wire covering back into place and secure with new Coroplast tape. See Figure 50.

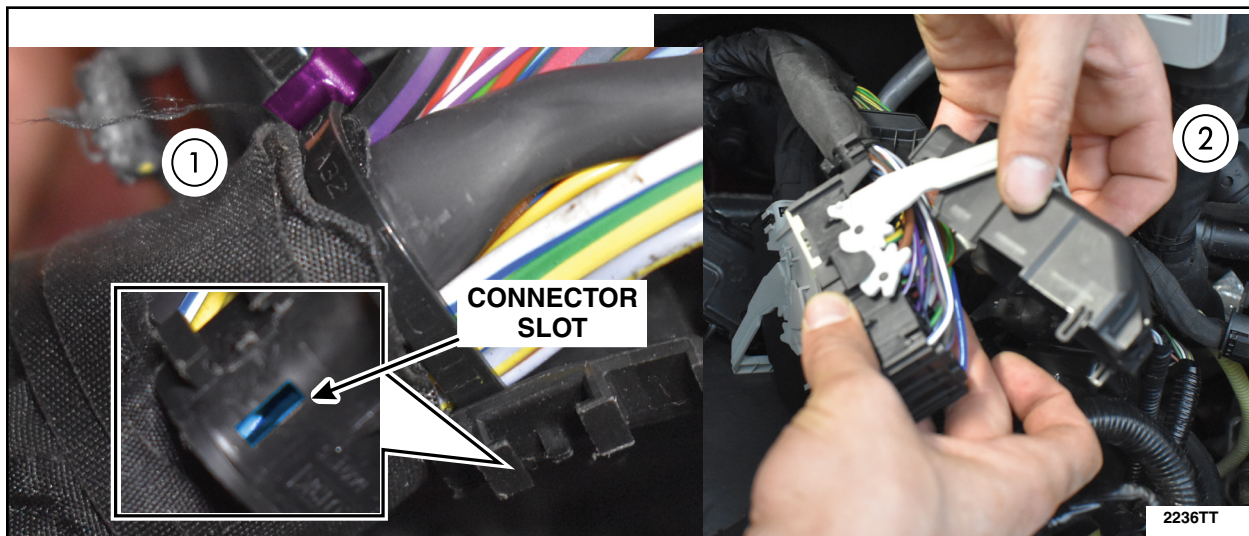
FIGURE 51

NOTE: Be sure to use identified slots to pull zip-tie through. Also, the head of the zip-tie must be placed so that it will be underneath the wire bundle, or it will not clip back into place.

61. Secure wire covering and wire bundle with a zip tie. Clip back shell into place on connector C1035B. See Figure 51.
