**SUBJECT: NEW VEHICLE DEMONSTRATION / DELIVERY HOLD –  
 Safety Recall 22S48**

Certain 2021 Model Year Expedition and Lincoln Navigator Vehicles equipped with a Heavy-Duty Cooling Fan  
 Underhood Fire

**REF: NEW VEHICLE DEMONSTRATION / DELIVERY HOLD –  
 Safety Recall 22S36 – Supplement #2**

Certain 2021 Model Year Expedition and Lincoln Navigator Vehicles equipped with a Standard-Duty Cooling Fan  
 Underhood Fire

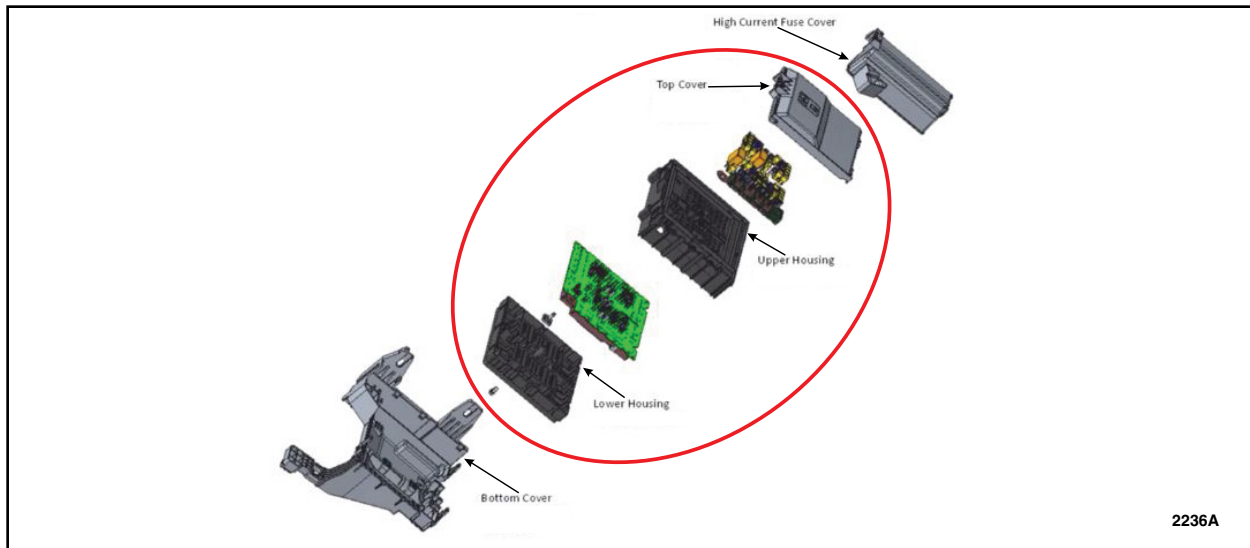
**FIGURE 1**

Figure 1 is a breakdown of the Battery Junction Box (BJB).

**NOTE:** Items circled in red are included with a new BJB. Covers can be ordered independently of the BJB.

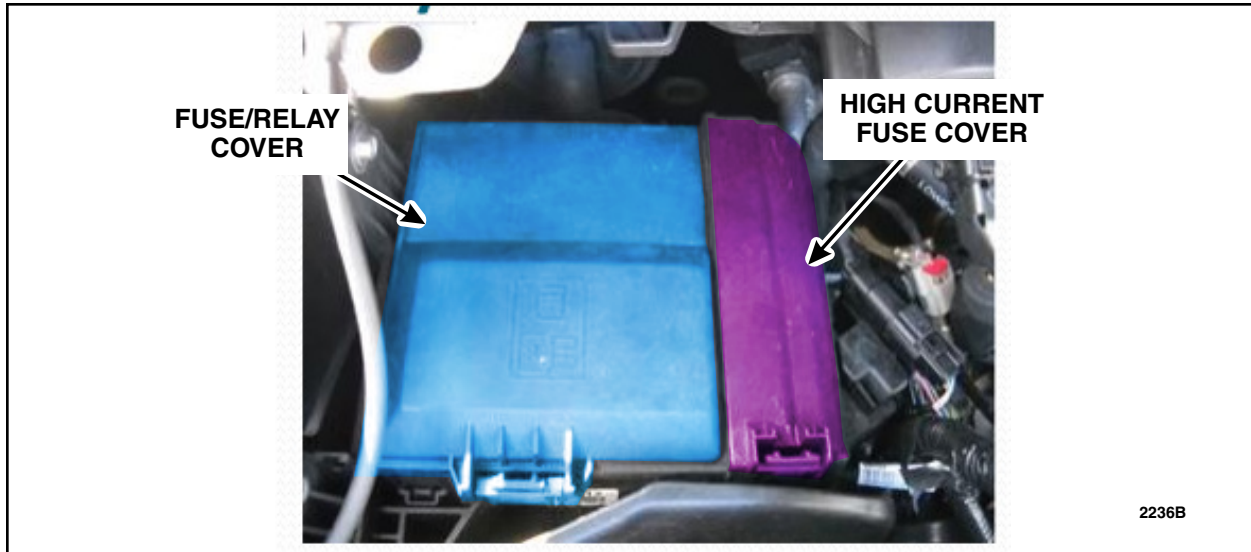
**FIGURE 2**

1. Are both the fuse/relay cover and the High Current fuse cover present. See Figure 2.  
Yes - Proceed to Step 2.  
No - Install new cover(s). Proceed to Step 2.

**IMPORTANT:** New cover(s) can be ordered WITHOUT ordering a new BJB.

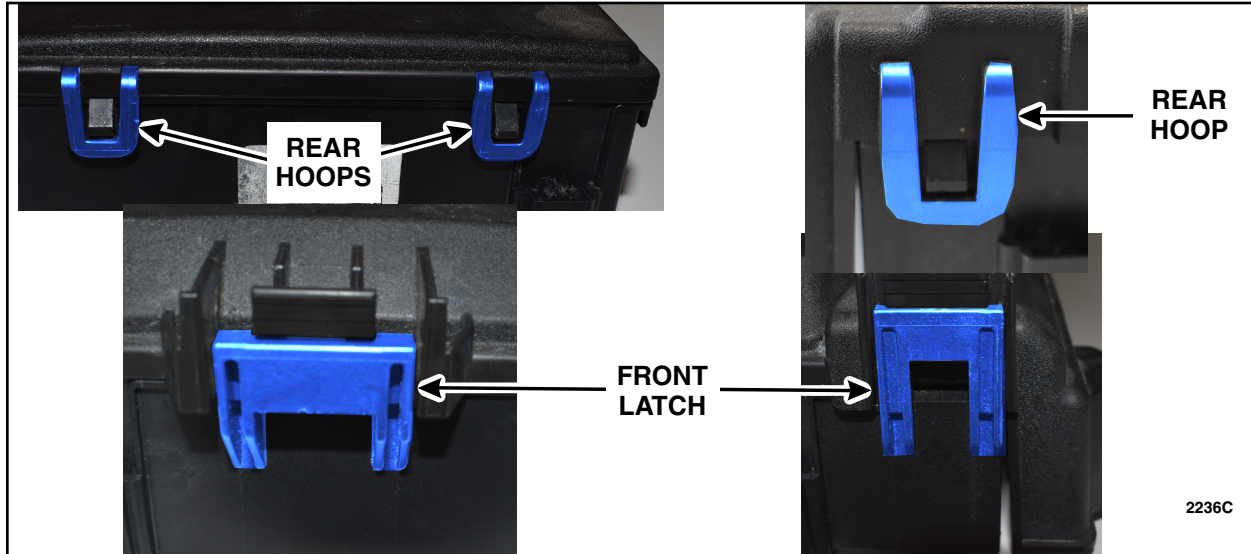
FIGURE 3

2. Check to make sure that the covers are properly installed. On the fuse box cover there are three attachment features securely engaged, two hoops in the rear and one latch in the front. On the High Current cover there are two attachment features securely engaged, one hoop in rear fully engaged and one latch in the front fully engaged. See Figure 3. Are both covers properly installed?

Yes - Proceed to Step 3.

No - Ensure that the covers latch and install properly. Proceed to Step 3.
